# **A Study of Corrosion in Hydroprocess Reactor Effluent Air Cooler Systems**

API PUBLICATION 932-A  
SEPTEMBER 2002

This study was sponsored by the American Petroleum Institute (API), Committee on Refinery Equipment, Subcommittee on Corrosion and Materials Research. The purpose of the study was to provide technical background, based on industry experience and consensus practice, for controlling corrosion in hydroprocess reactor effluent systems. The findings reported herein will be used as an interim resource by the industry and as a basis for a future API recommended practice document.

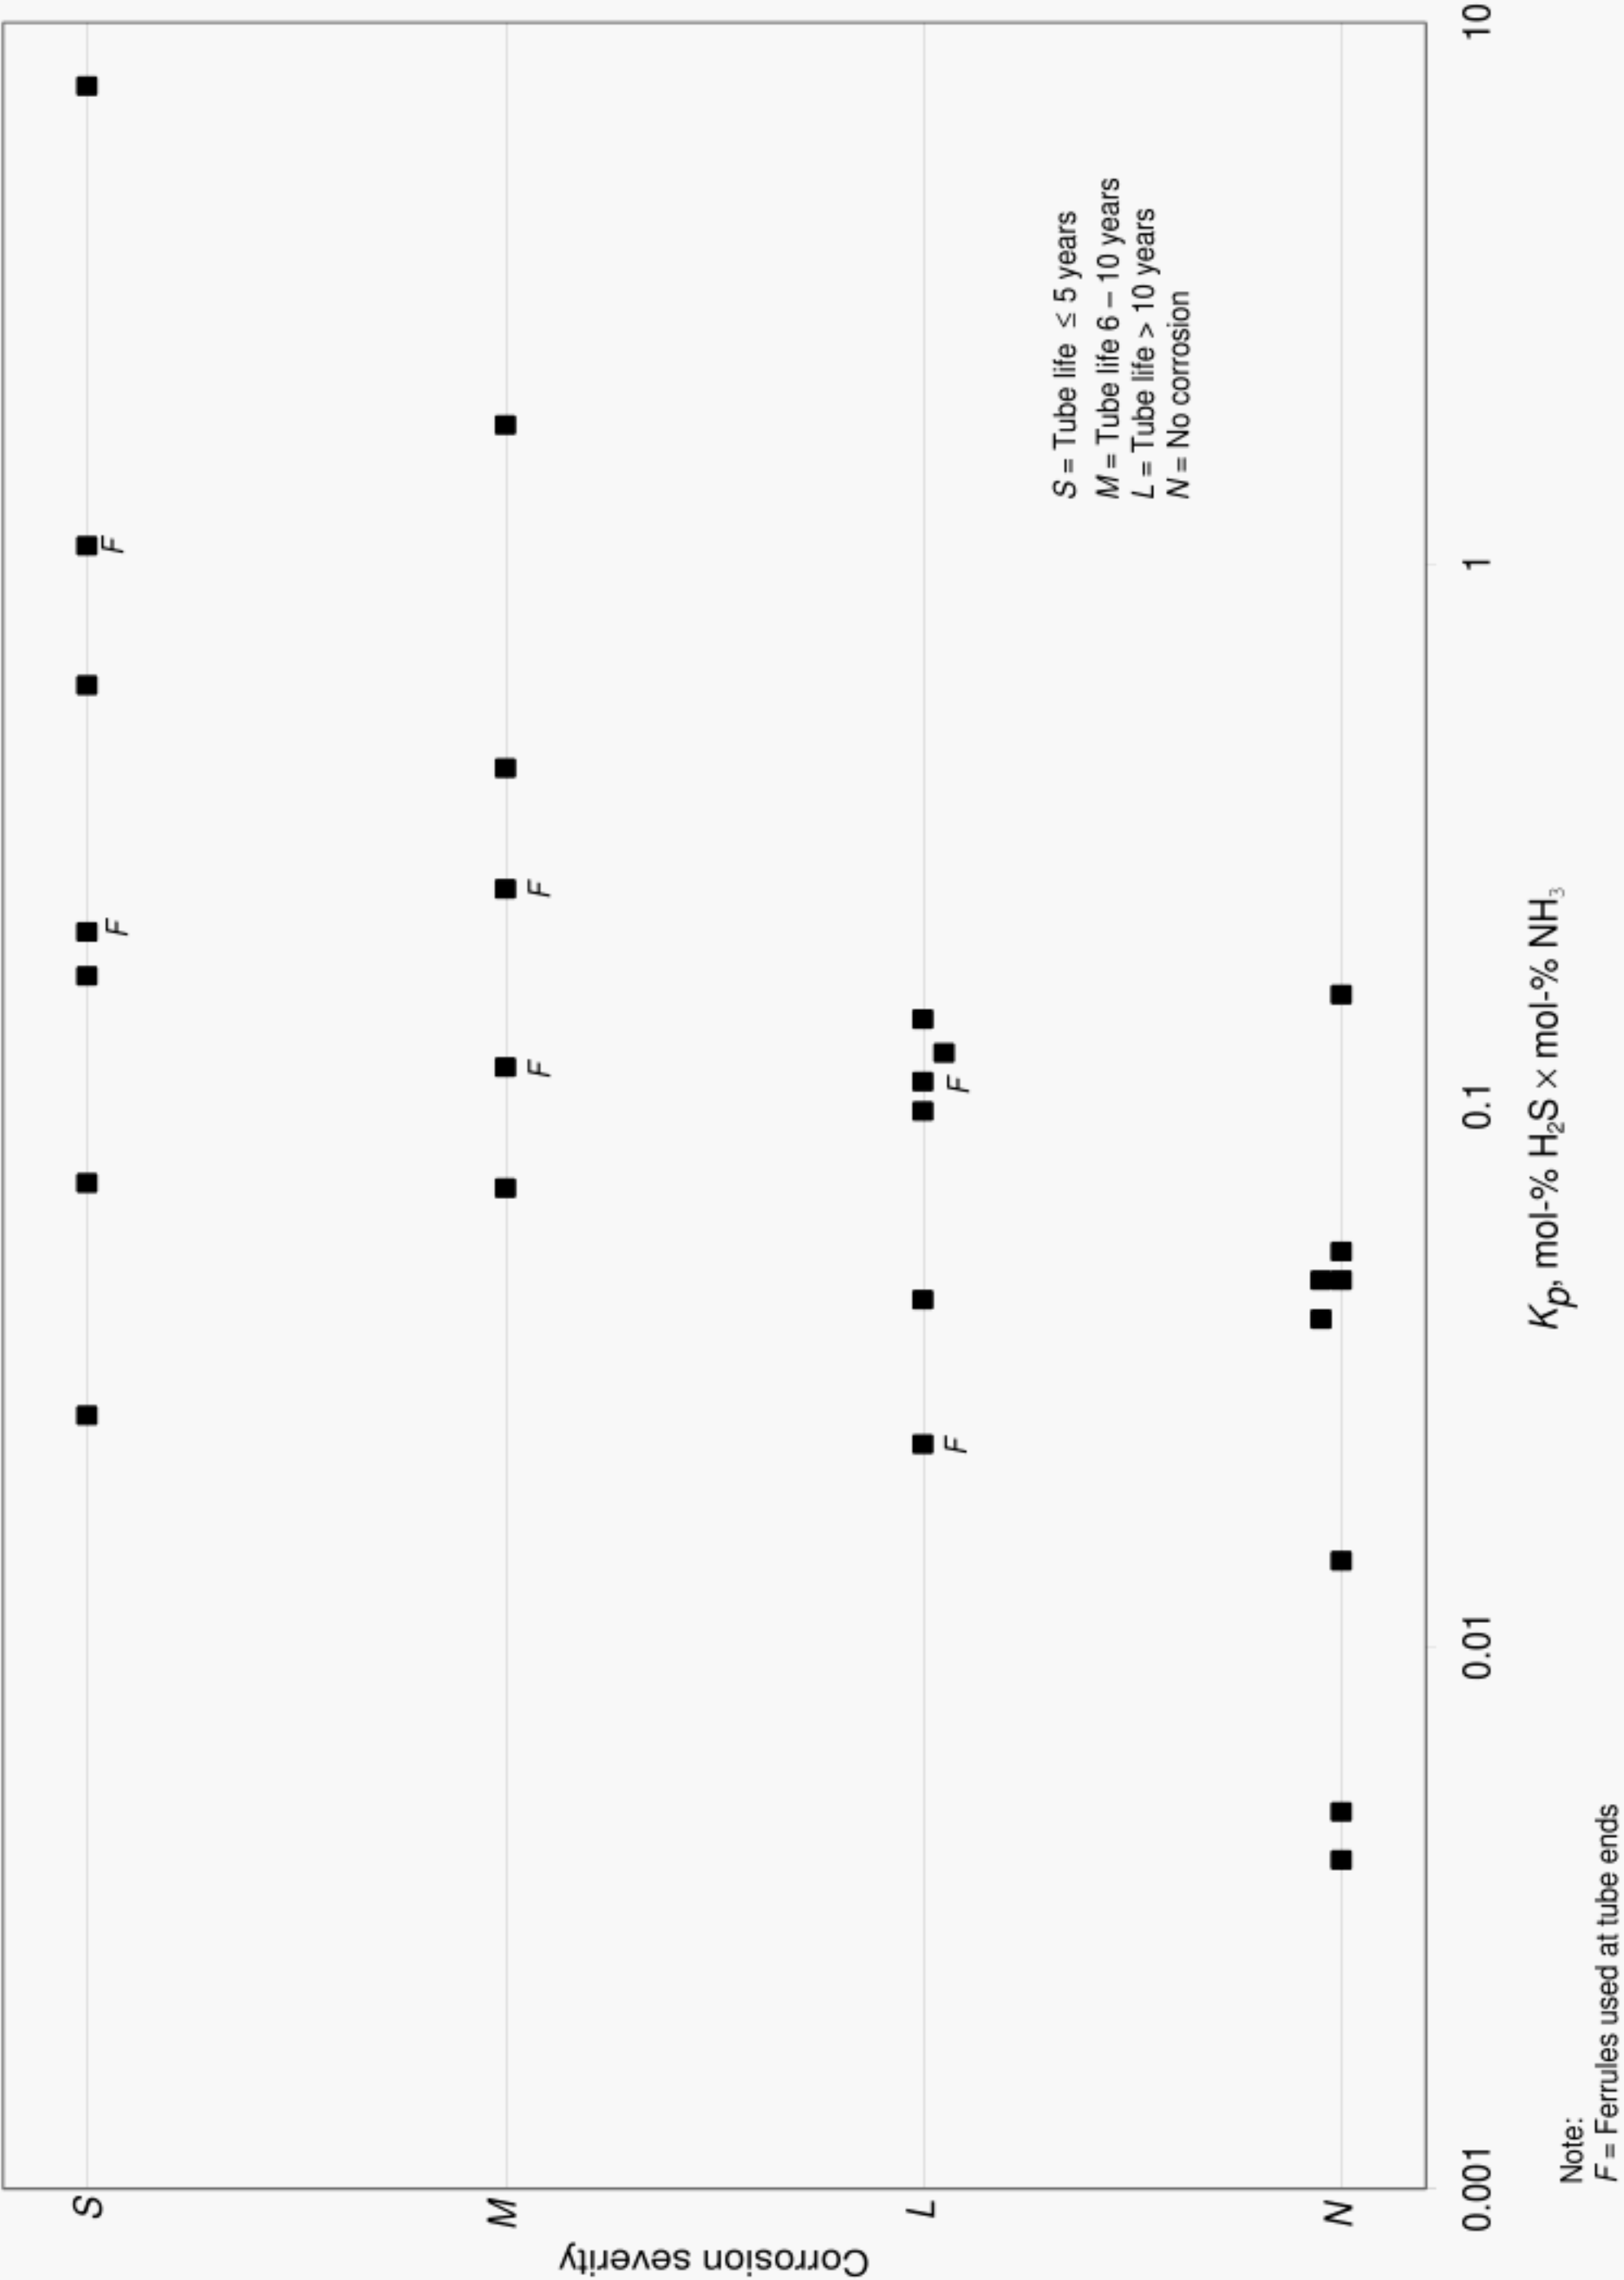
Figure 1—Effect of  $K_p$  on REAC Tube Corrosion (from Ref. 7)

A plot of the data is shown in Figure 1. The four horizontal bands represent the four levels of corrosion but it can be seen that there is considerable overlap in the range of  $K_p$  factors at each level. The best conclusion that can be drawn is that there is a trend showing that the severity of corrosion increases with increase of  $K_p$ , confirming Piehl's observation. The imprecise nature of the correlation however does not permit a useful guideline to be developed. Similar plots were developed for corrosion severity versus:

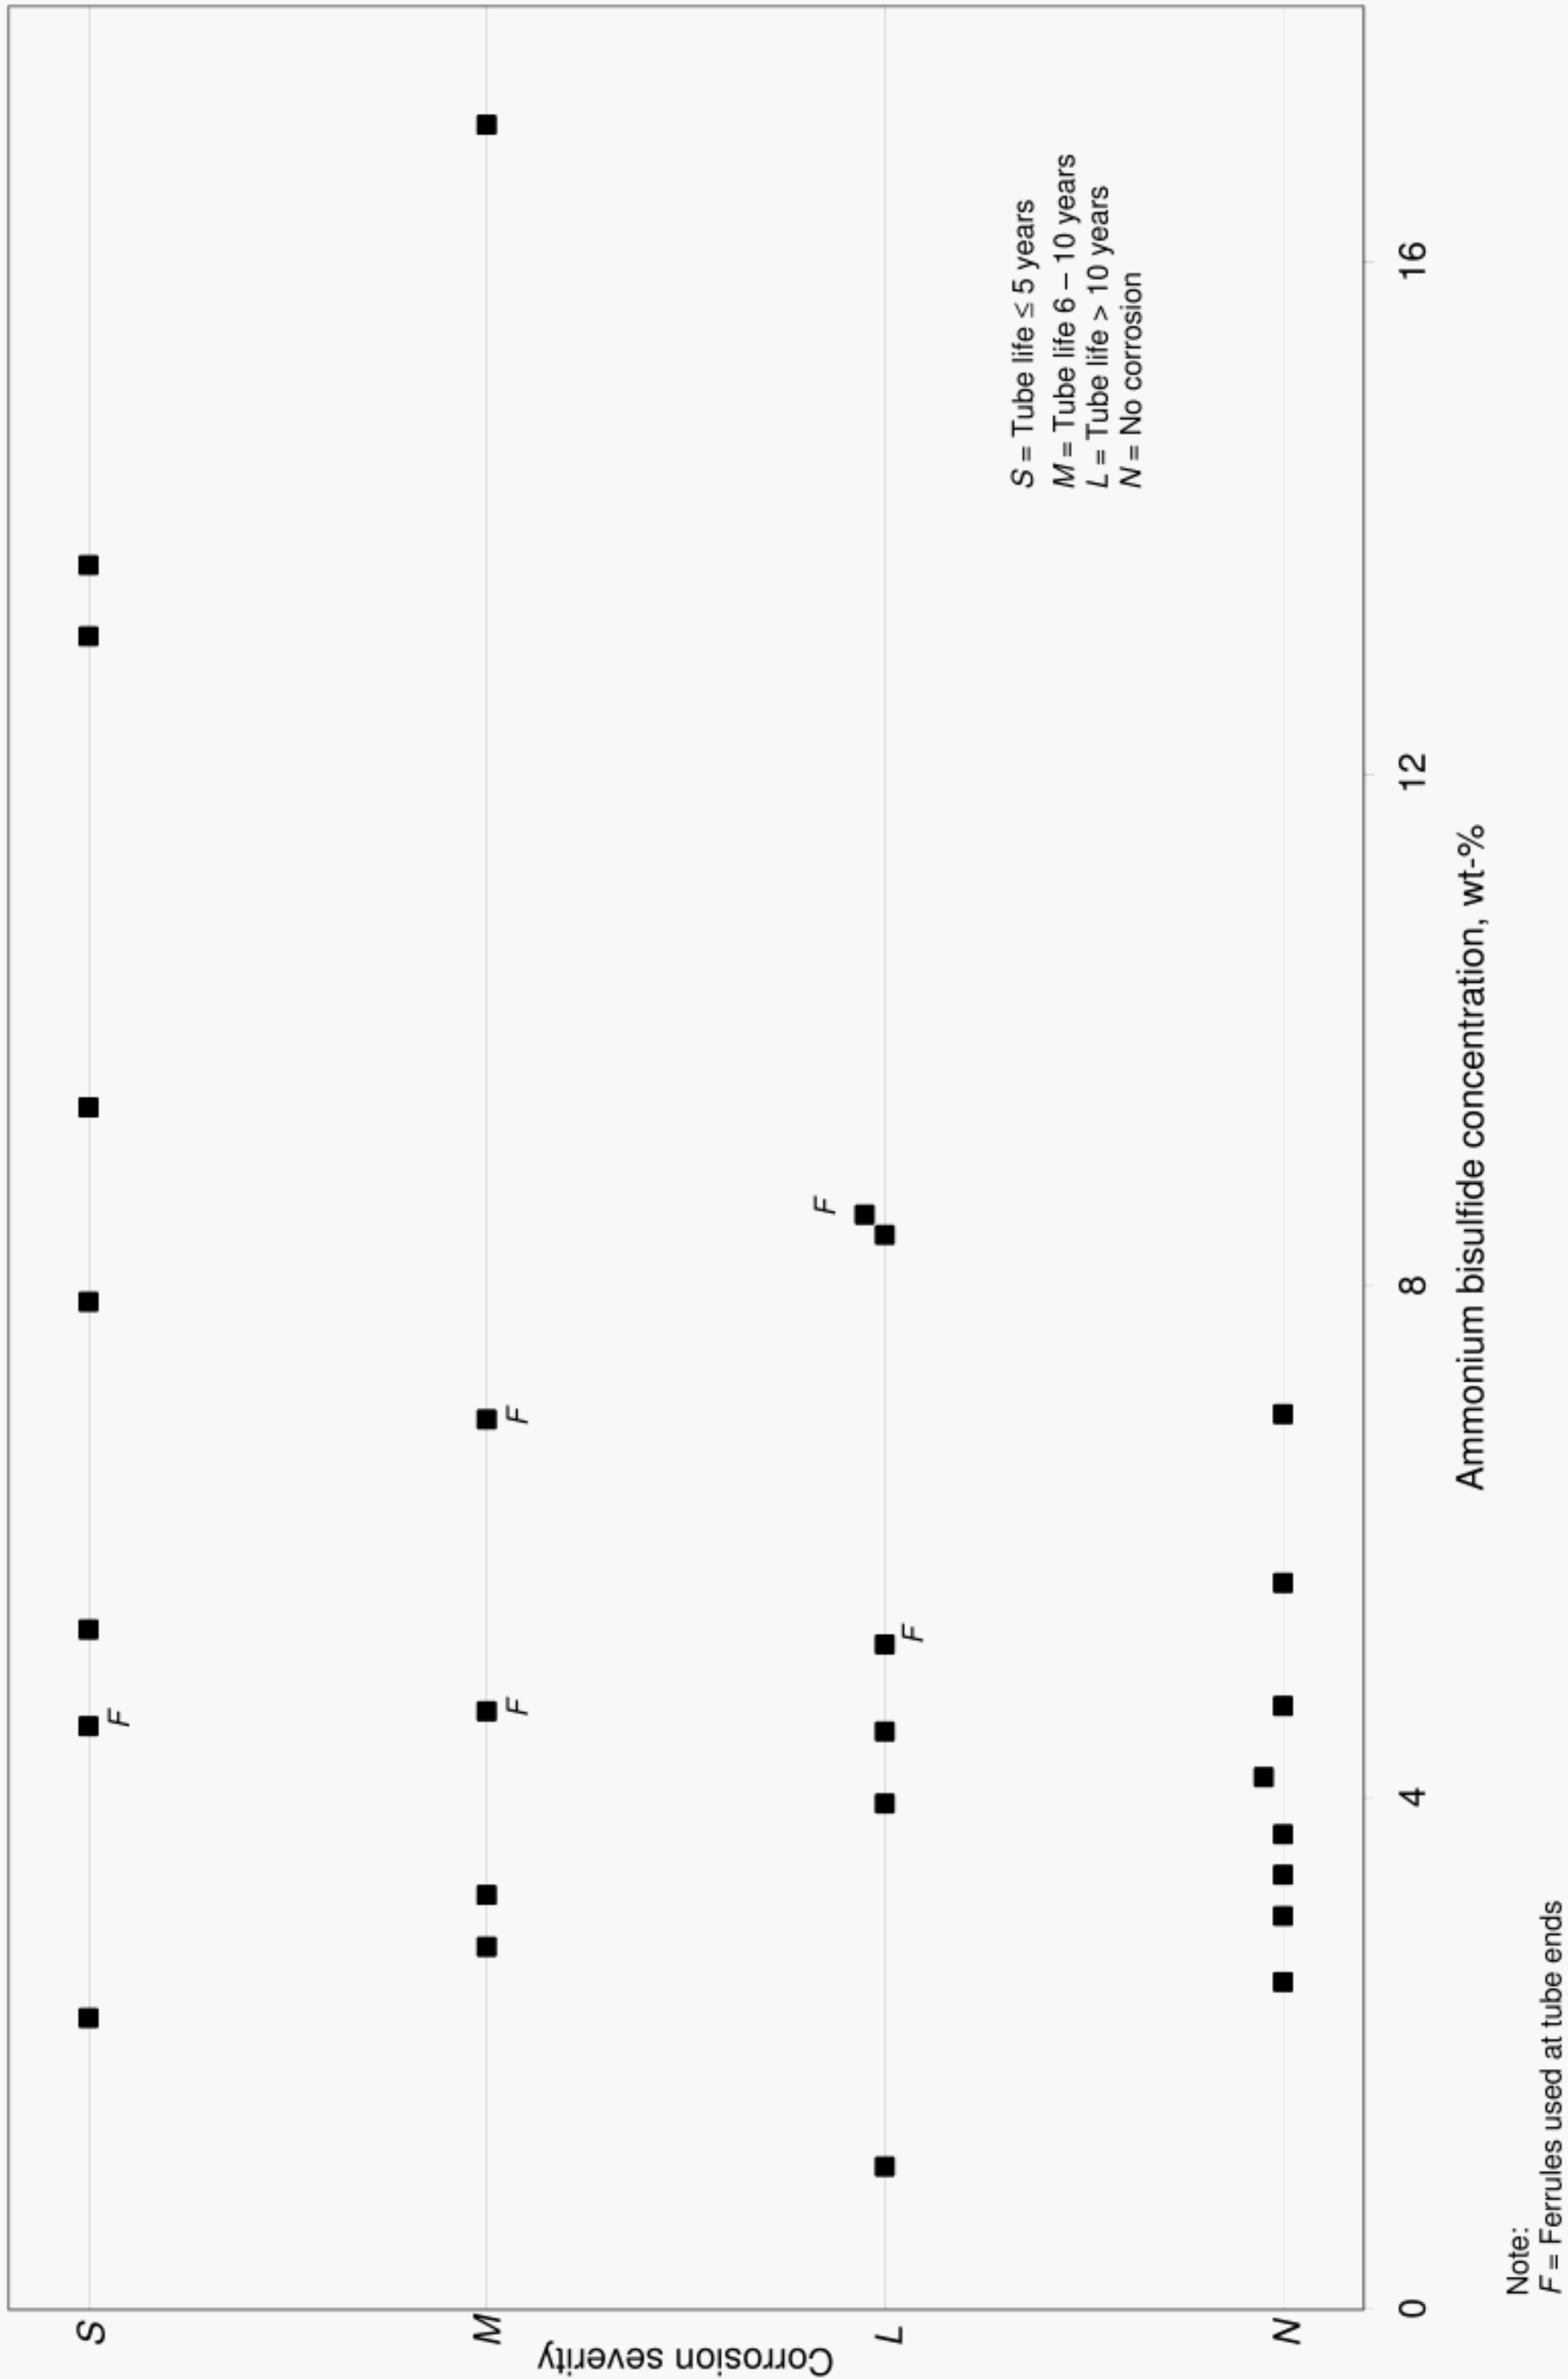
Figure 2—Effect of  $\text{NH}_4\text{HS}$  Concentration in the Downstream Separator on REAC Tube Corrosion (from Ref. 7)

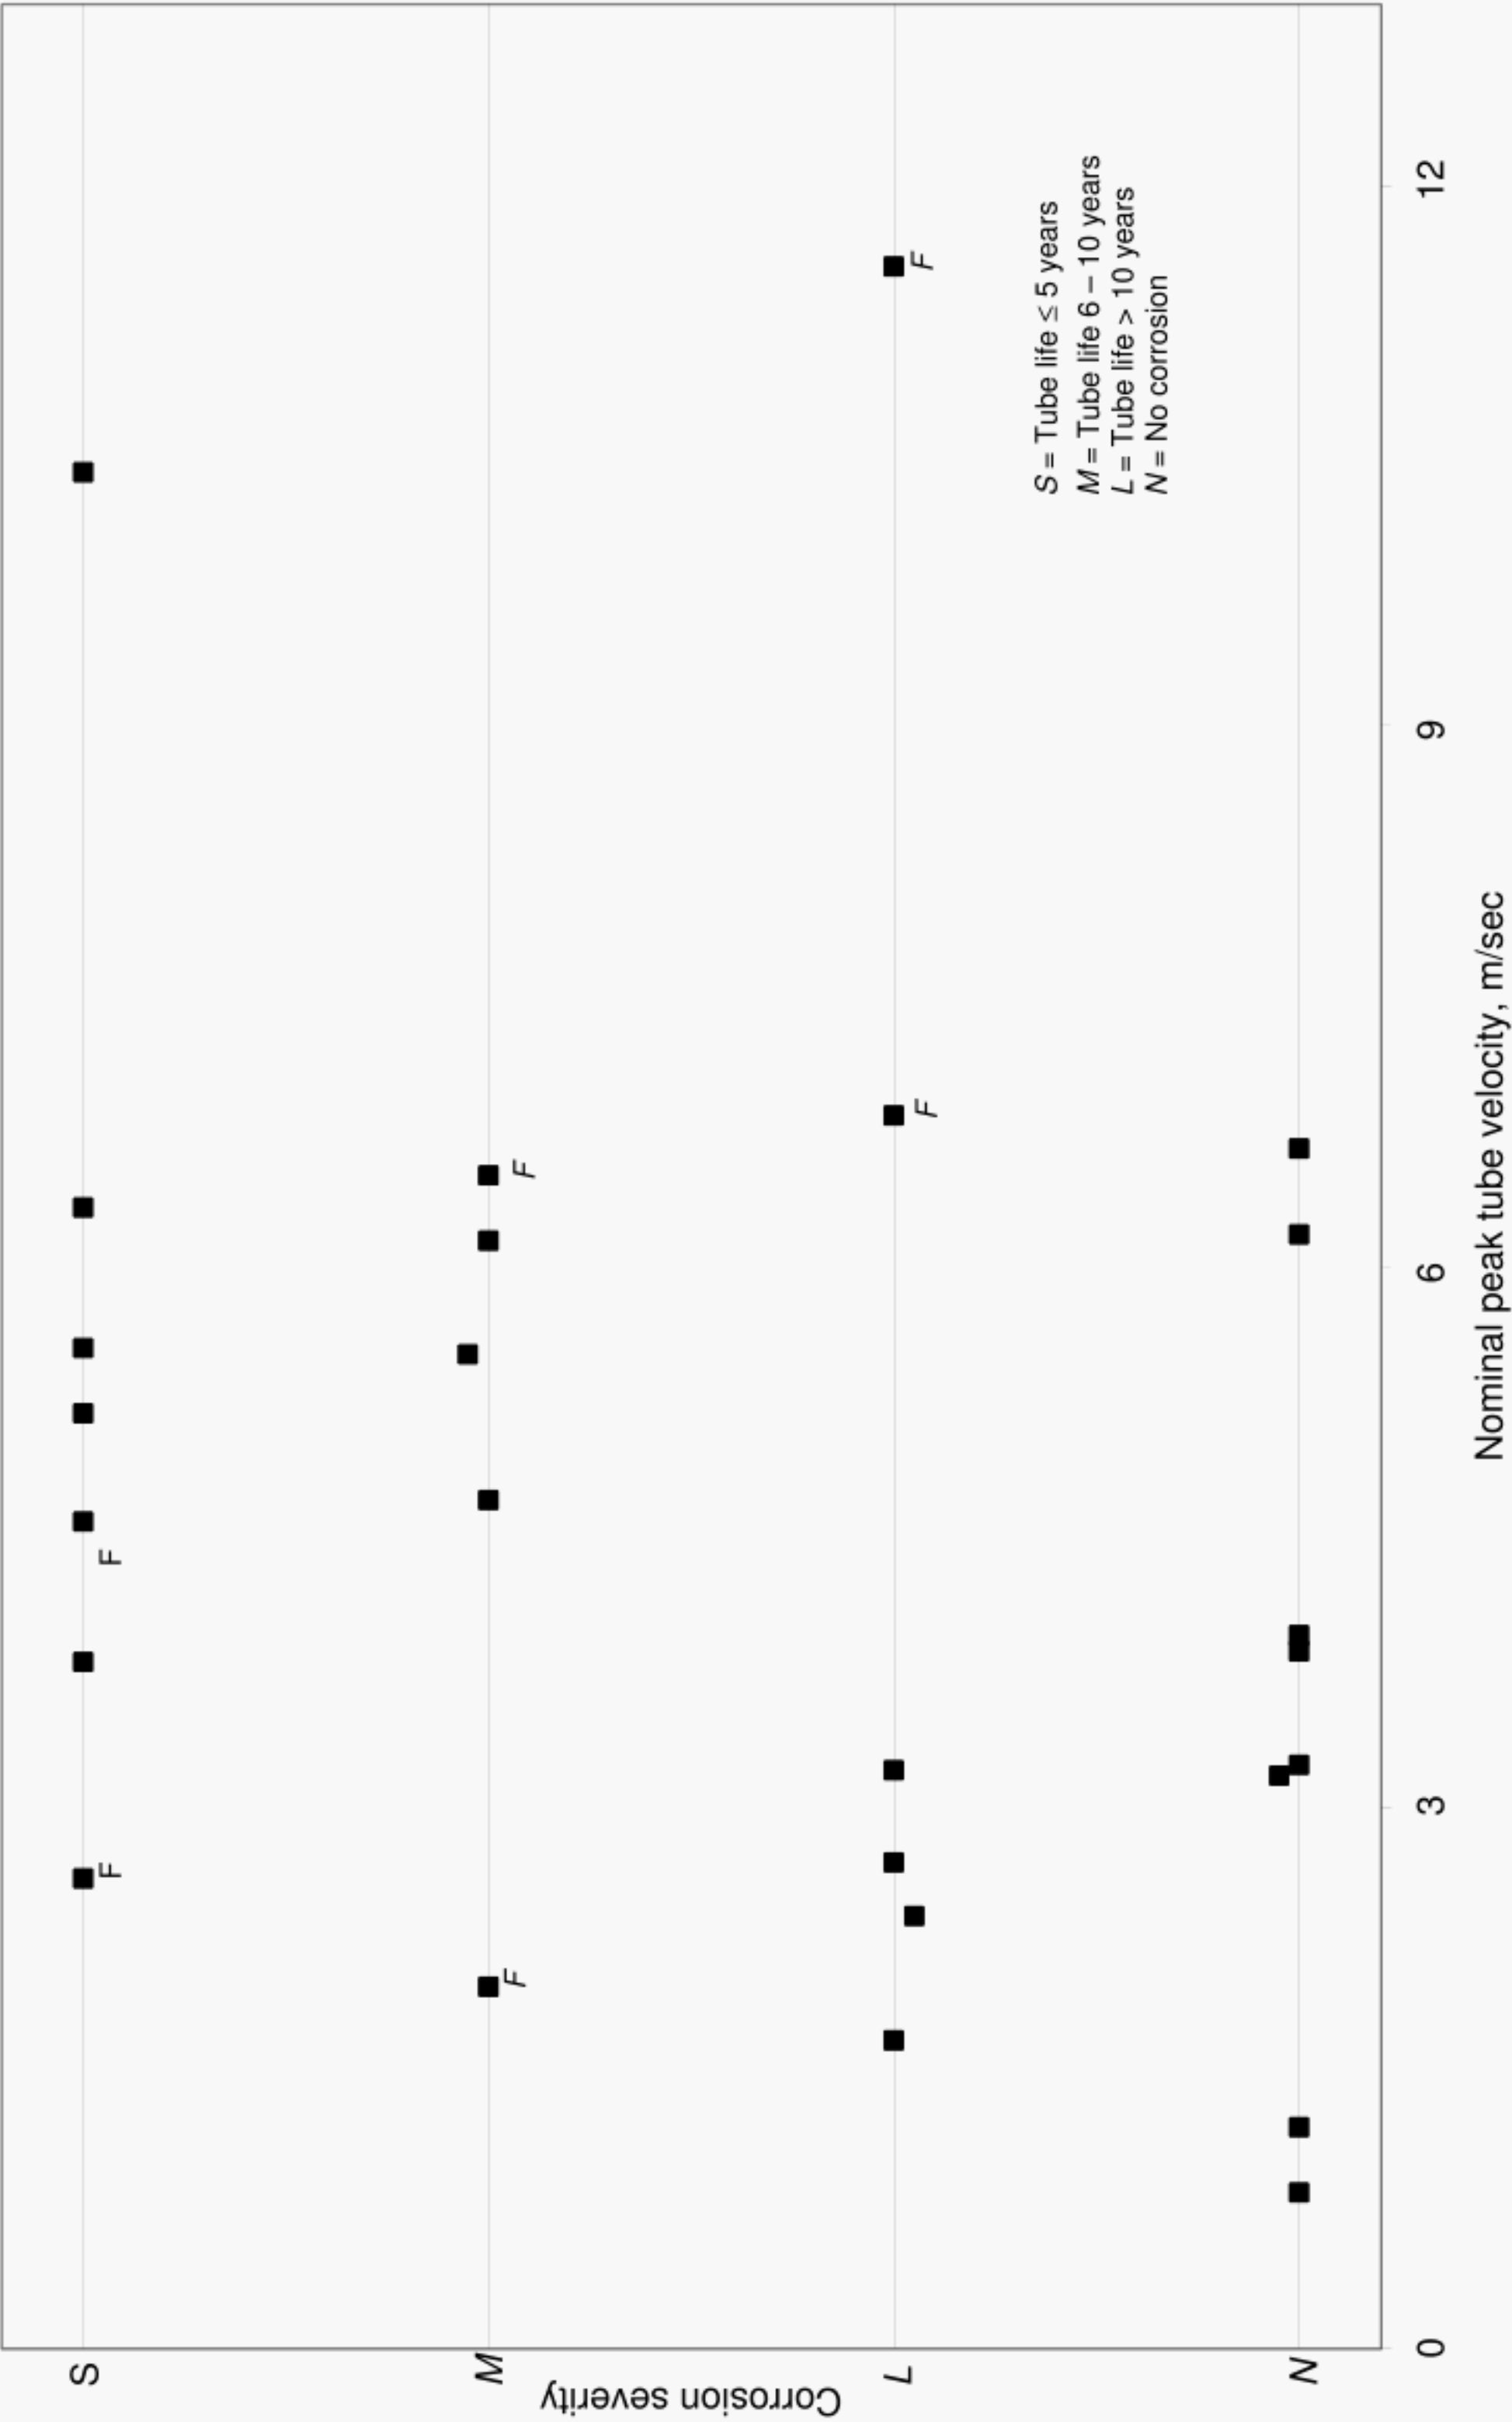
Figure 3—Effect of Velocity on REAC Tube Corrosion (from Ref. 7)

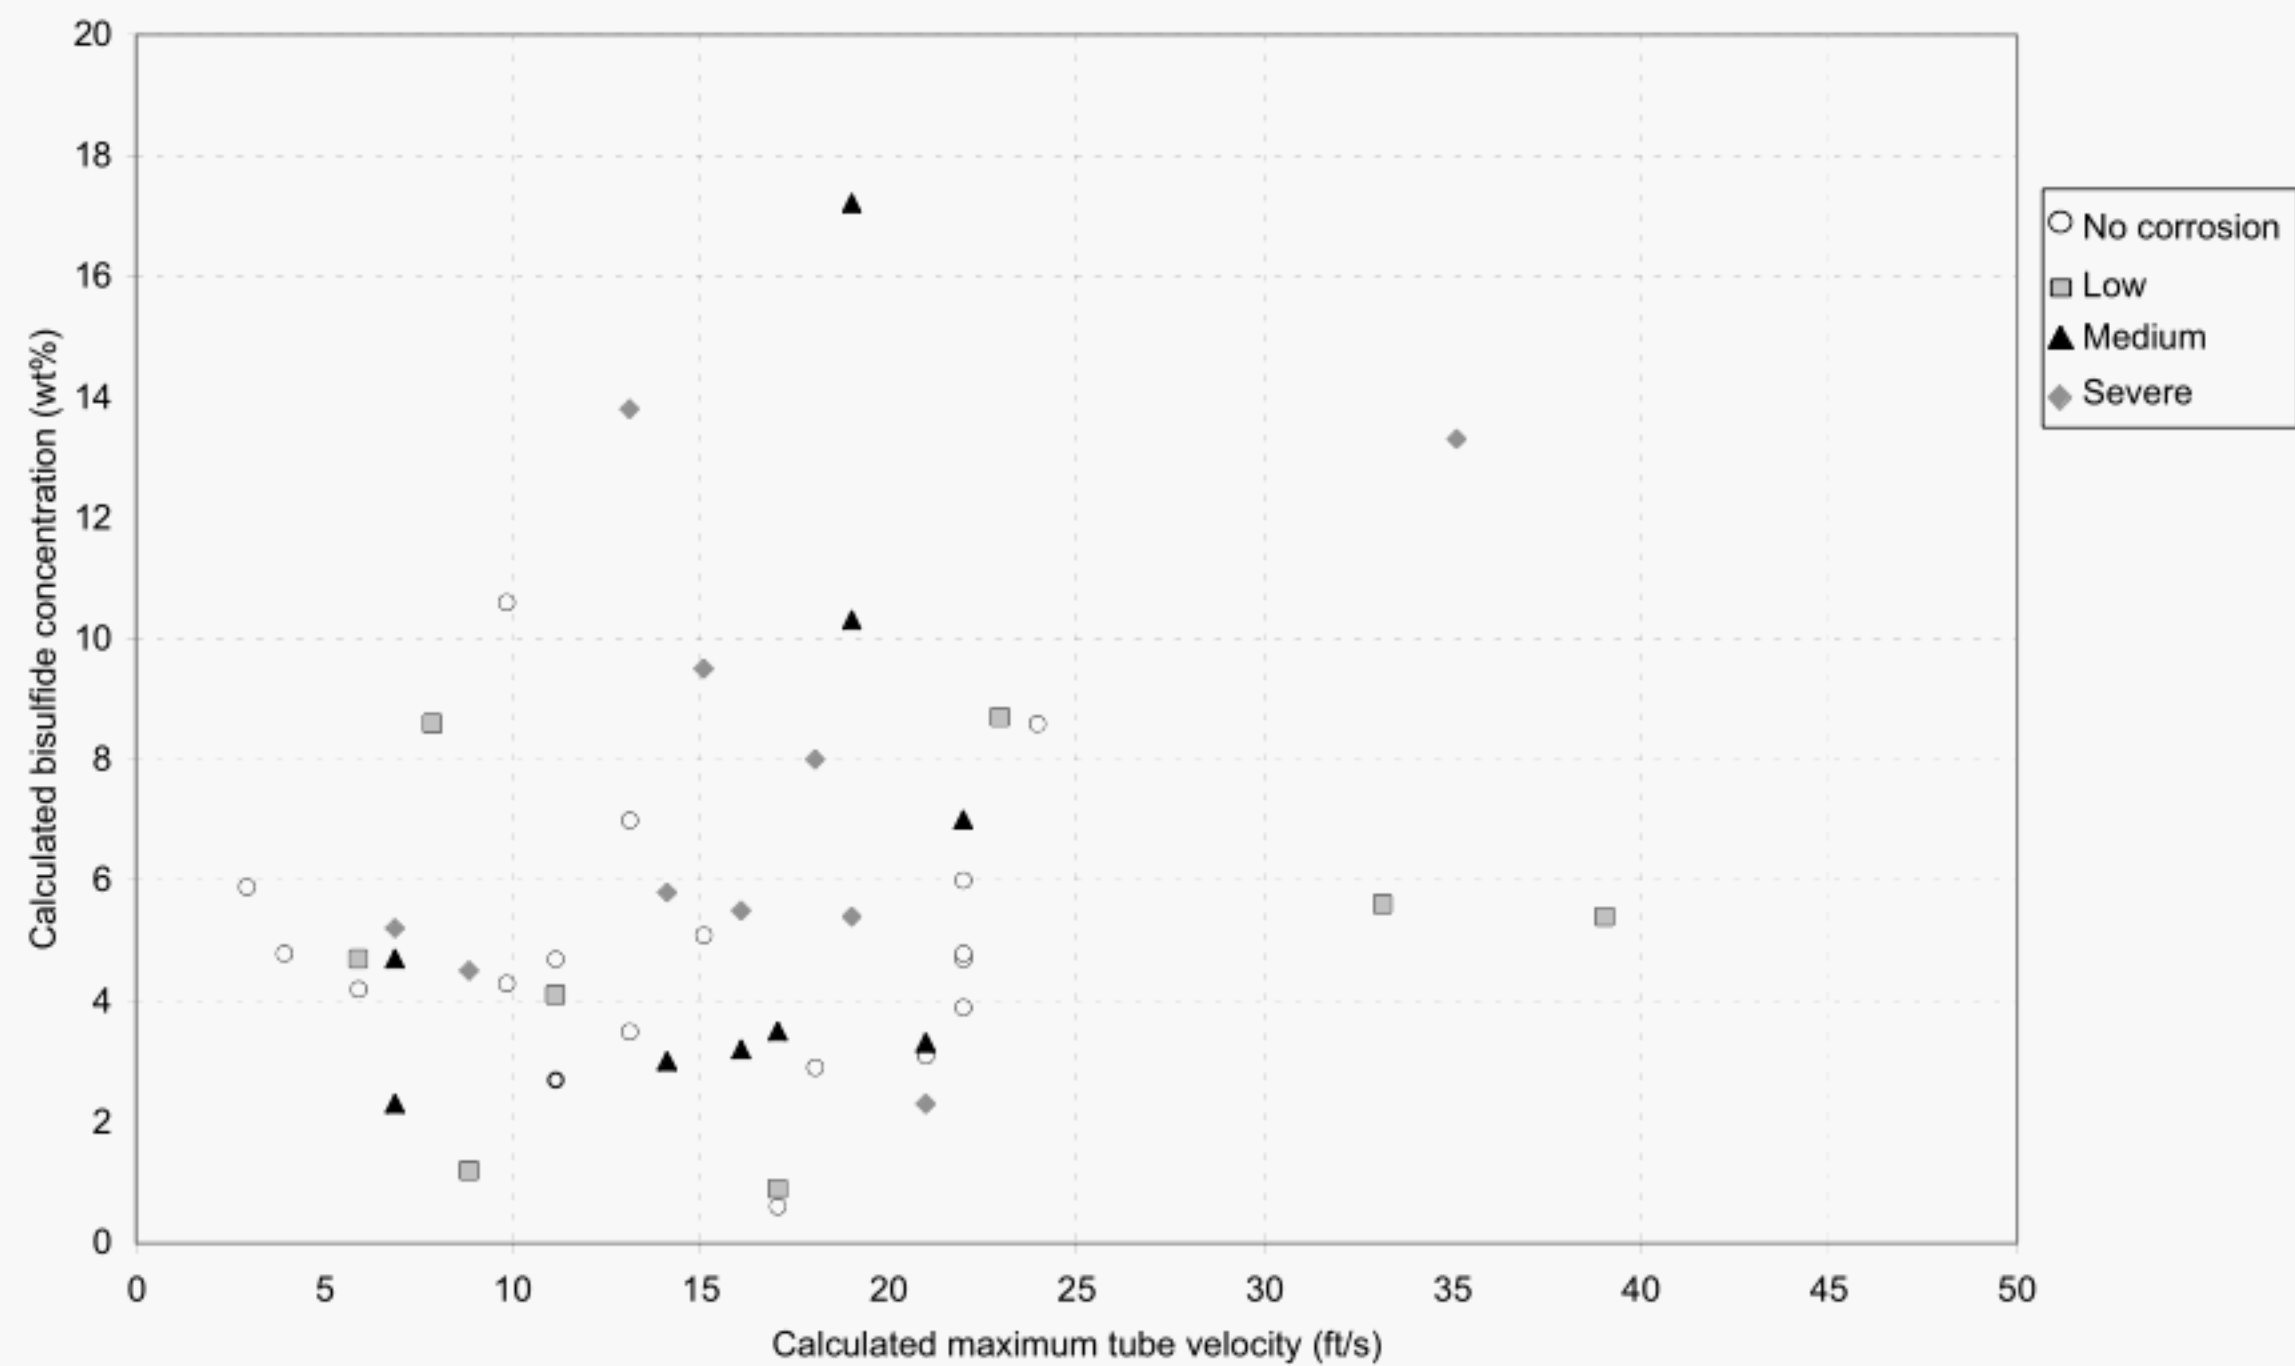
Figure A-1—Corrosion of Air Cooler Tubes—The Combined Effect of Calculated Ammonium Bisulfide Concentration in the Downstream Separator and Calculated Maximum Tube Velocity (ft/s) on Corrosion Severity

sion points appeared, but two of these were associated with very high bisulfide concentrations. Similarly, where the inlet piping header is balanced, corrosion tends to be low (see Figure A-4). On the other hand, when both headers were unbalanced (see Figure A-5), corrosion of the tubes was predominantly severe or moderate. It is clear that uneven distribution of flow through the air cooler creates conditions of either low or high velocities where corrosion can occur. Unfortunately, in most cases reported, neither the bisulfide concentration nor the magnitude of the velocity at the location where corrosion occurs is known, so that a more refined correlation is not possible. The data were screened to exclude air coolers with return bend tubes and those with ferrules. All of the plots are included in Appendix A (see Figures A-1 to A-5).

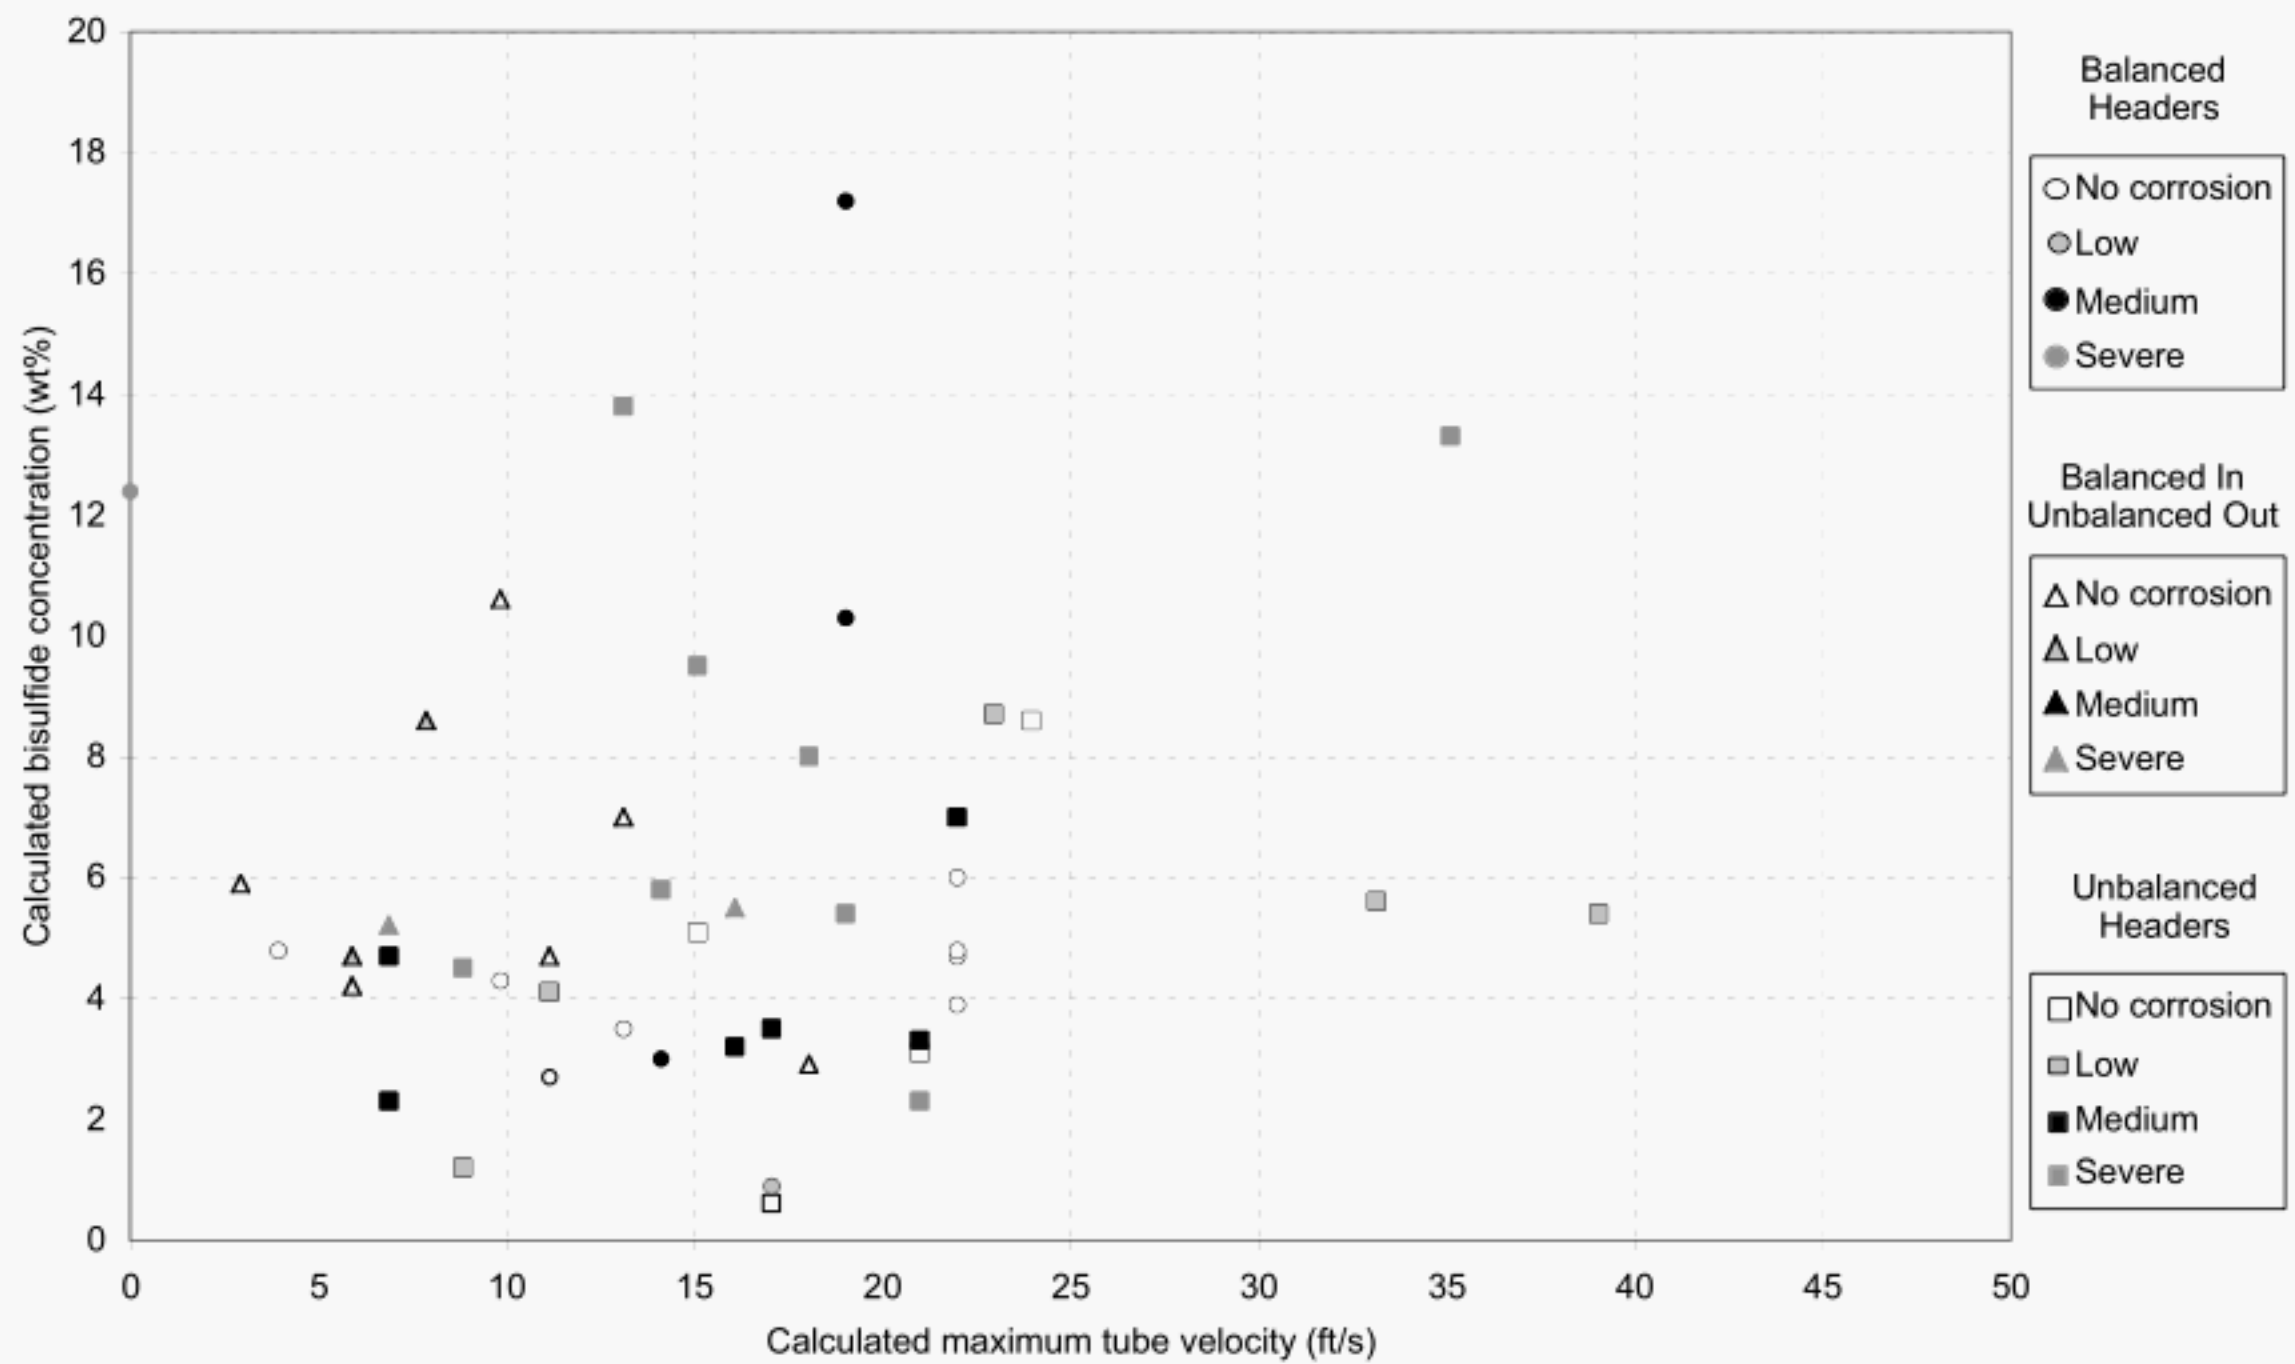
Figure A-2—Corrosion of Air Cooler Tubes—The Combined Effect of Calculated Ammonium Bisulfide Concentration in the Downstream Separator and Calculated Maximum Tube Velocity (ft/s) on Corrosion Severity for Balanced and Unbalanced Headers

Note: Where values were not reported by the plants, values calculated by UOP were used. These calculated values are valid only for balanced systems with assumed uniform flow distribution. They may be inaccurate where less than full condensation has occurred. As presented, the data were so scattered that no correlation or inference could be drawn. It was evident that occurrences of corrosion do not correlate well with individual parameters partly because of the inaccuracies just discussed and in addition, because of the interdependency of some of the parameters. By simultaneously plotting the level of corrosion against both bisulfide concentration and velocity, only a very slight improvement was obtained (see Appendix A, Figure A-1). However, when the influence of piping symmetry on the distribution of flow through the air coolers was introduced as a fourth parameter, more striking relationships were apparent (see Appendix A, Figures A-2 through A-5).

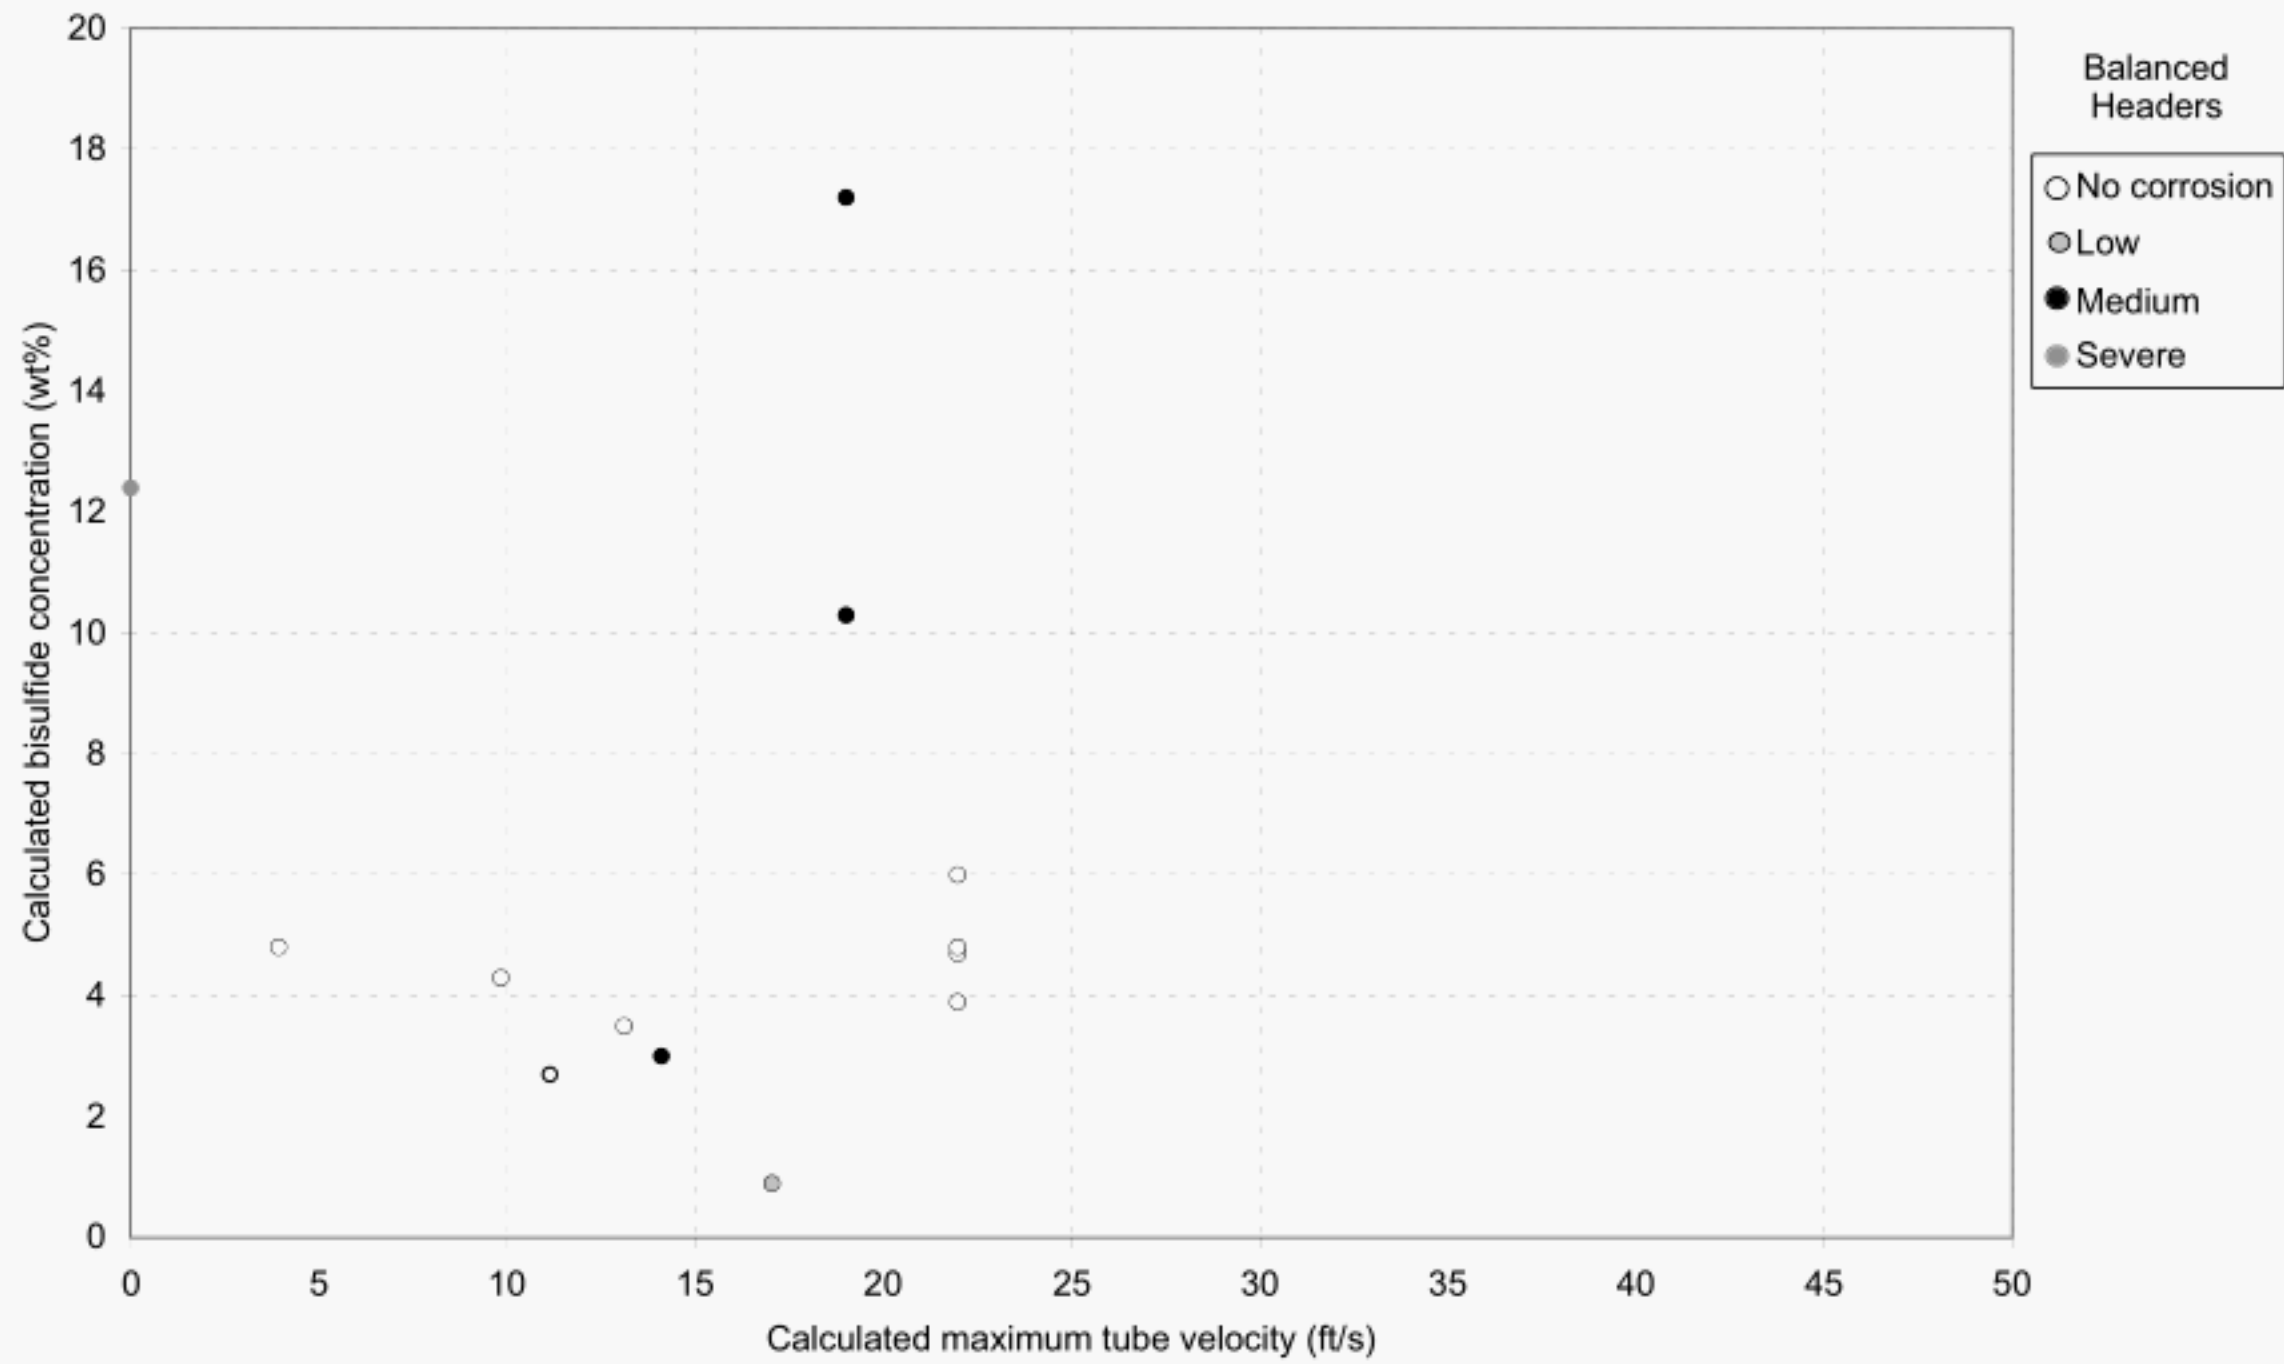
Figure A-3—Corrosion of Air Cooler Tubes—The Combined Effect of Calculated Ammonium Bisulfide Concentration in the Downstream Separator and Calculated Maximum Tube Velocity (ft/s) on Corrosion Severity for Balanced Header Systems
