# **A Study of Corrosion in Hydroprocess Reactor Effluent Air Cooler Systems**

API PUBLICATION 932-A  
SEPTEMBER 2002

This study was sponsored by the American Petroleum Institute (API), Committee on Refinery Equipment, Subcommittee on Corrosion and Materials Research. The purpose of the study was to provide technical background, based on industry experience and consensus practice, for controlling corrosion in hydroprocess reactor effluent systems. The findings reported herein will be used as an interim resource by the industry and as a basis for a future API recommended practice document.

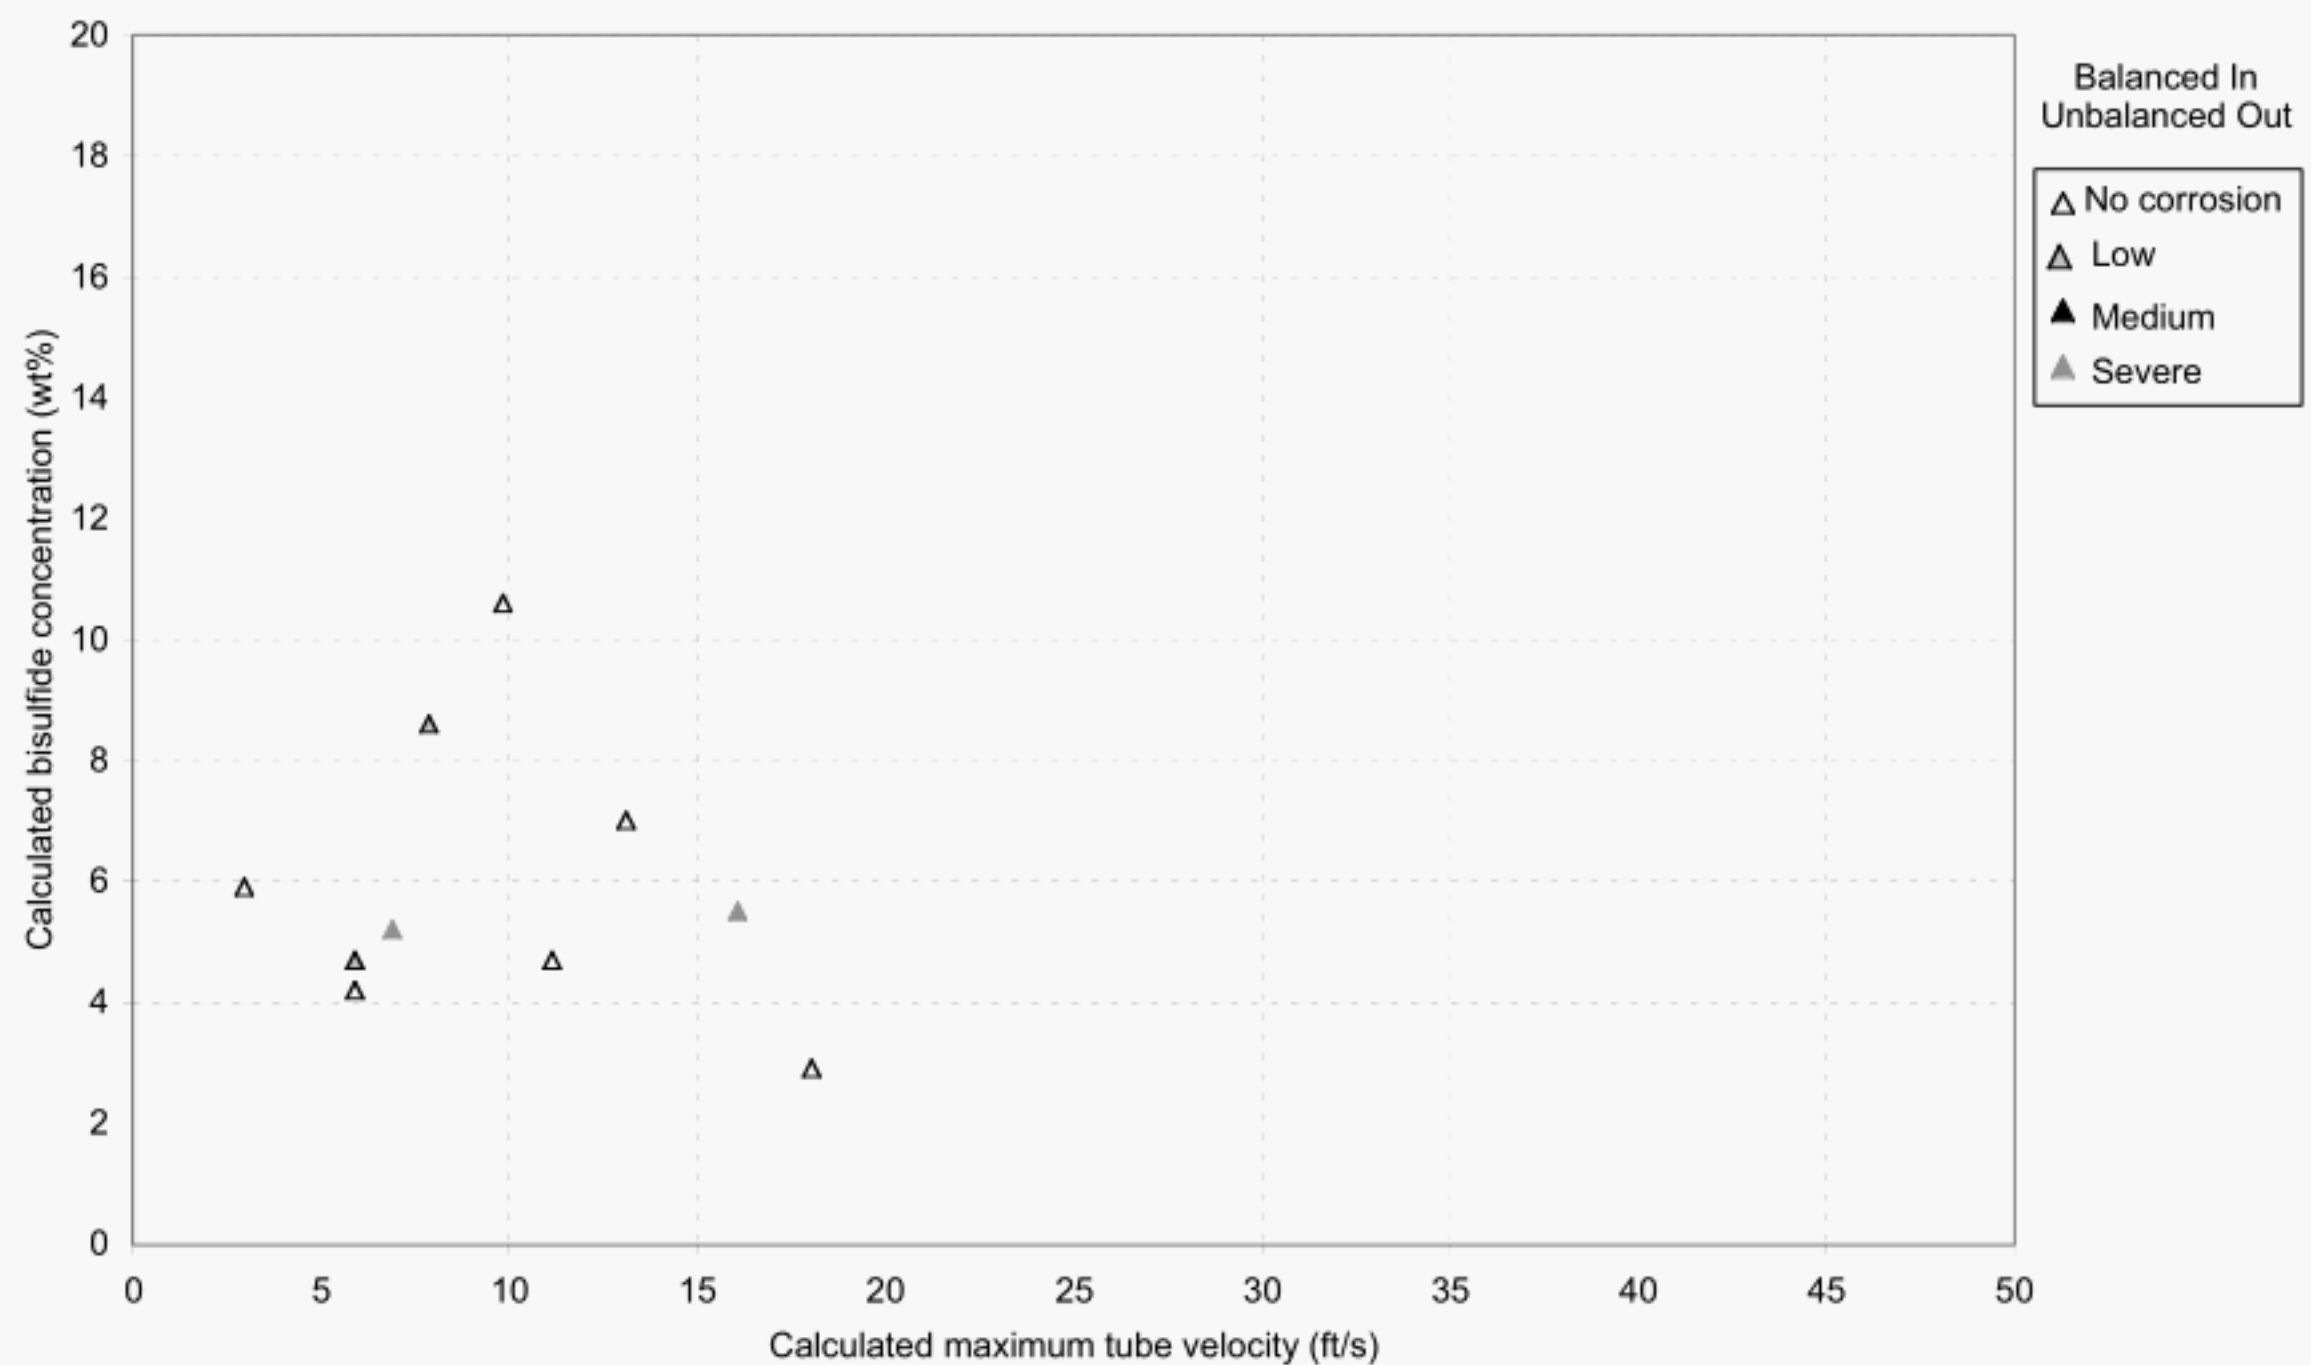
Figure A-4—Corrosion of Air Cooler Tubes—The Combined Effect of Calculated Ammonium Bisulfide Concentration in the Downstream Separator and Calculated Maximum Tube Velocity (ft/s) on Corrosion Severity for Balanced Inlet and Unbalanced Outlet Header Systems

sion points appeared, but two of these were associated with very high bisulfide concentrations. Similarly, where the inlet piping header is balanced, corrosion tends to be low (see Figure A-4). On the other hand, when both headers were unbalanced (see Figure A-5), corrosion of the tubes was predominantly severe or moderate. It is clear that uneven distribution of flow through the air cooler creates conditions of either low or high velocities where corrosion can occur. Unfortunately, in most cases reported, neither the bisulfide concentration nor the magnitude of the velocity at the location where corrosion occurs is known, so that a more refined correlation is not possible. The data were screened to exclude air coolers with return bend tubes and those with ferrules. All of the plots are included in Appendix A (see Figures A-1 to A-5).

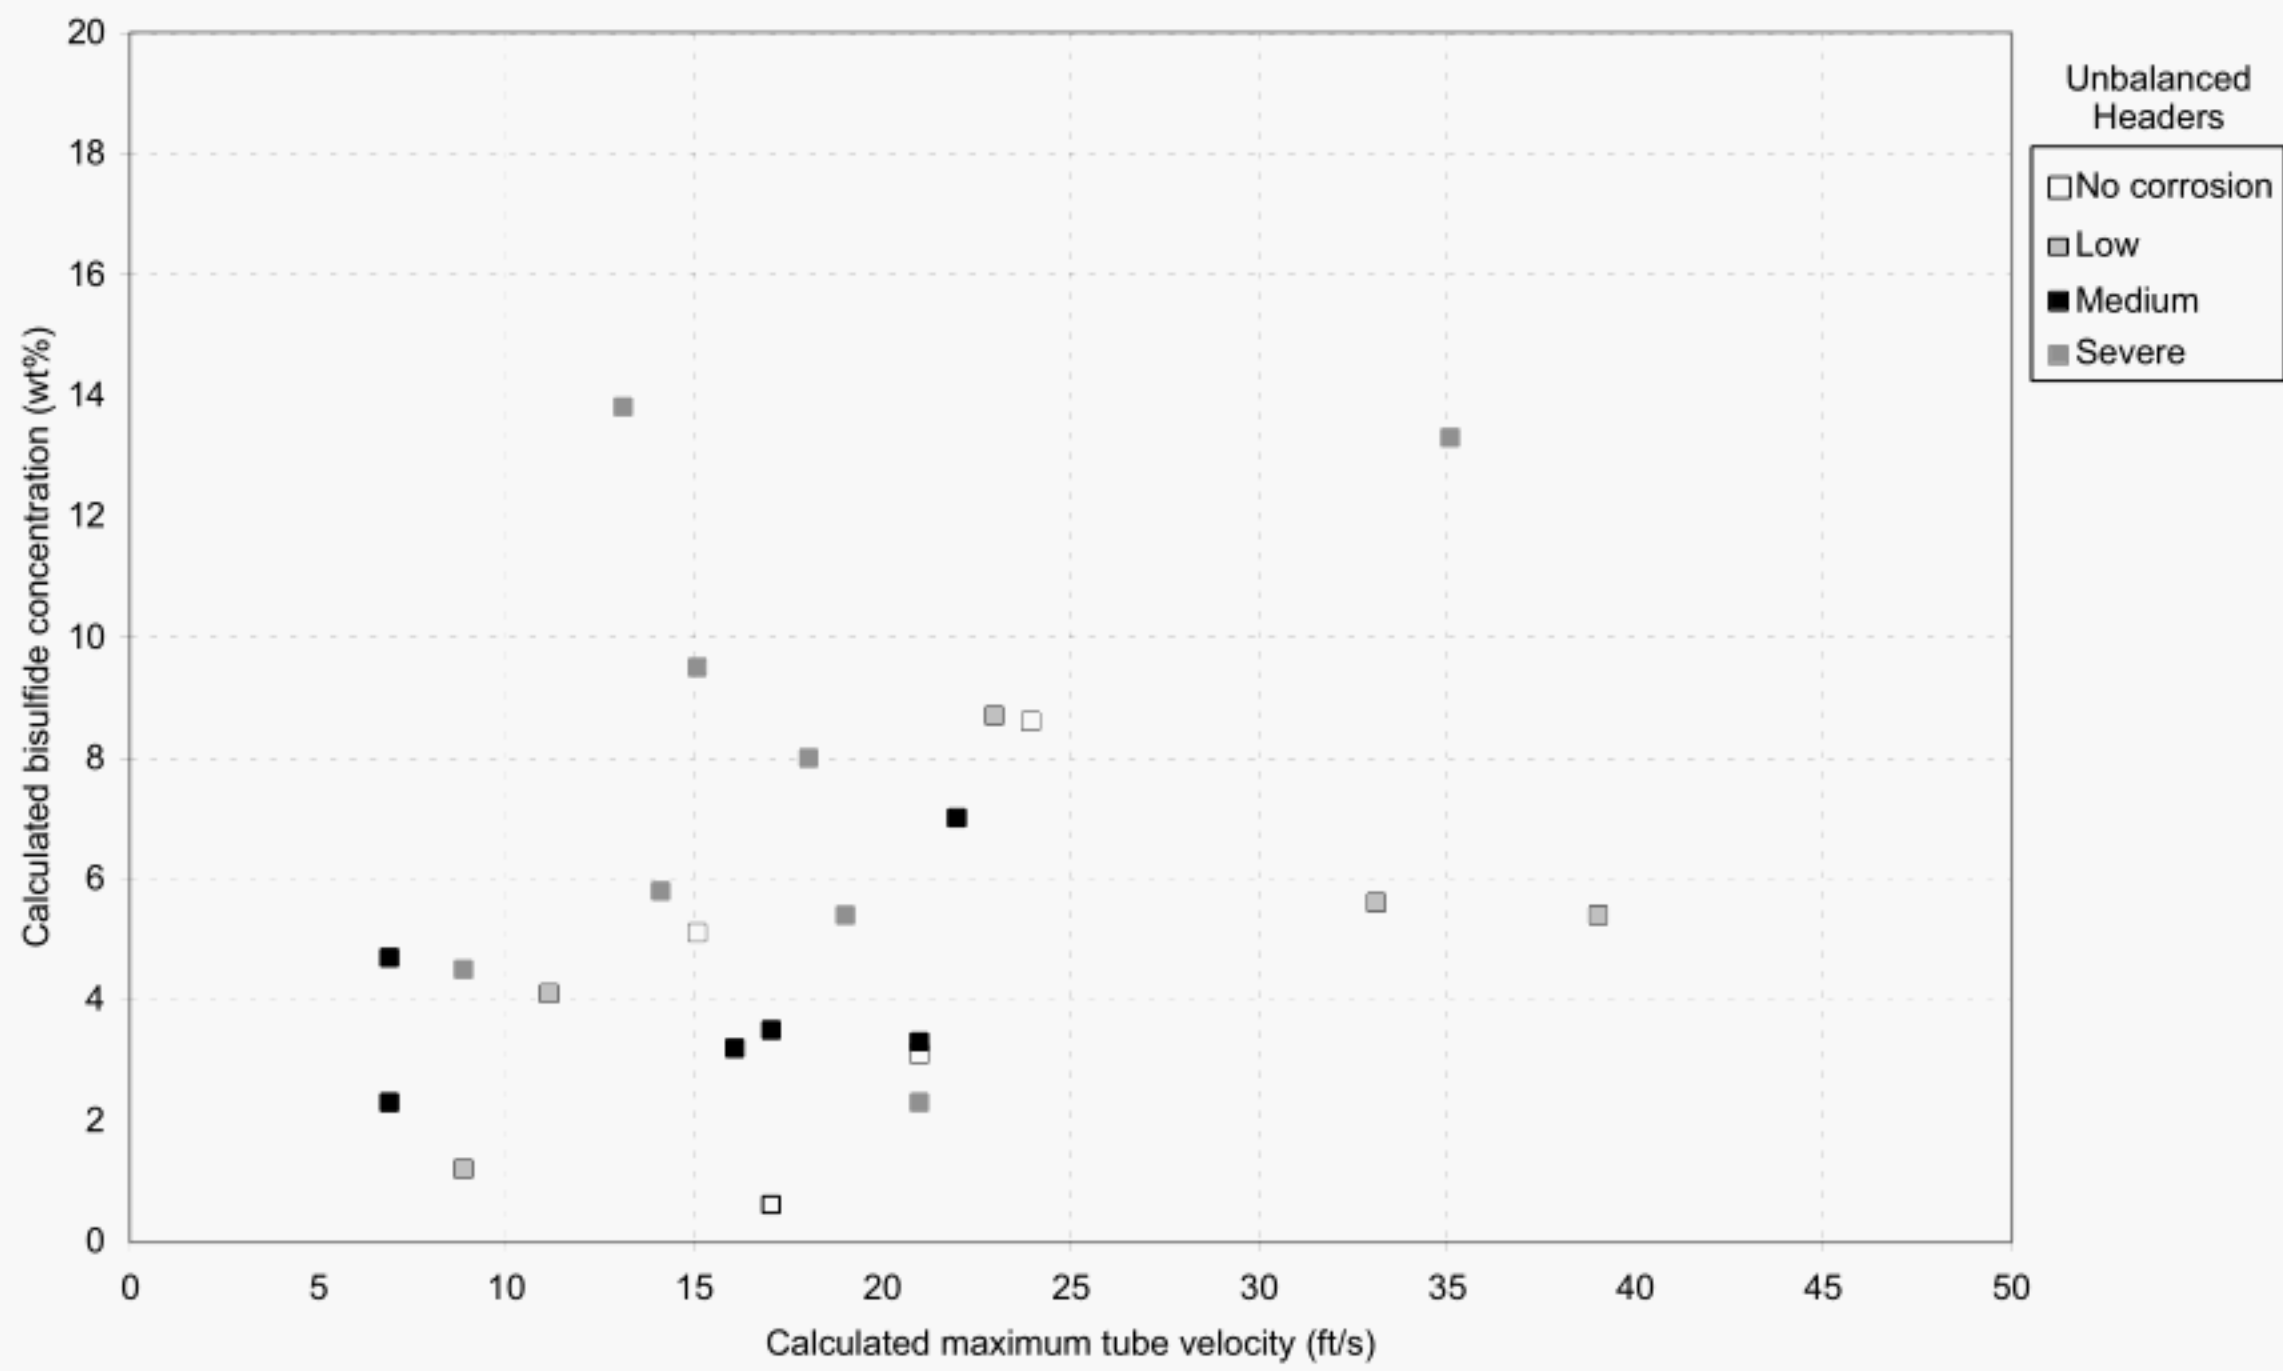
Figure A-5—Corrosion of Air Cooler Tubes—The Combined Effect of Calculated Ammonium Bisulfide Concentration in the Downstream Separator and Calculated Maximum Tube Velocity (ft/s) on Corrosion Severity for Unbalanced Header Systems

Note: Where values were not reported by the plants, values calculated by UOP were used. These calculated values are valid only for balanced systems with assumed uniform flow distribution. They may be inaccurate where less than full condensation has occurred. As presented, the data were so scattered that no correlation or inference could be drawn. It was evident that occurrences of corrosion do not correlate well with individual parameters partly because of the inaccuracies just discussed and in addition, because of the interdependency of some of the parameters. By simultaneously plotting the level of corrosion against both bisulfide concentration and velocity, only a very slight improvement was obtained (see Appendix A, Figure A-1). However, when the influence of piping symmetry on the distribution of flow through the air coolers was introduced as a fourth parameter, more striking relationships were apparent (see Appendix A, Figures A-2 through A-5).

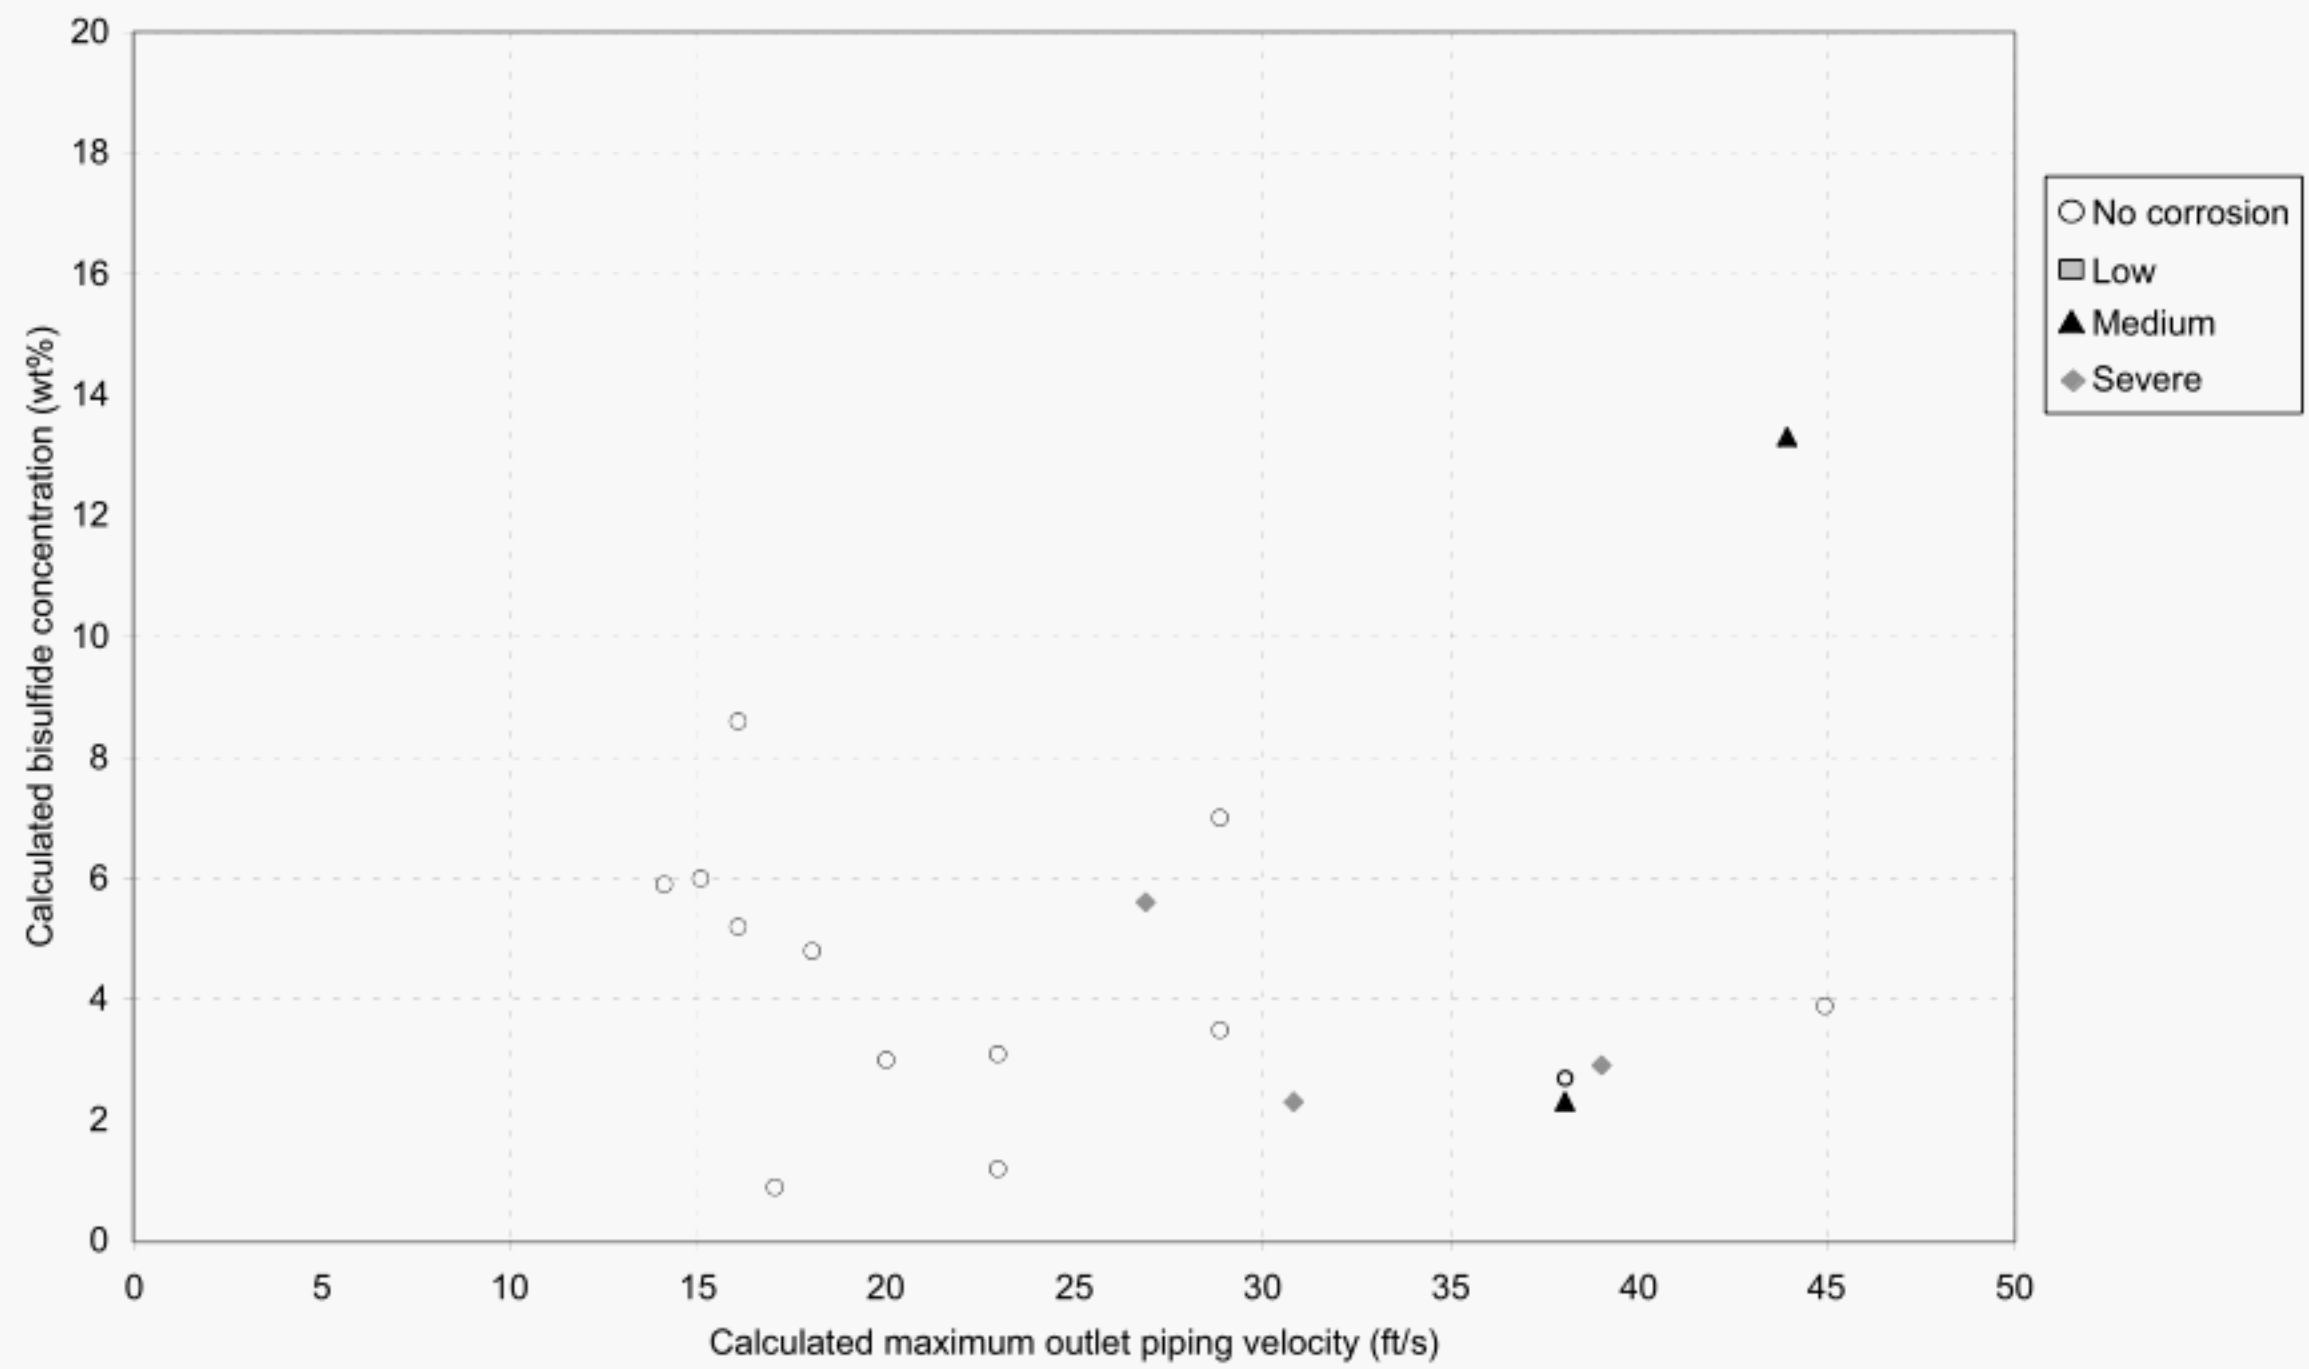
Figure B-3—Corrosion of REAC Outlet Piping—The Combined Effect of Calculated Ammonium Bisulfide Concentration in the Downstream Separator and Calculated Maximum Outlet Piping Velocity (ft/s) on Corrosion Severity

The conclusions are similar to those for the air coolers showing an unclear relationship when just two or three parameters are plotted and an improvement when the fourth parameter is added. Figure B-1 shows the combined effect of bisulfide concentration and header velocity on corrosion. The exceptions to good performance generally lie in the regime of high bisulfide and high velocity. There are however several severe corrosion data points that fall below 4% bisulfide and less than 20 ft/s velocity, a regime that is normally regarded as acceptable. If the maximum piping velocity is included in the data (see Figure B-2), severe corrosion shifts to the right indicating that corrosion is associated with higher velocities. The correlation is stronger when only the maximum outlet piping velocity is plotted (see Figure B-3), and severe corrosion is shown only when velocities are greater than 25 ft/s.

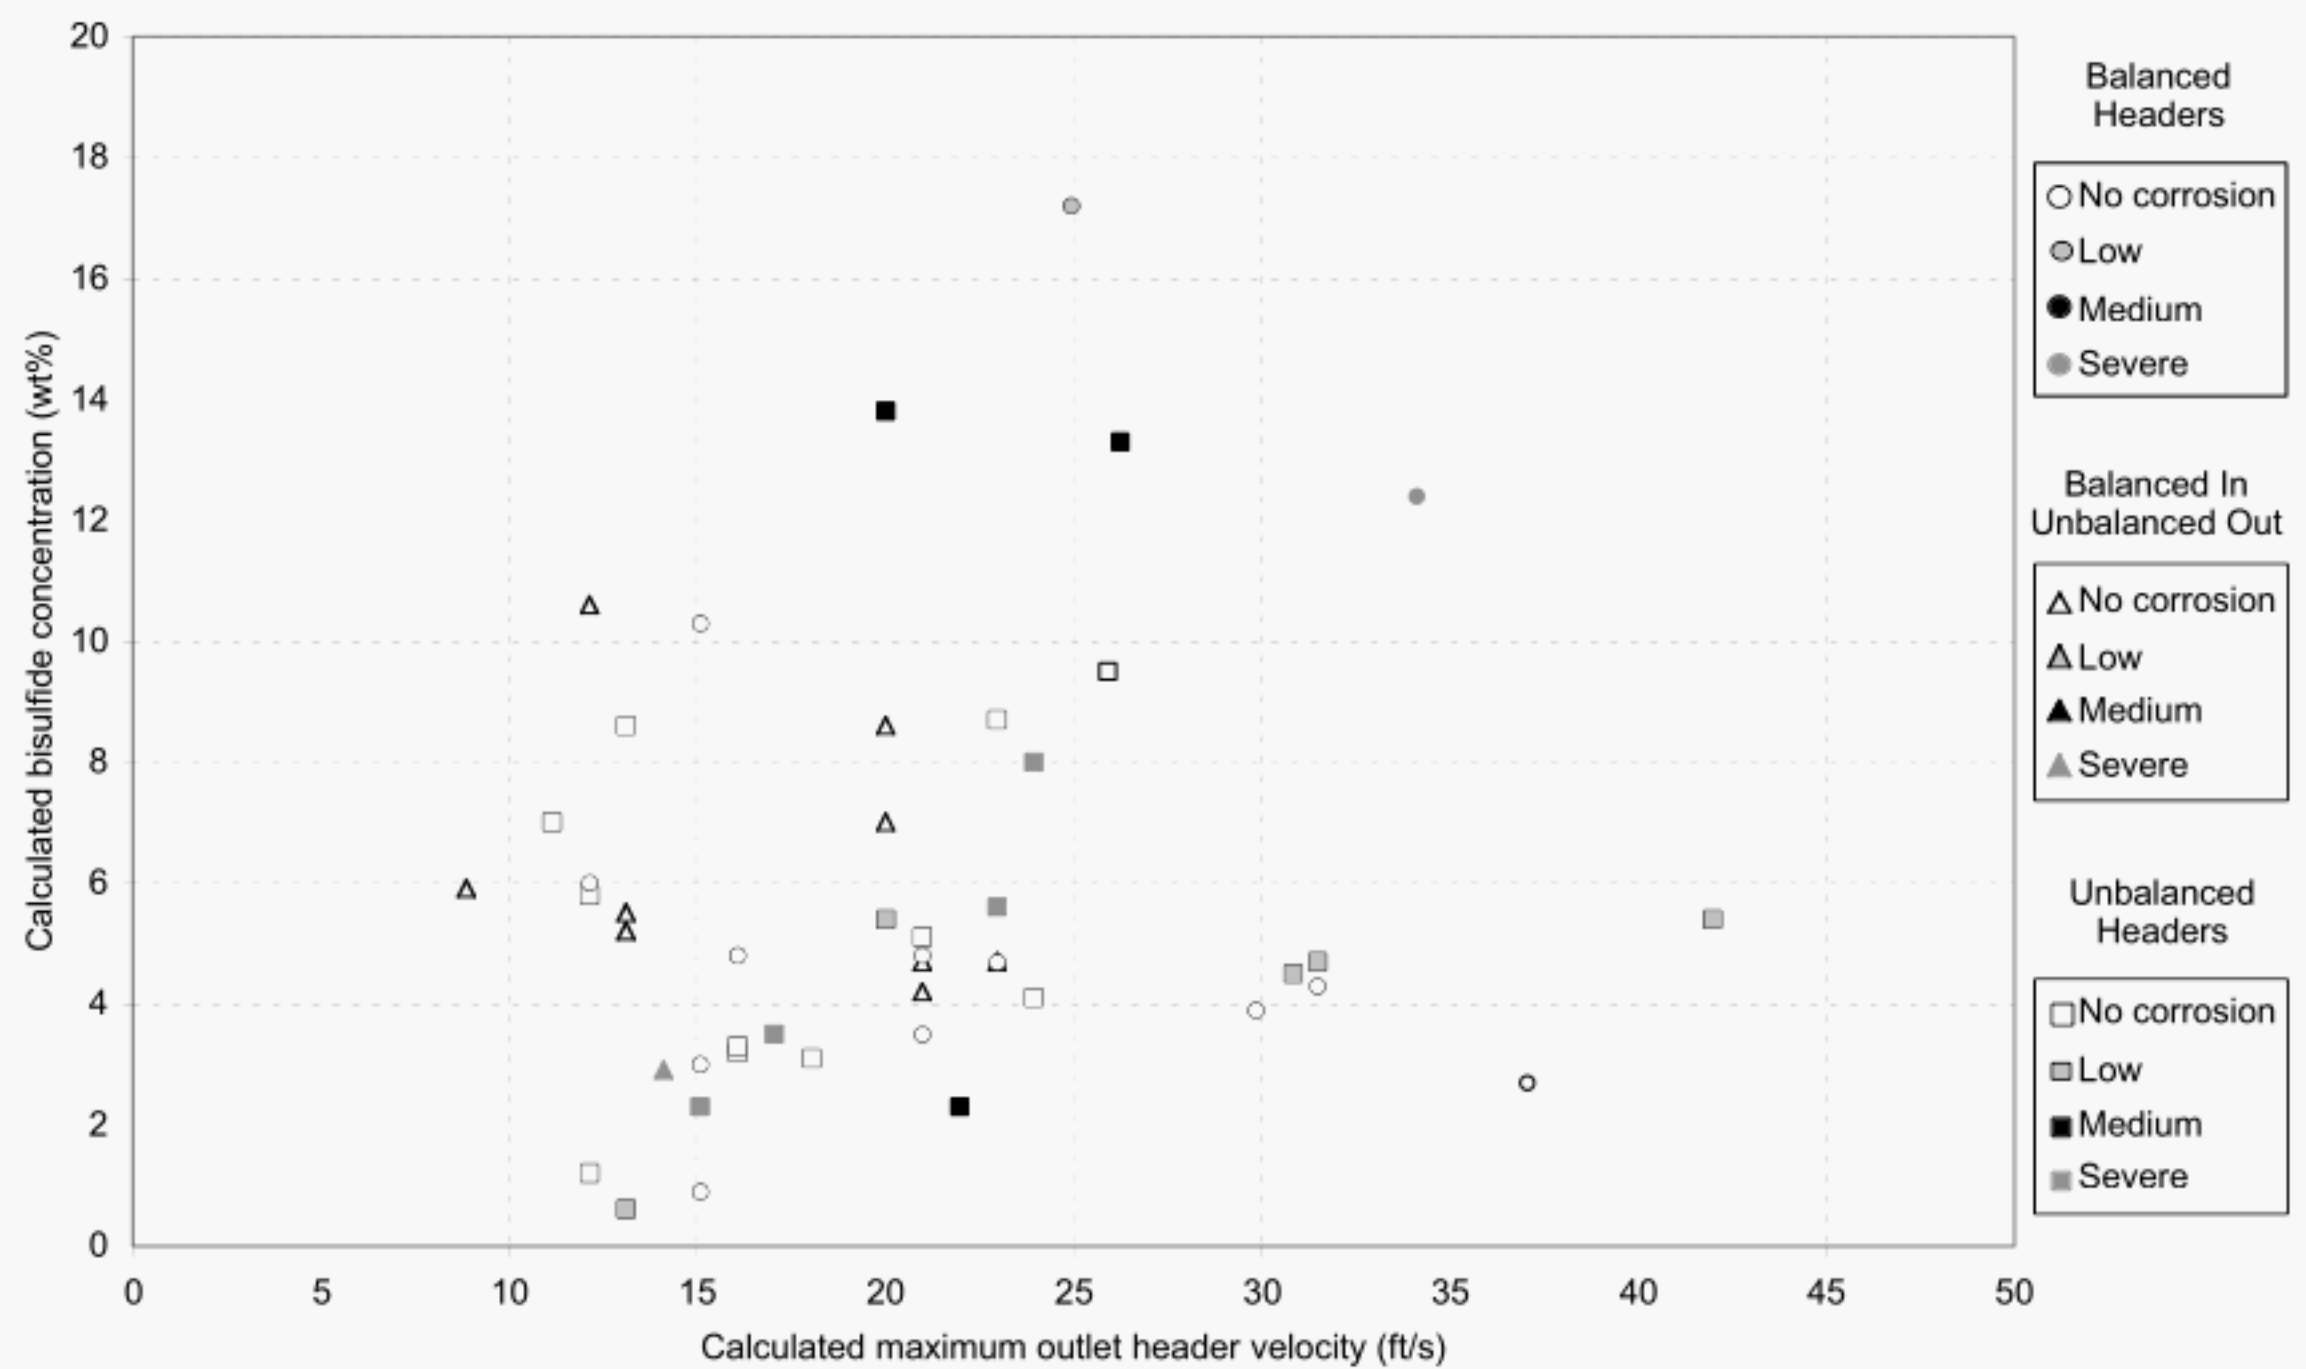
Figure B-4—Corrosion of REAC Outlet Header—The Combined Effect of Calculated Ammonium Bisulfide Concentration in the Downstream Separator and Calculated Maximum Outlet Header Velocity (ft/s) on Corrosion Severity for Balanced and Unbalanced Header Systems

Figure B-4 includes the effect of the header configuration and indicates that serious corrosion has been experienced only when the system is unbalanced whereas with balanced headers experience has been favorable even at surprisingly high veloc-

ities and bisulfide concentrations. The data in Figure B-4 is clarified by showing the effect of each configuration separately as in Figures B-5, B-6, and B-7. Unfortunately, these observations do not provide any precise guidance as to corrosion behavior with velocity but on the other hand are not in conflict with the suggested ranges proposed by Piehl. A serious shortcoming is the lack of predictability of erosion-corrosion in terms of both the velocity conditions that initiate it and the locations where it might occur.

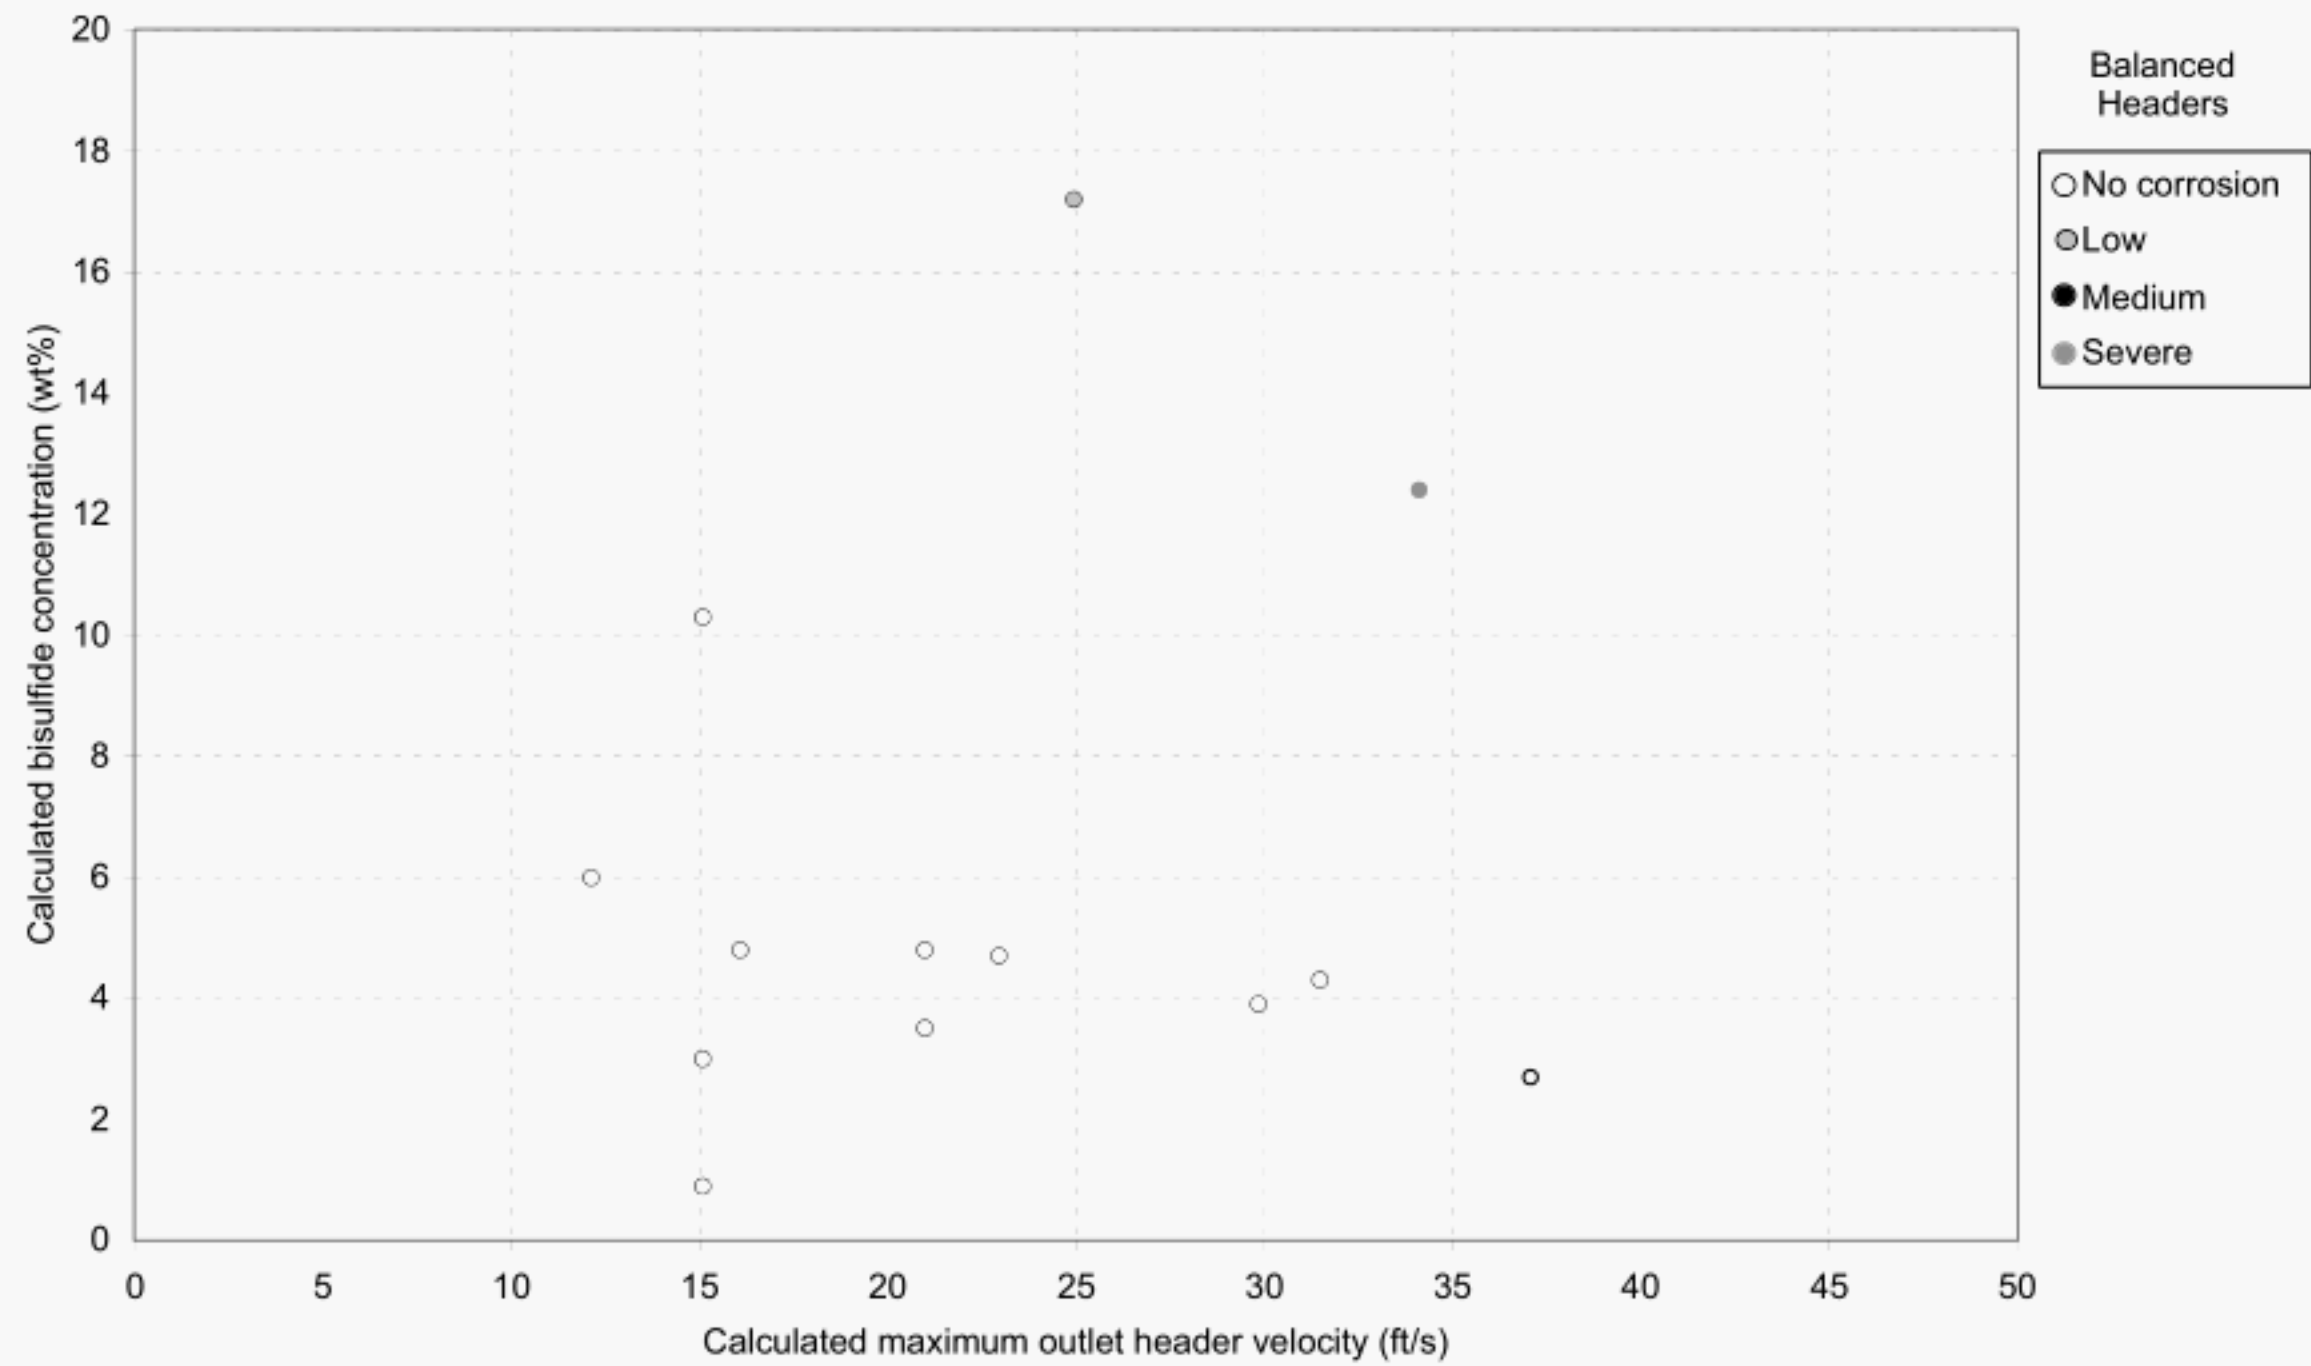
Figure B-5—Corrosion of REAC Outlet Header—The Combined Effect of Calculated Ammonium Bisulfide Concentration in the Downstream Separator and Calculated Maximum Outlet Header Velocity (ft/s) on Corrosion Severity for Balanced Header Systems

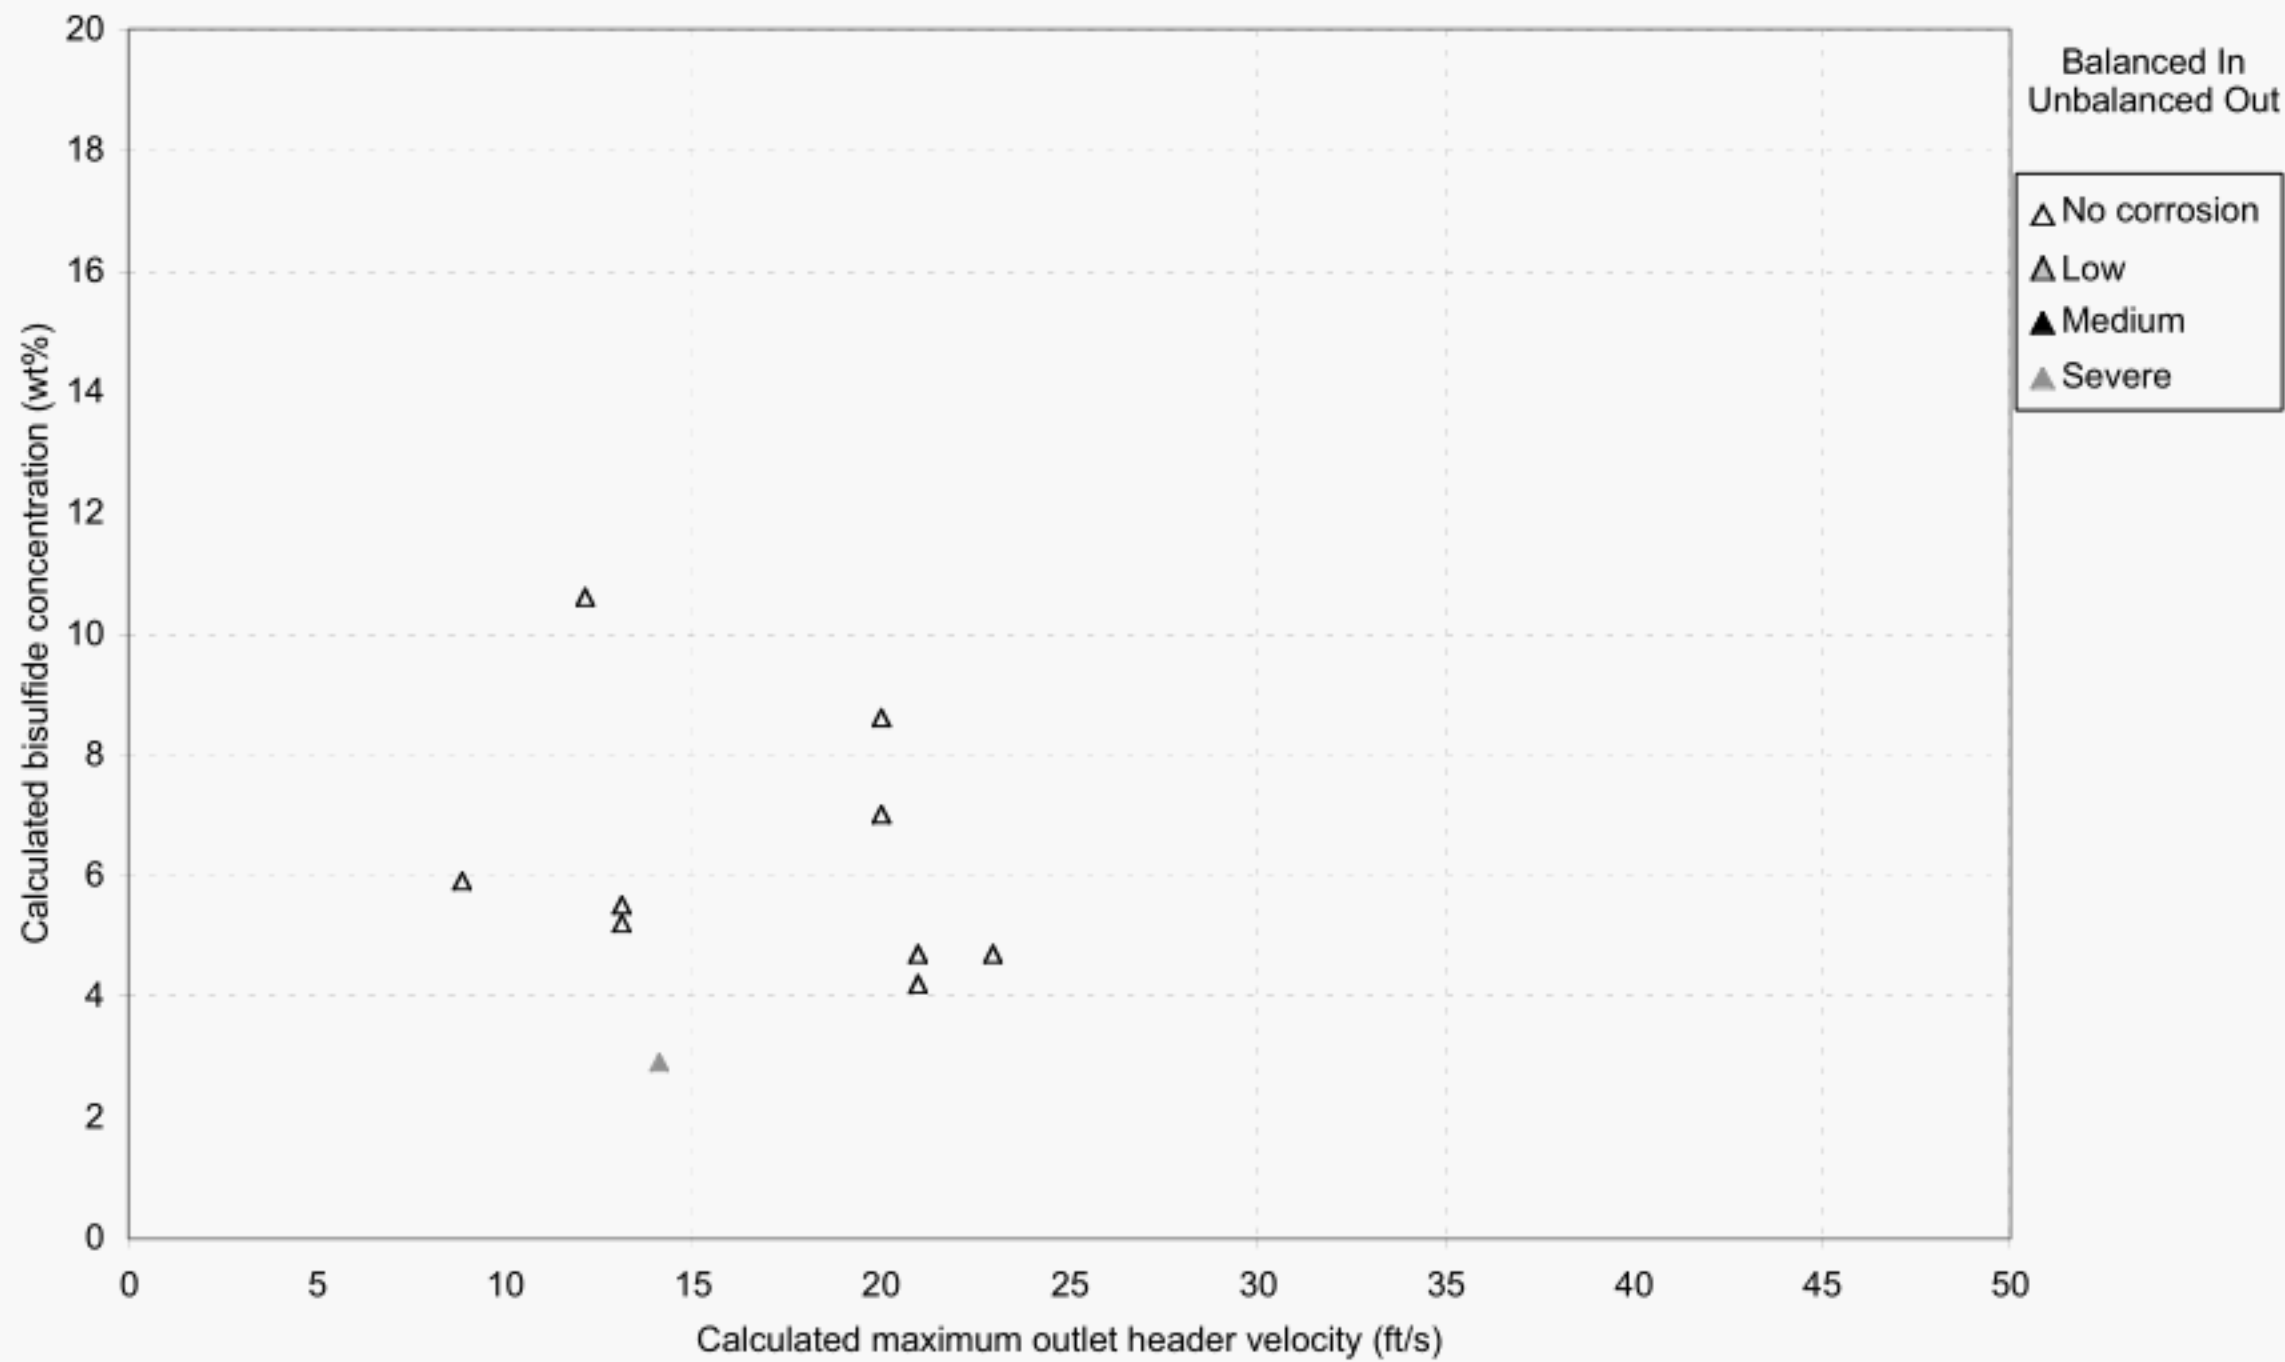
Figure B-6—Corrosion of REAC Outlet Header—The Combined Effect of Calculated Ammonium Bisulfide Concentration in the Downstream Separator and Calculated Maximum Outlet Header Velocity (ft/s) on Corrosion Severity for Balanced Inlet and Unbalanced Outlet Header Systems
