# **A Study of Corrosion in Hydroprocess Reactor Effluent Air Cooler Systems**

API PUBLICATION 932-A  
SEPTEMBER 2002

This study was sponsored by the American Petroleum Institute (API), Committee on Refinery Equipment, Subcommittee on Corrosion and Materials Research. The purpose of the study was to provide technical background, based on industry experience and consensus practice, for controlling corrosion in hydroprocess reactor effluent systems. The findings reported herein will be used as an interim resource by the industry and as a basis for a future API recommended practice document.

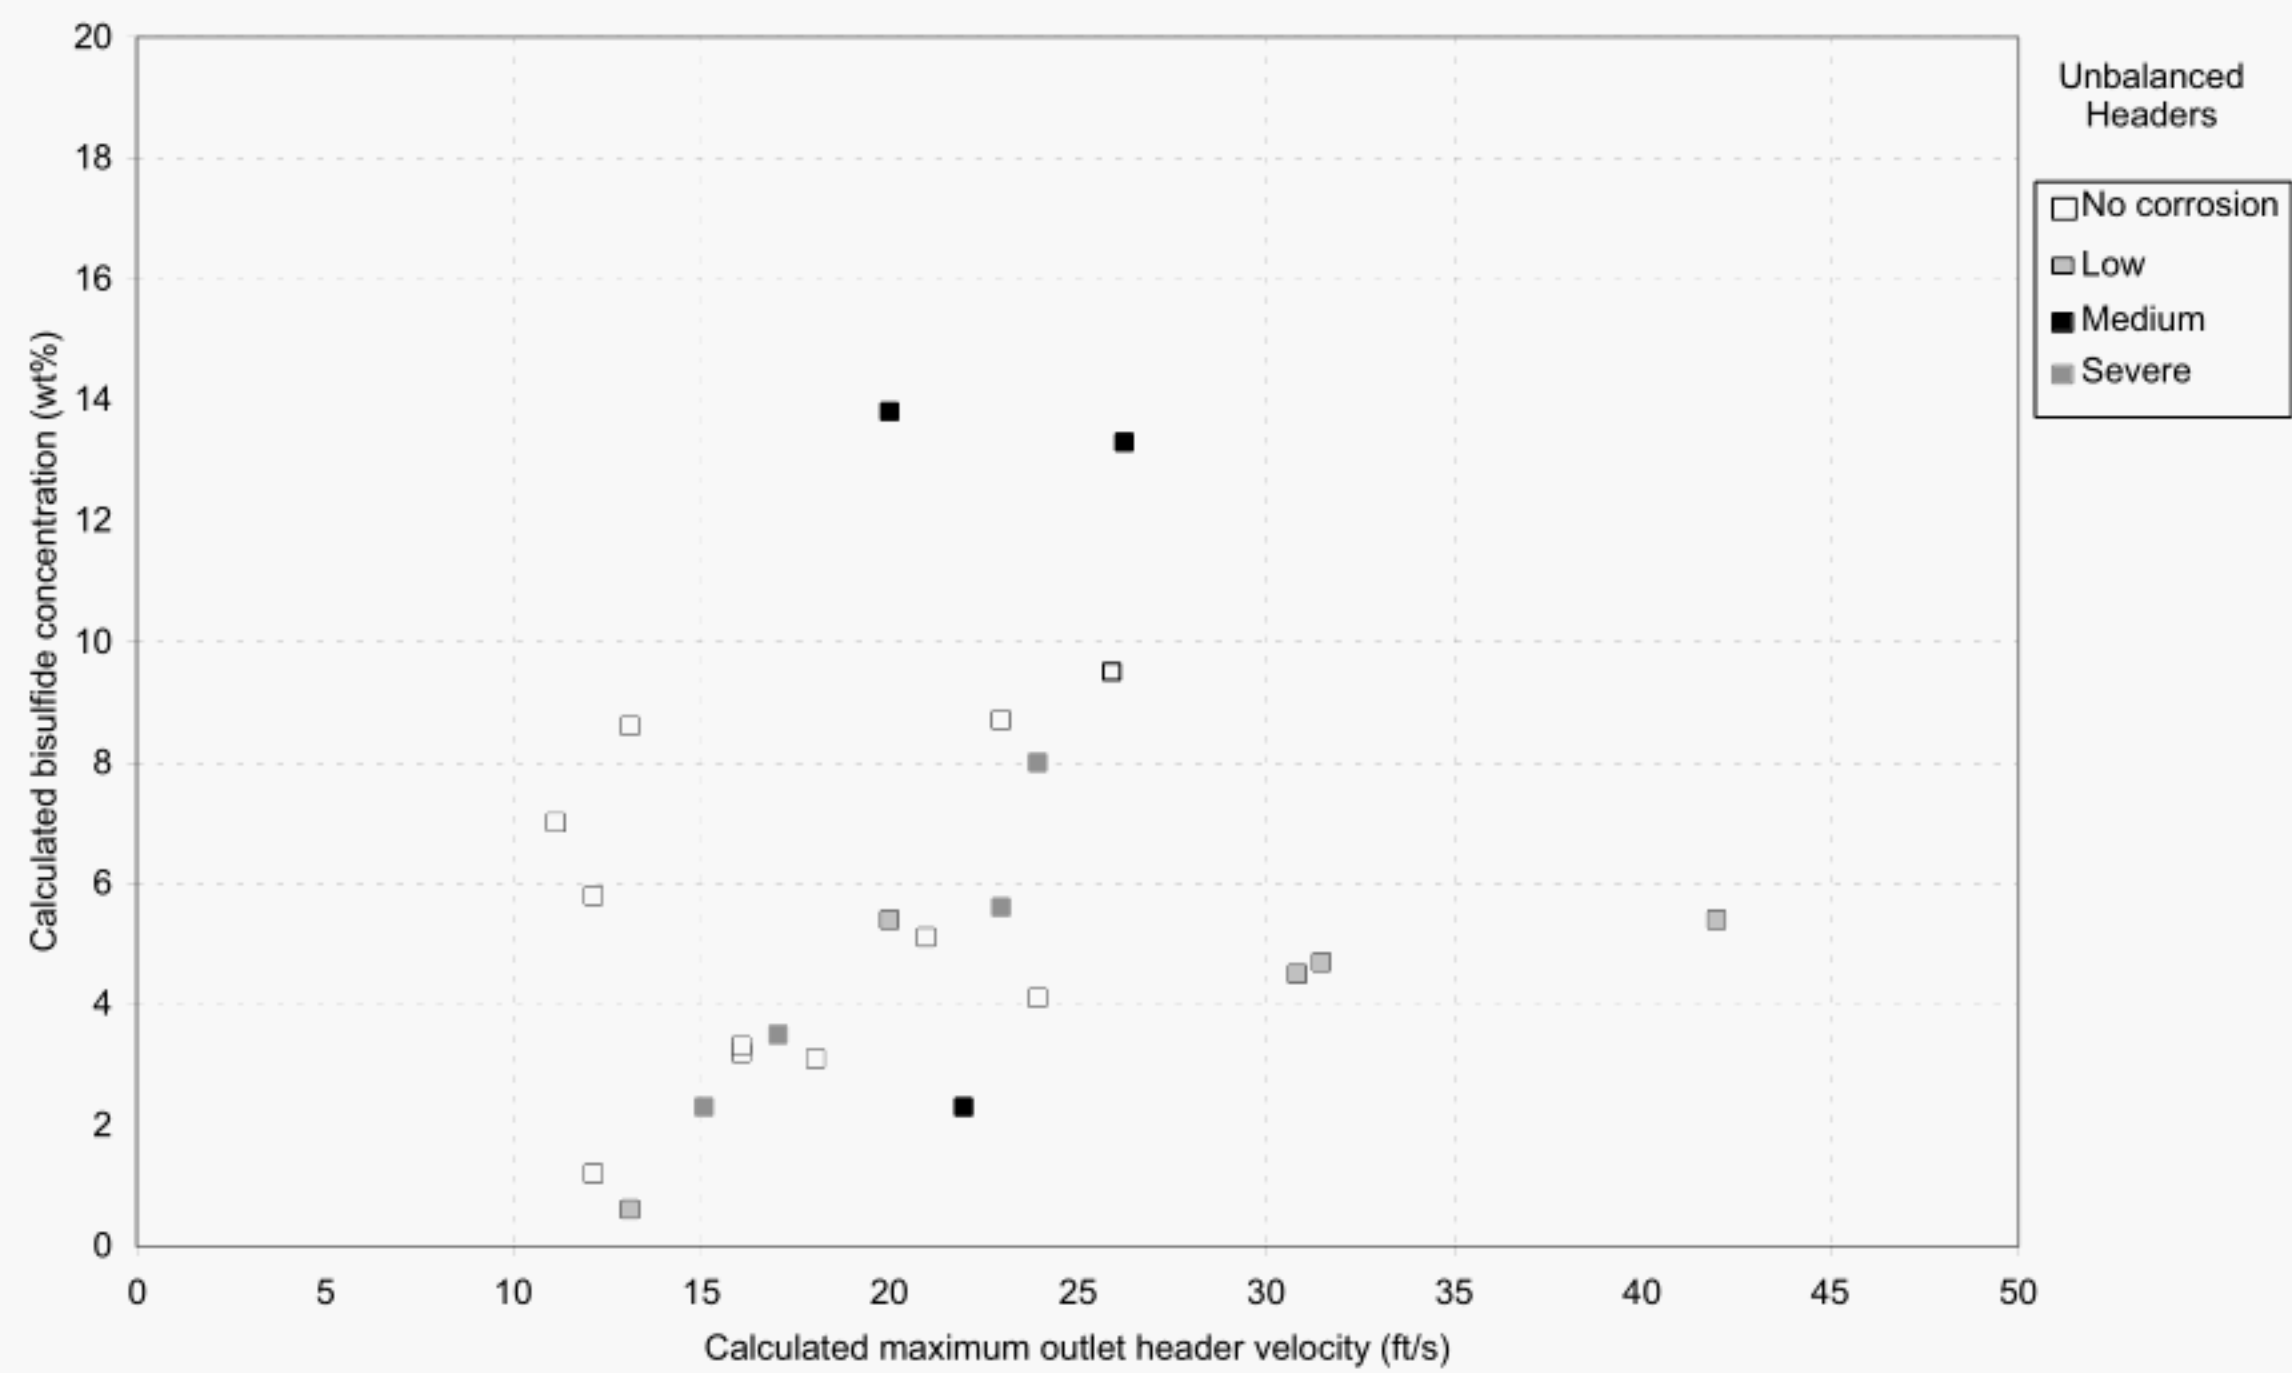
Figure B-7—Corrosion of REAC Outlet Header—The Combined Effect of Calculated Ammonium Bisulfide Concentration in the Downstream Separator and Calculated Maximum Outlet Header Velocity (ft/s) on Corrosion Severity for Unbalanced Header Systems

ities and bisulfide concentrations. The data in Figure B-4 is clarified by showing the effect of each configuration separately as in Figures B-5, B-6, and B-7. Unfortunately, these observations do not provide any precise guidance as to corrosion behavior with velocity but on the other hand are not in conflict with the suggested ranges proposed by Piehl. A serious shortcoming is the lack of predictability of erosion-corrosion in terms of both the velocity conditions that initiate it and the locations where it might occur.
