Stress Corrosion Cracking of Carbon Steel in Fuel Grade Ethanol: Review and Survey

API TECHNICAL REPORT 939-D
SEPTEMBER 2003

Prepared under contract for API by:
    Dr. Russell D. Kane
    Dr. Julio G. Maldonado
     InterCorr International, Inc.
    Houston, TX

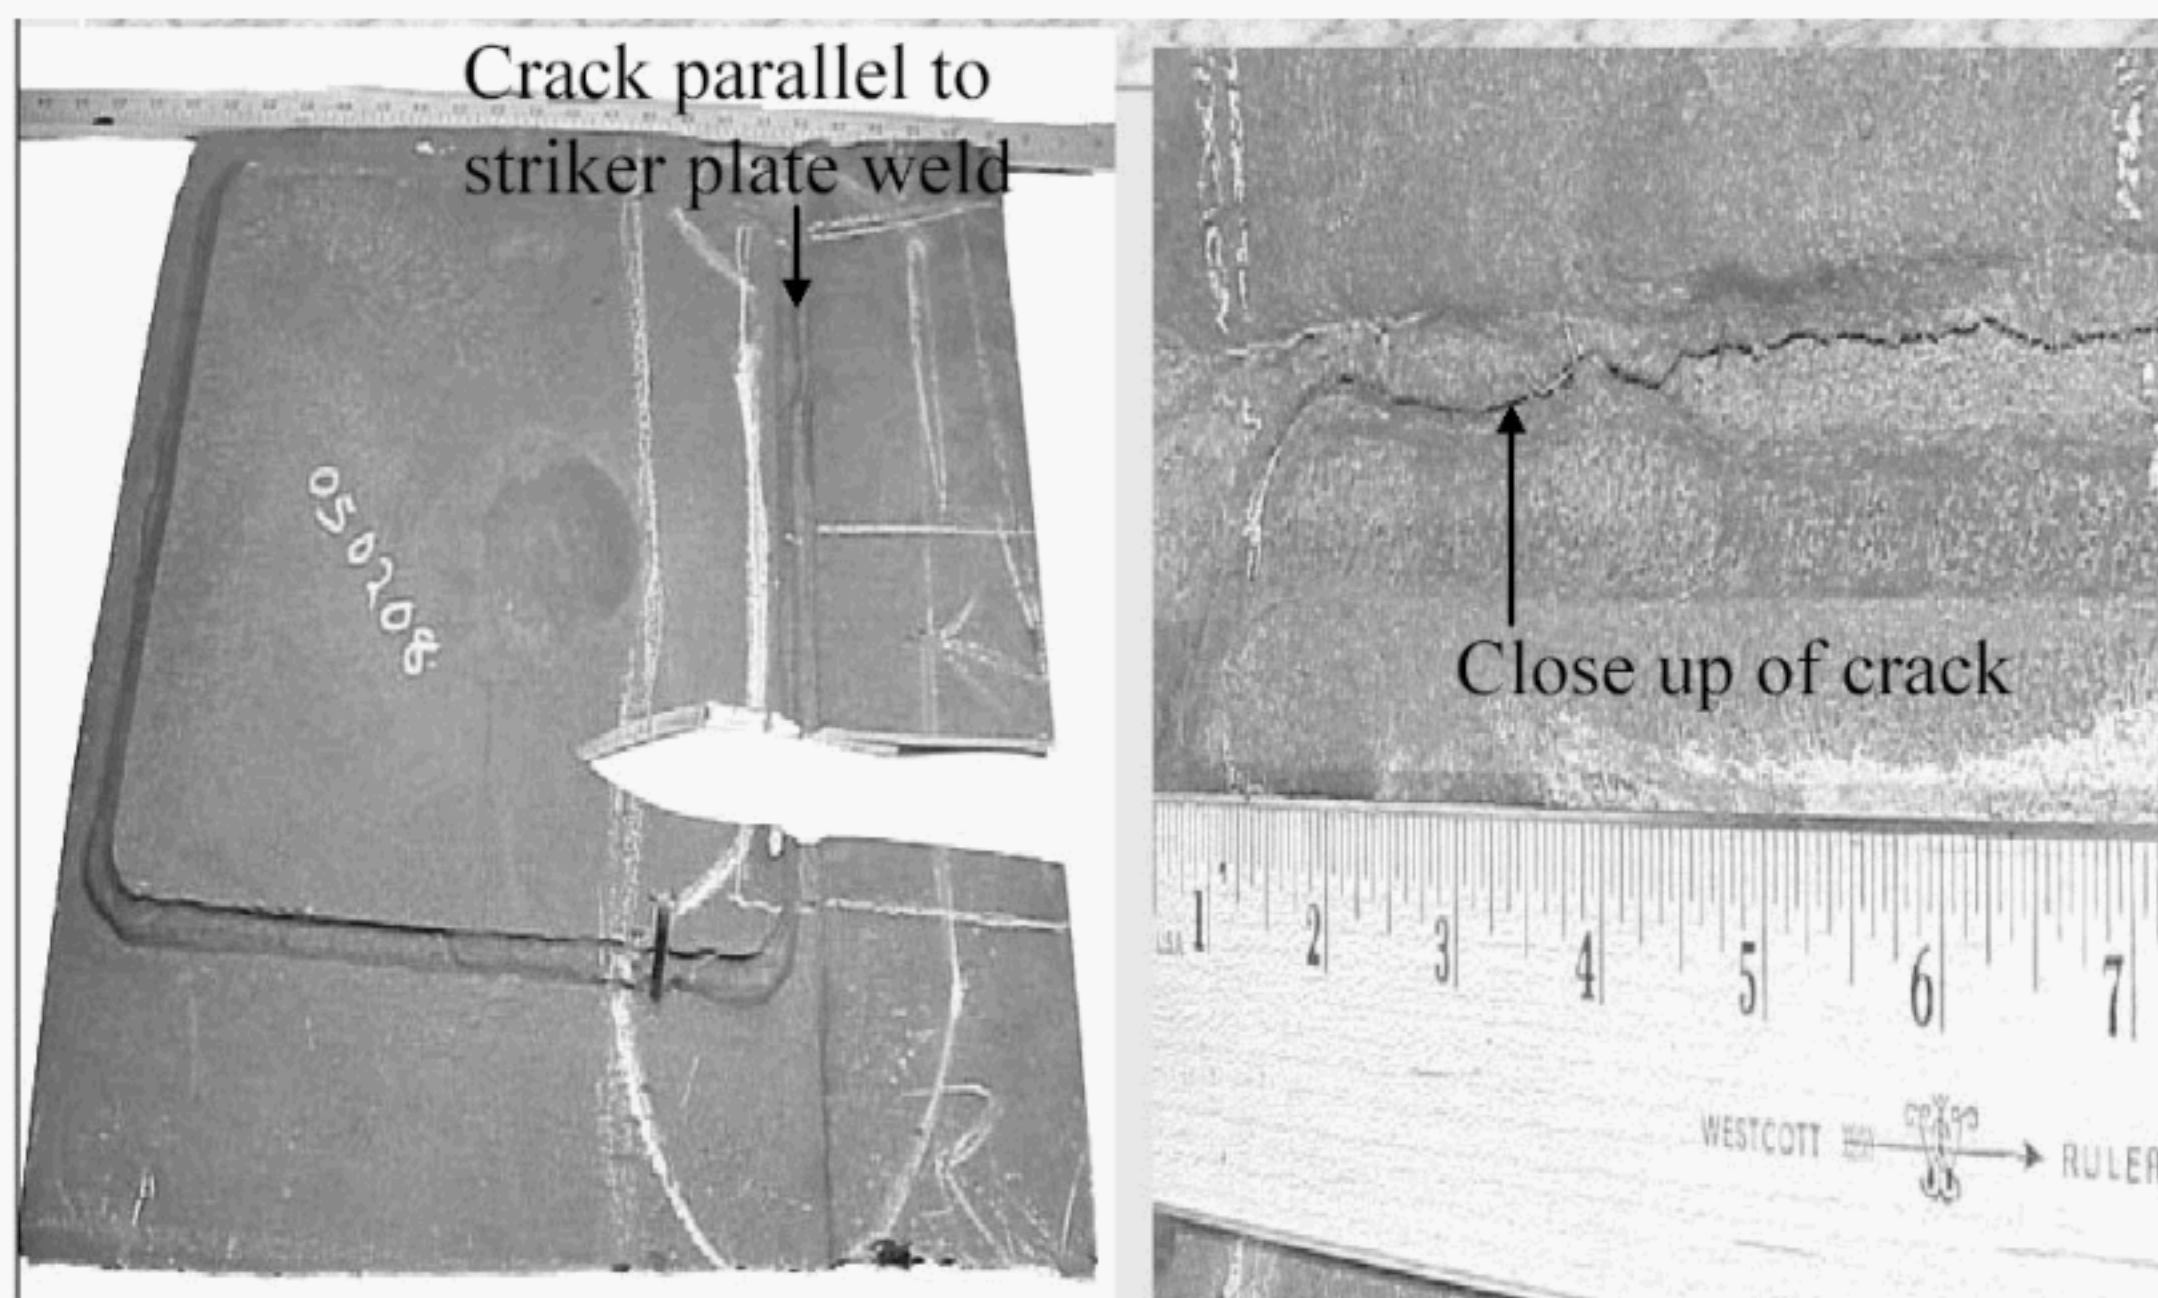
With the exception of cases involving roof springs, failures from SCC in fuel ethanol have mainly occurred in plate steels, in locations around, but not in, welds. The reports indicate that the cracking can be either transverse or longitudinal with respect to the weld orientation. These cracking regions are located in the base metal adjacent to welds. Multiple reports indicate that the cracking was located generally in a region between the weld heat affected zone (HAZ) to about 1 in. into the base metal (see Figures 12 – 14).

Note: Crack running parallel to fillet weld in striker plate.

Figure 12—SCC in Steel Tank Bottom

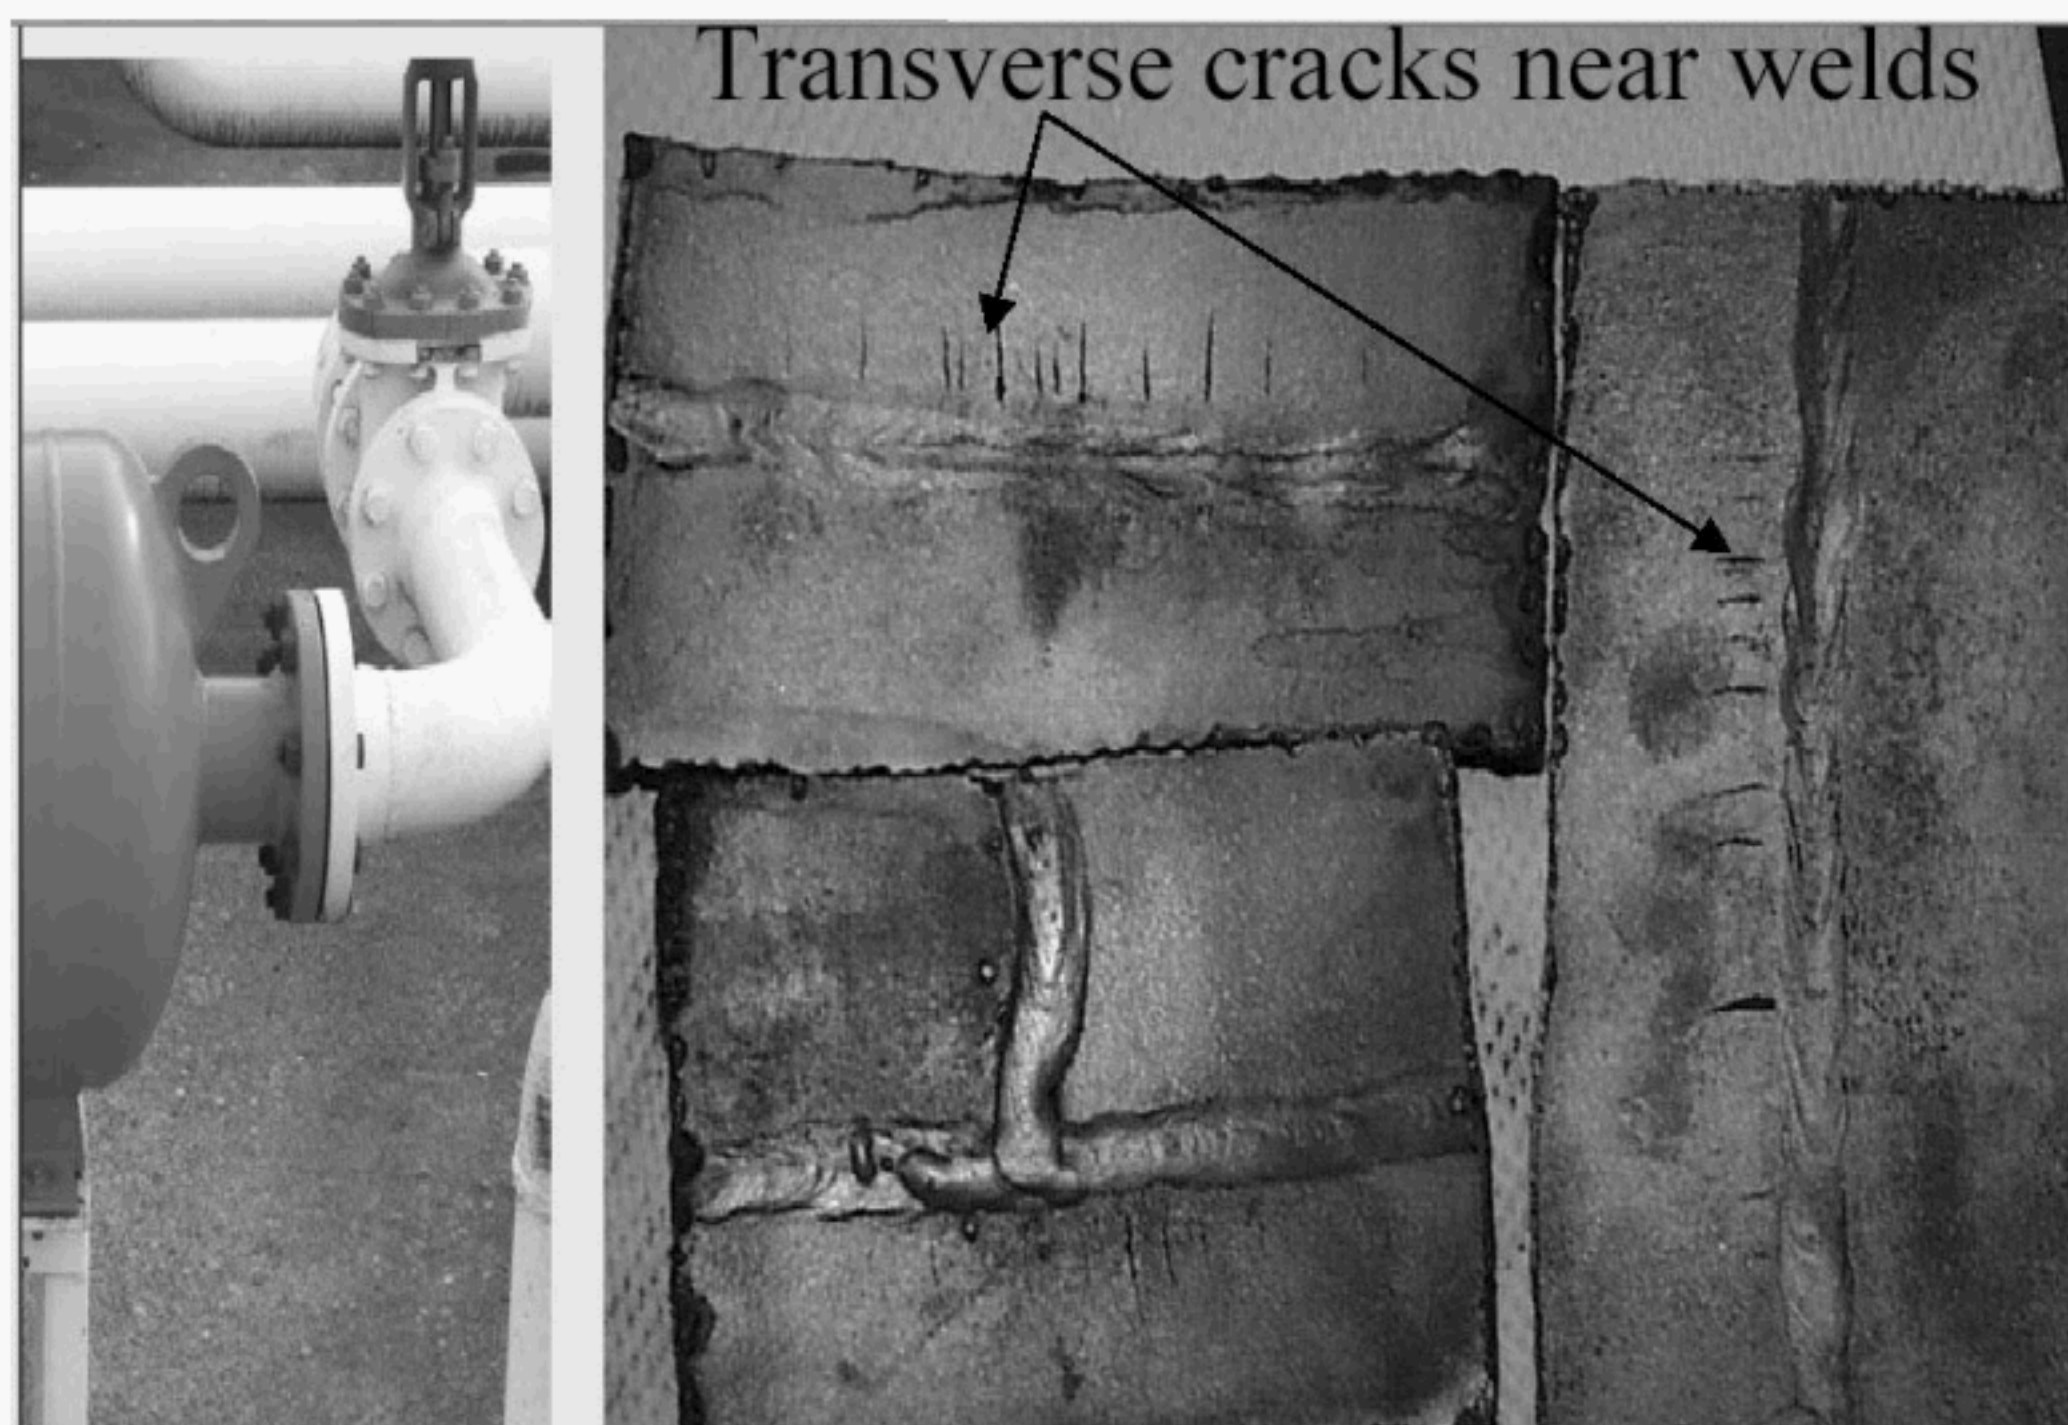
Note: Cracks running perpendicular to weld.

Figure 13—SCC in Steel Air Eliminator Vessel

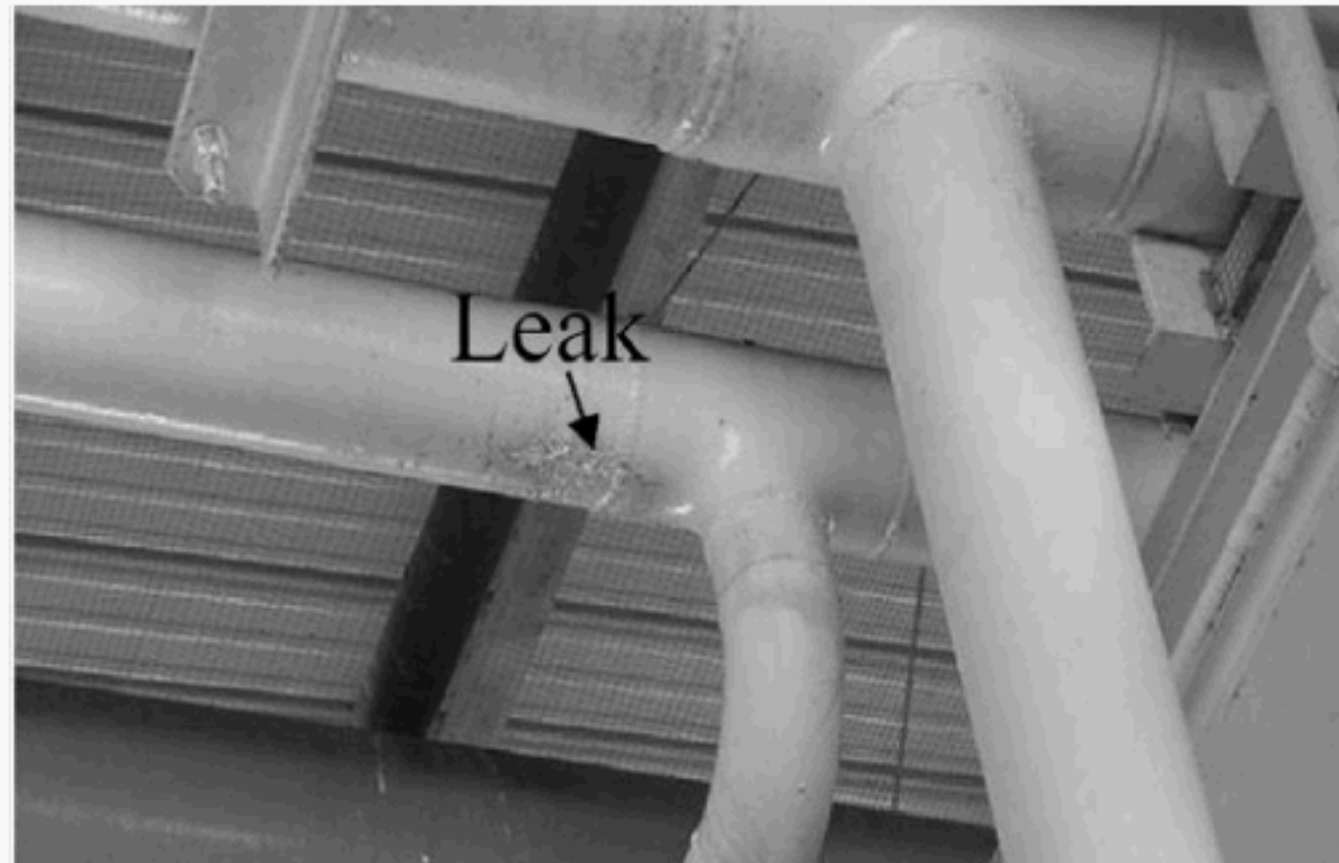
Figure 14—Leak in Piping Resulting from a Crack Adjacent to the Weld

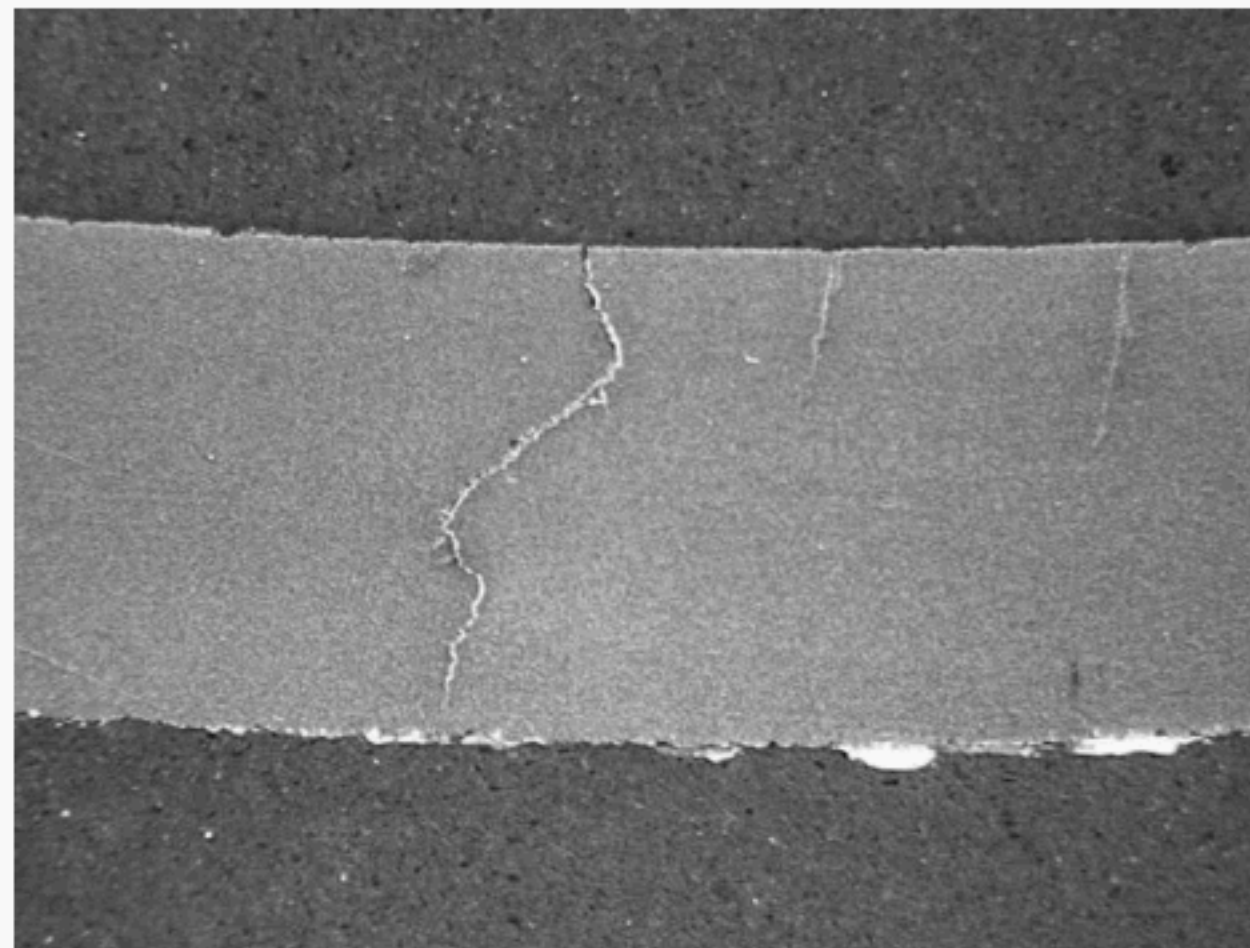
Figure 15—Characteristics of SCC in Steel Exposed to Fuel Ethanol, Showing Multiple Crack Initiations and Through-Thickness Propagation in Piping

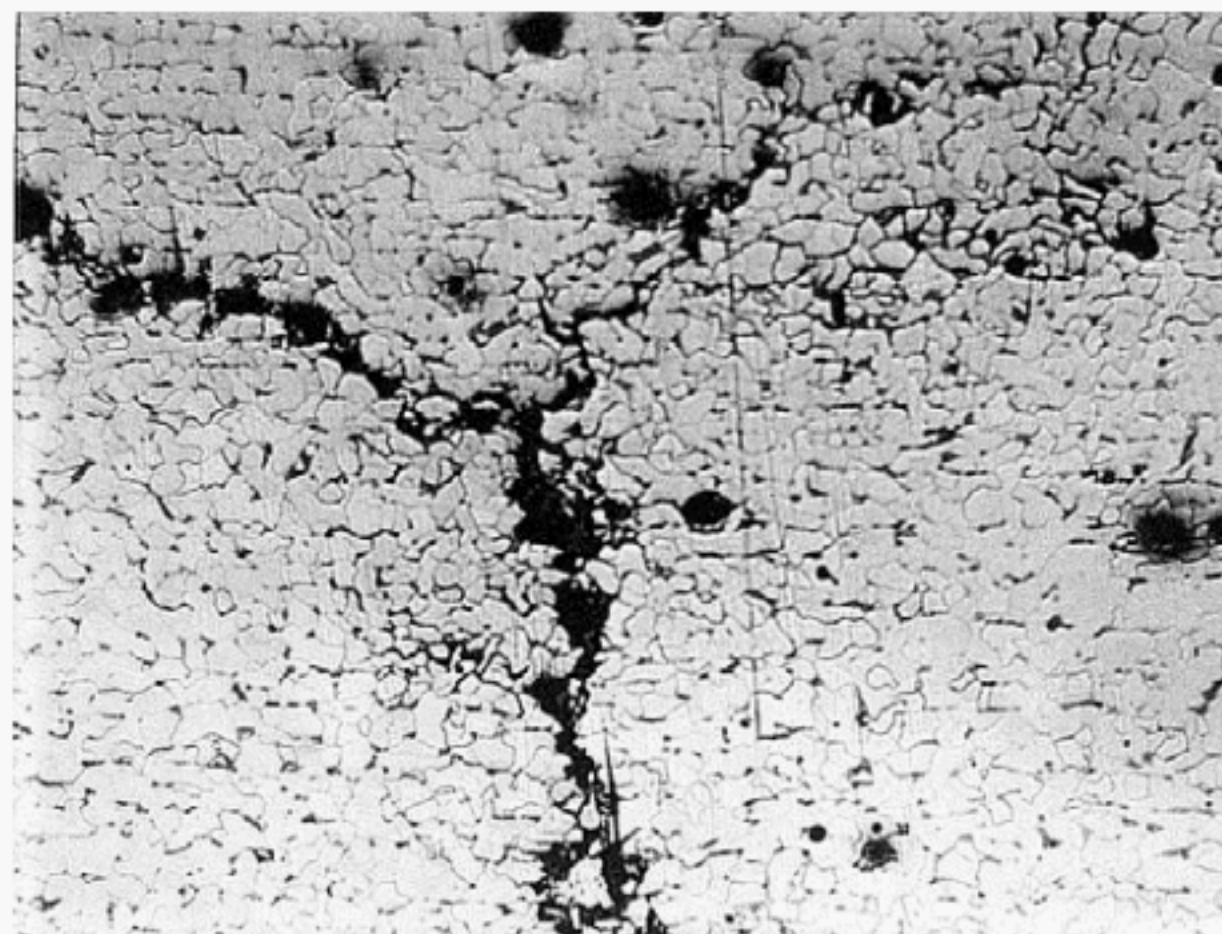
Figure 16—CC in Steel Tank Bottom Showing Highly Branched, Intergranular Cracks at 100×

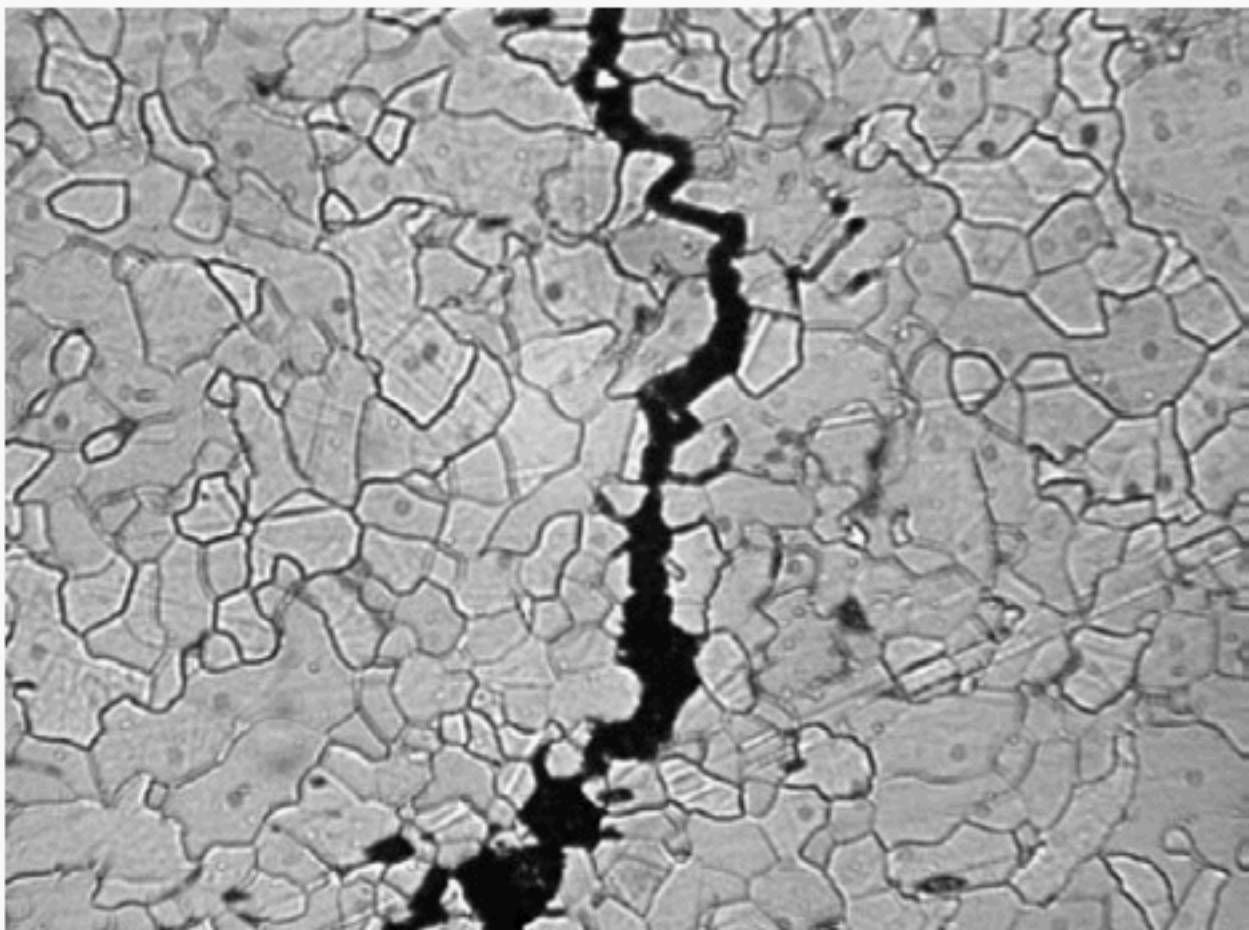
Note: Intergranular Cracking features.

Figure 17—SCC in Steel Metallographically Prepared with Grain Boundary Etch at 500×

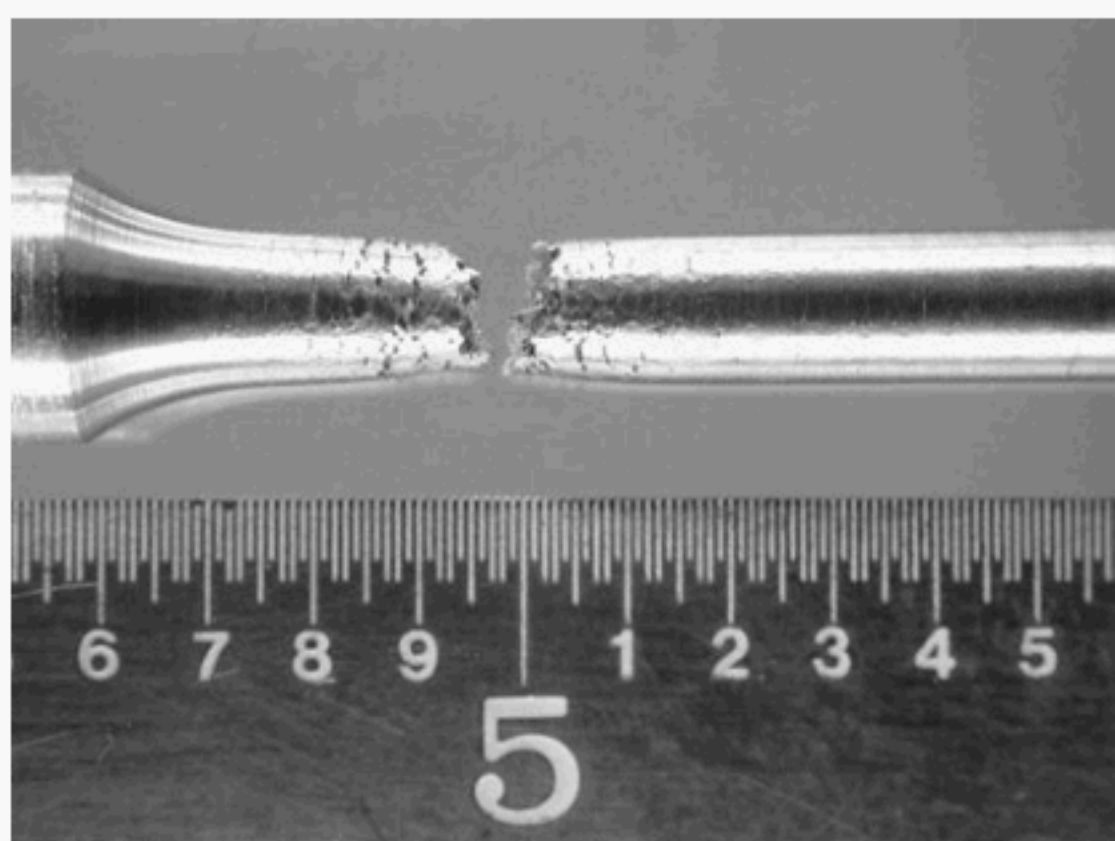
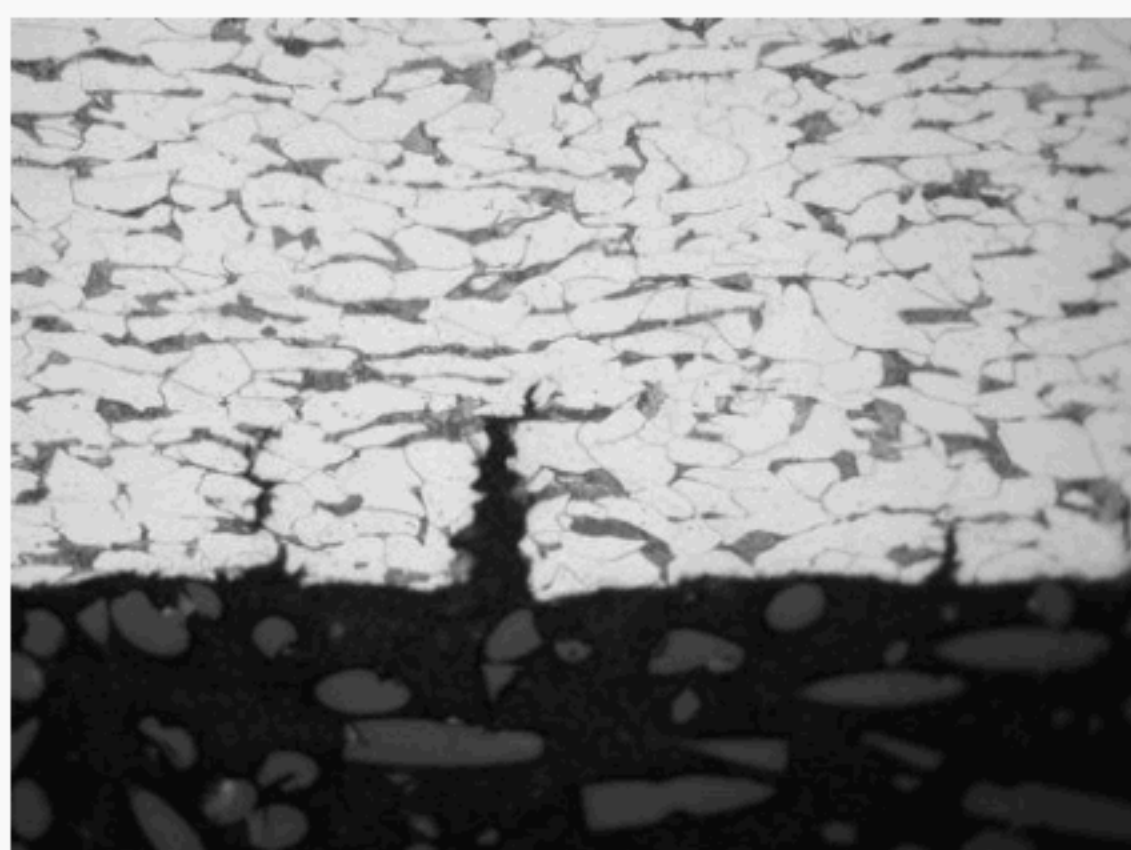
Figure 18—SCC Produced on Welded Carbon Steel in Fuel Ethanol

Note: Cracking was a mixture of intergranular and transgranular features.

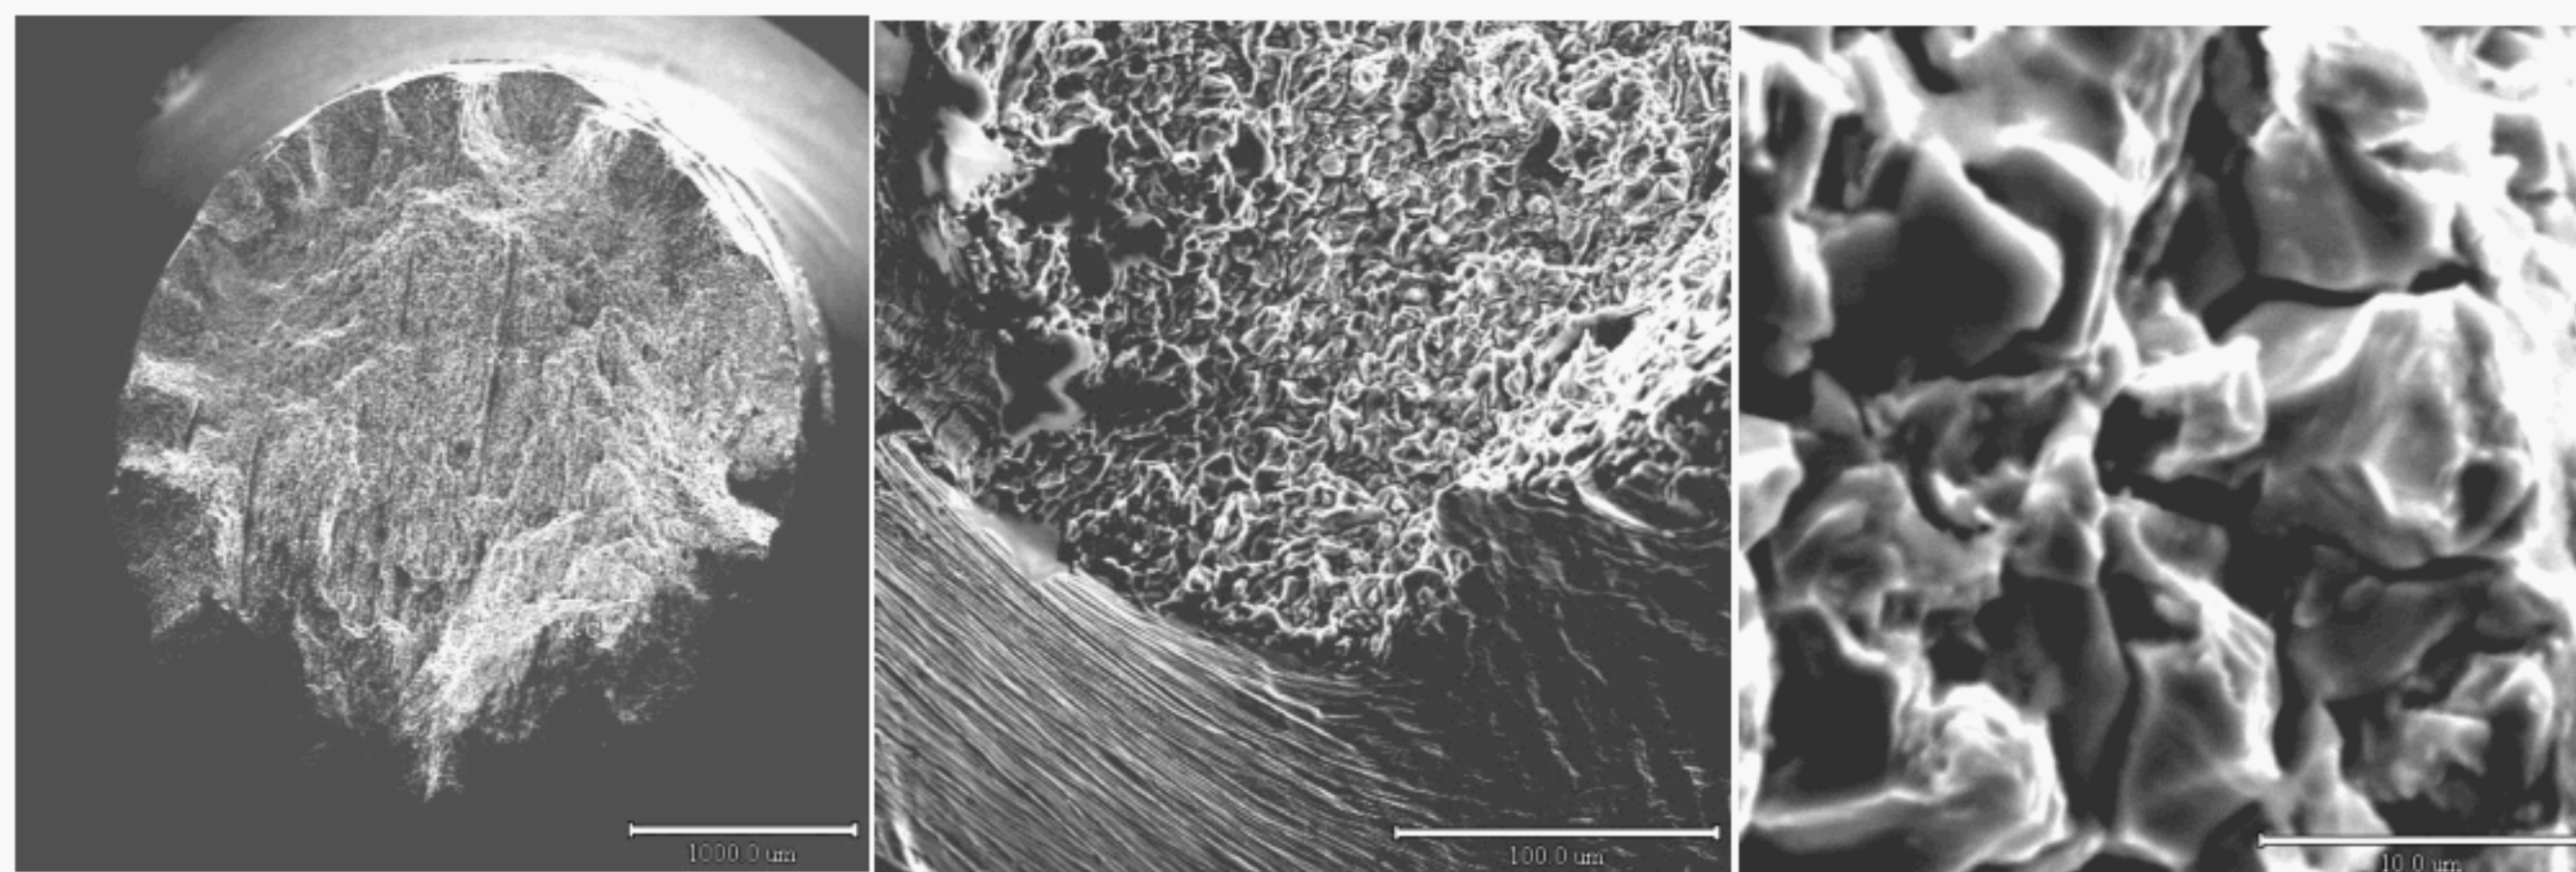
Note: Produced by SCC in laboratory environment.

Figure 20—Close-up SEM Photomicrographs of Fracture Surface

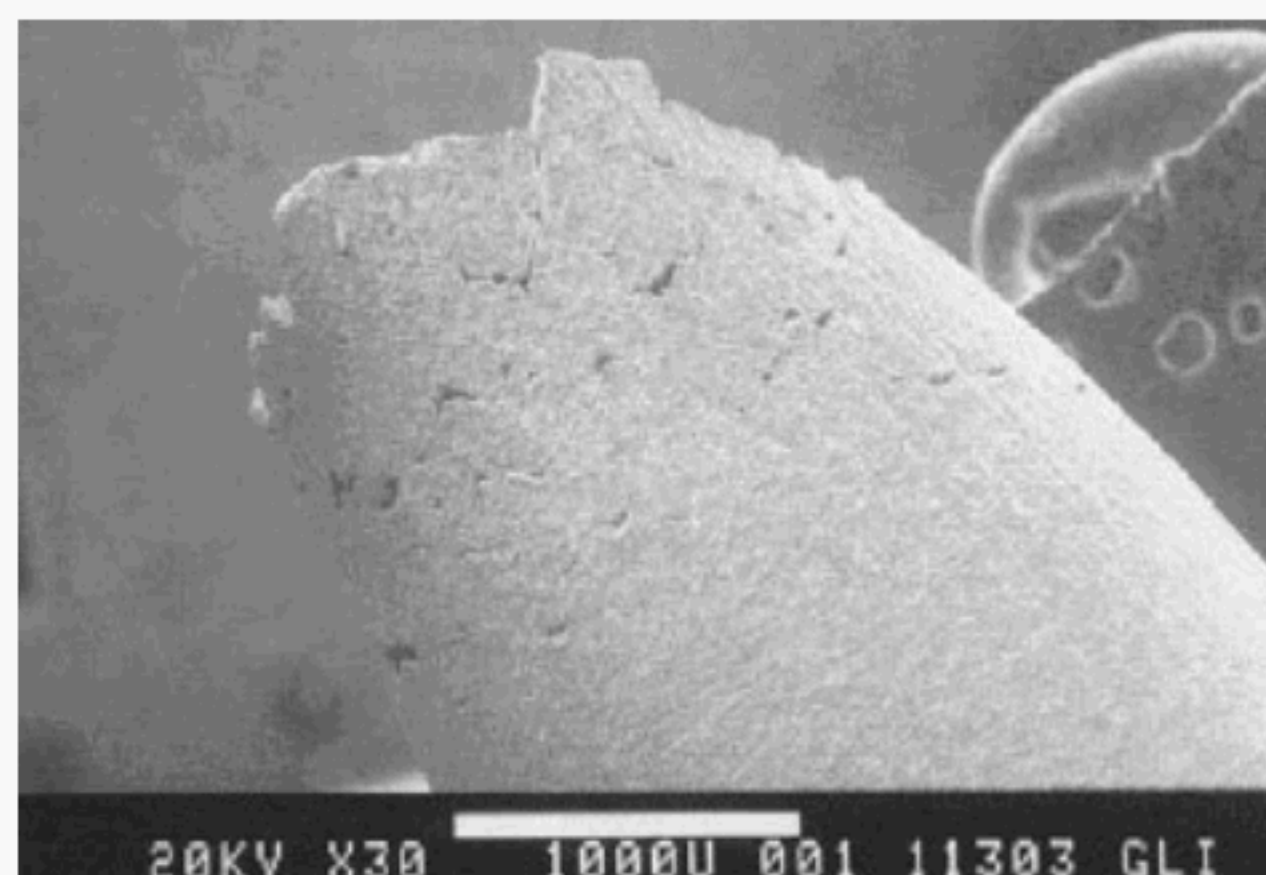
A limited program was conducted that included a combination of electrochemical and SSR testing. [42] These tests were performed using synthetically prepared ethanolic environments with additions of 5% methanol and 1% water, and in a simulated fuel grade ethanol based on the specifications of ASTM D 4806. These tests were conducted on specimens machined from API X 46 line pipe steel at room temperature at an initial strain rate of 1×10^{-6} sec.$^{-1}$. No evidence of SCC was observed in 100% ethanol or when 5% methanol or 5% methanol plus 0.5% water was added. When a simulated fuel grade ethanol was used as the test environment fissuring was obtained in the highly strained necked region as shown in Figure 21.

Note: Fissures in necked region of specimen.

Figure 21—SEM Photomicrograph of SSR Specimen Tested in a Simulated Fuel Grade Ethanol Environment
