Avoiding Environmental Cracking in Amine Units

API RECOMMENDED PRACTICE 945
THIRD EDITION, JUNE 2003

1 Scope

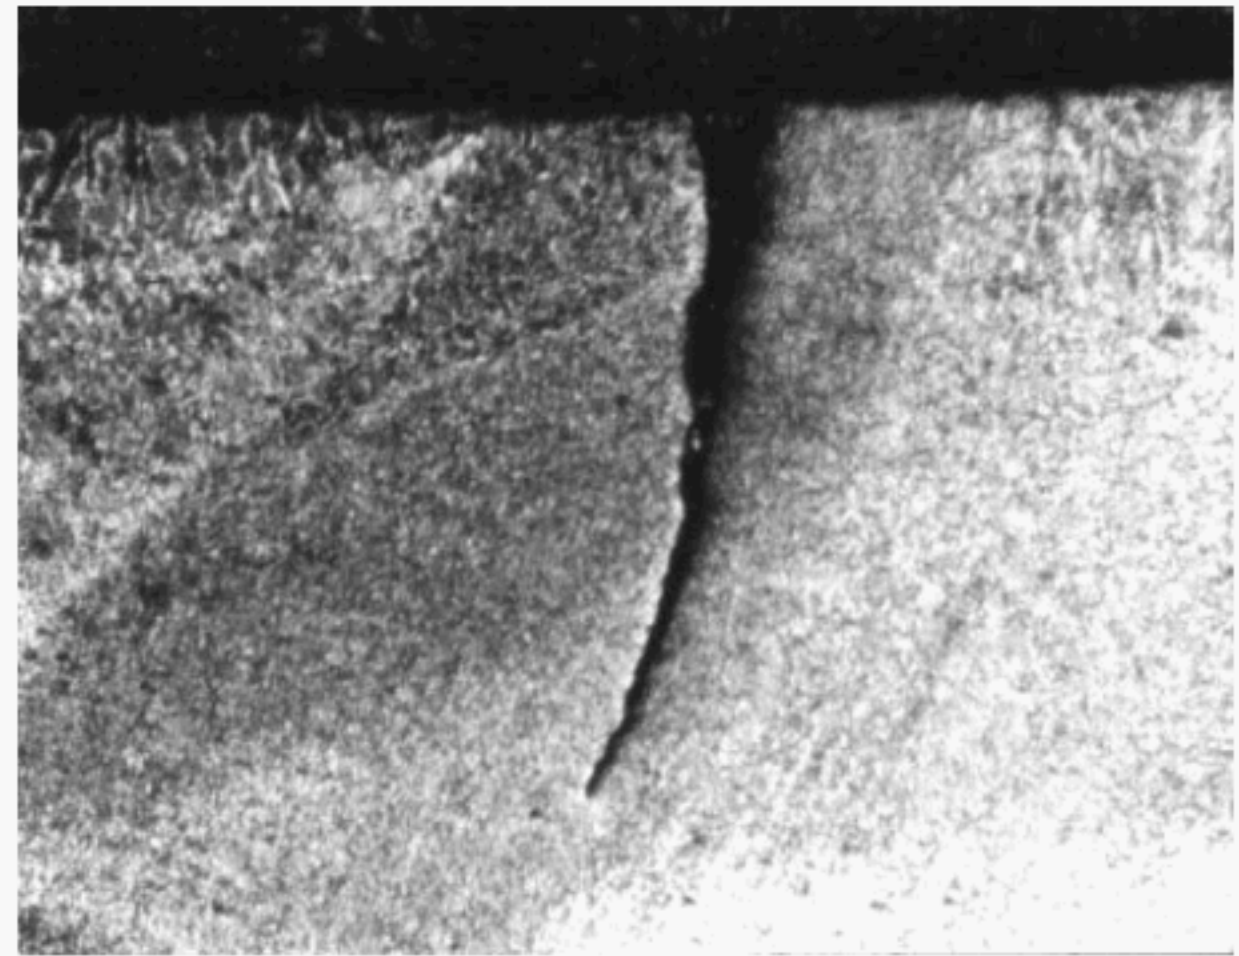
Figure A-1—Sulfide Stress Cracking in an Existing Hardened Heat-Affected Zone of a Weld

Note: Two-percent nital etch at 30X magnification.

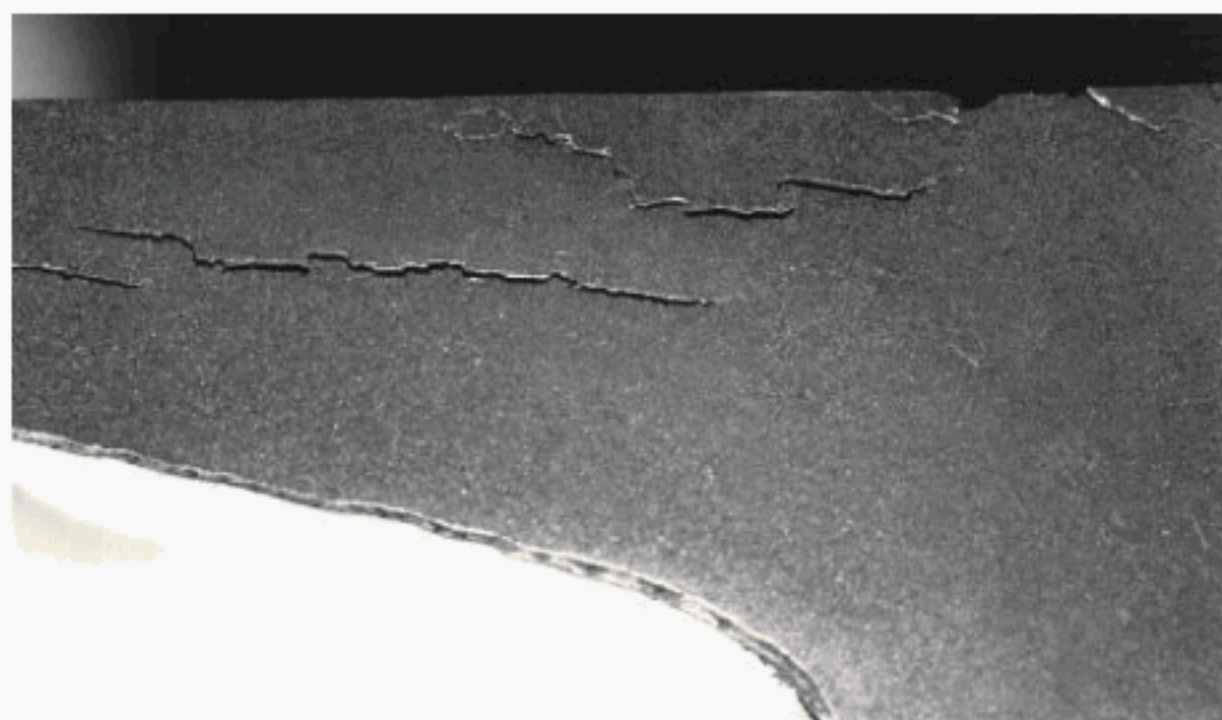
Figure A-2—Hydrogen Blisters near the ID Surface of a Carbon Steel Flange

Note: Two-percent nital etch at 4.5X magnification.

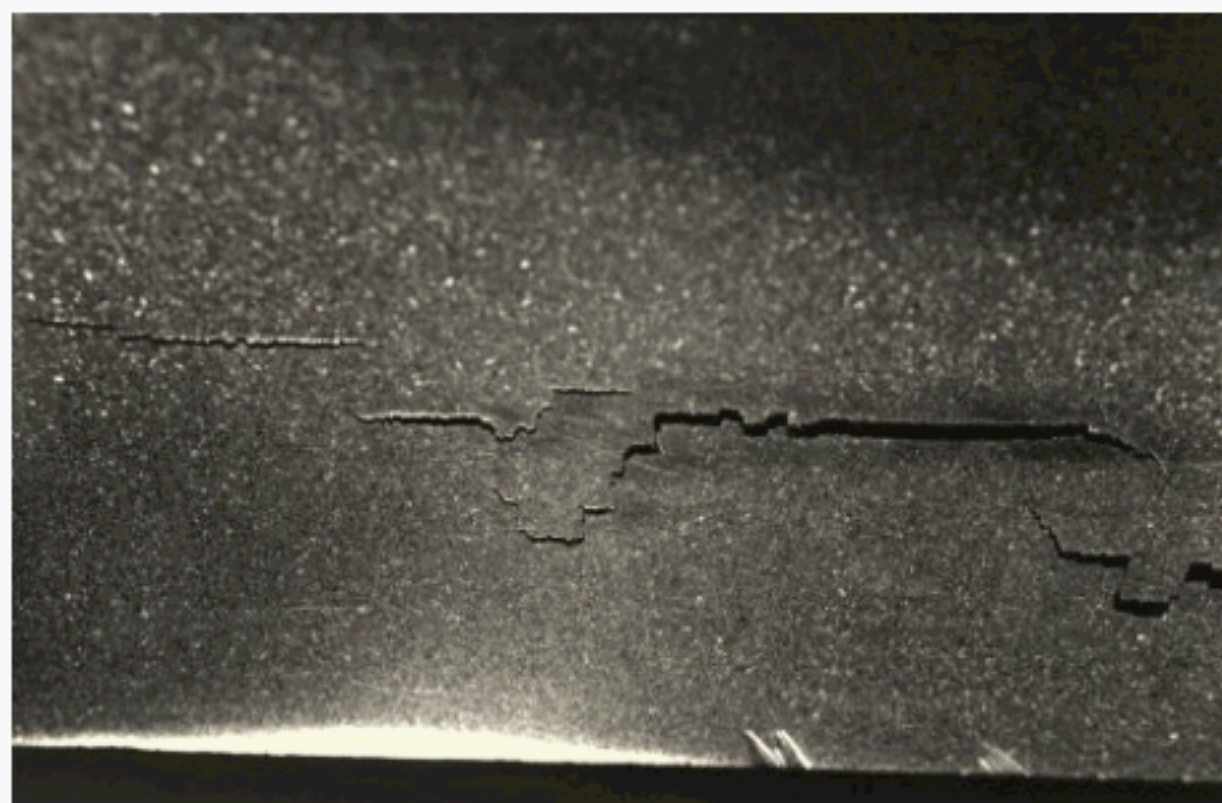
Figure A-3—Stepwise Hydrogen-Induced Cracking (HIC) in a Carbon Steel Specimen

Note: Two-percent nital etch at 5.5X magnification.

HIC is defined as stepwise internal cracks that connect adjacent hydrogen blisters on different planes in the metal, or to the metal surface. No externally applied stress is needed for the formation of HIC. The driving force for the crack propagation is high stresses at the circumference of the blisters that are caused by the buildup of internal pressure in the blisters. Interaction between these high stress fields tends to cause cracks to develop that link blisters on different planes. The link-up of blisters on different planes in steels has been referred to as stepwise cracking to characterize the nature of

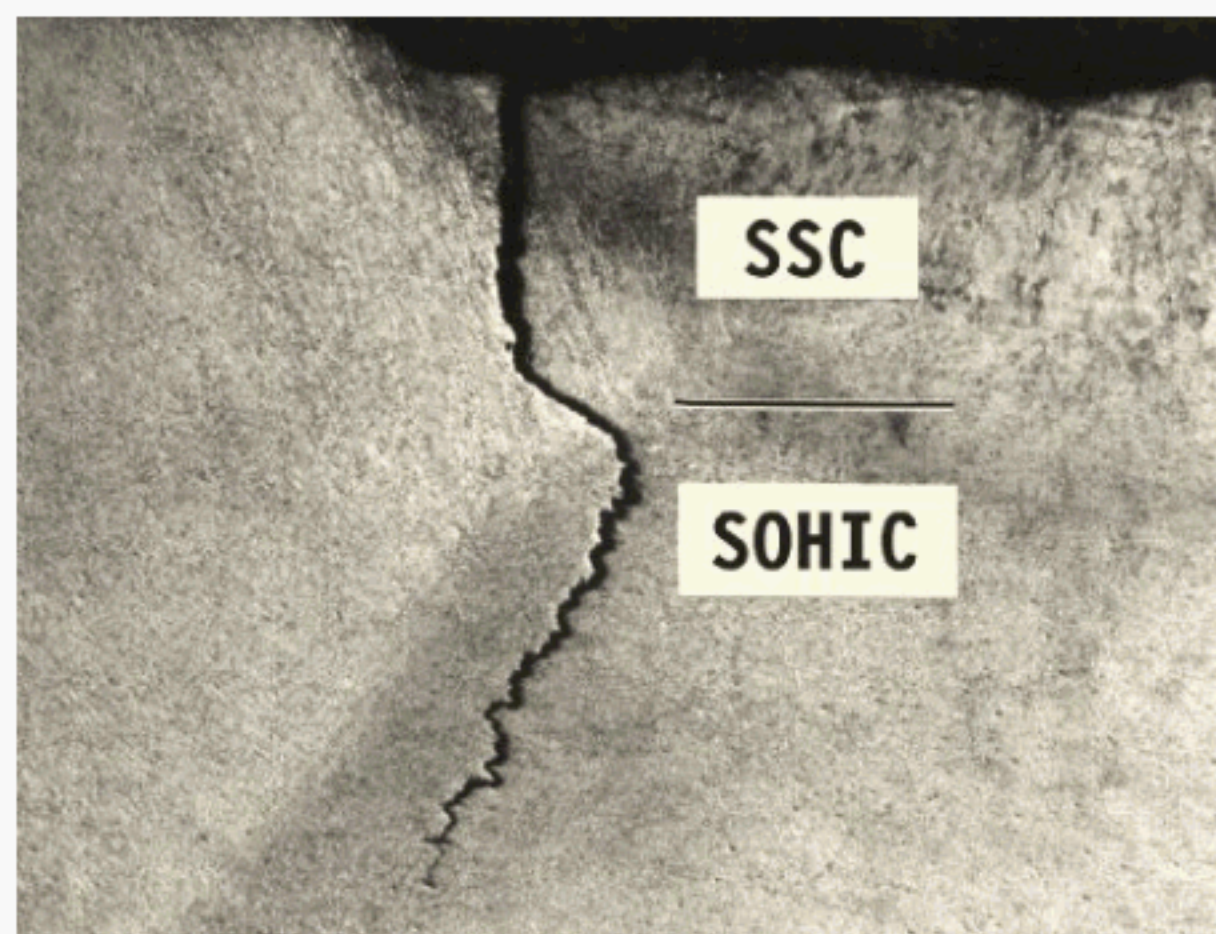
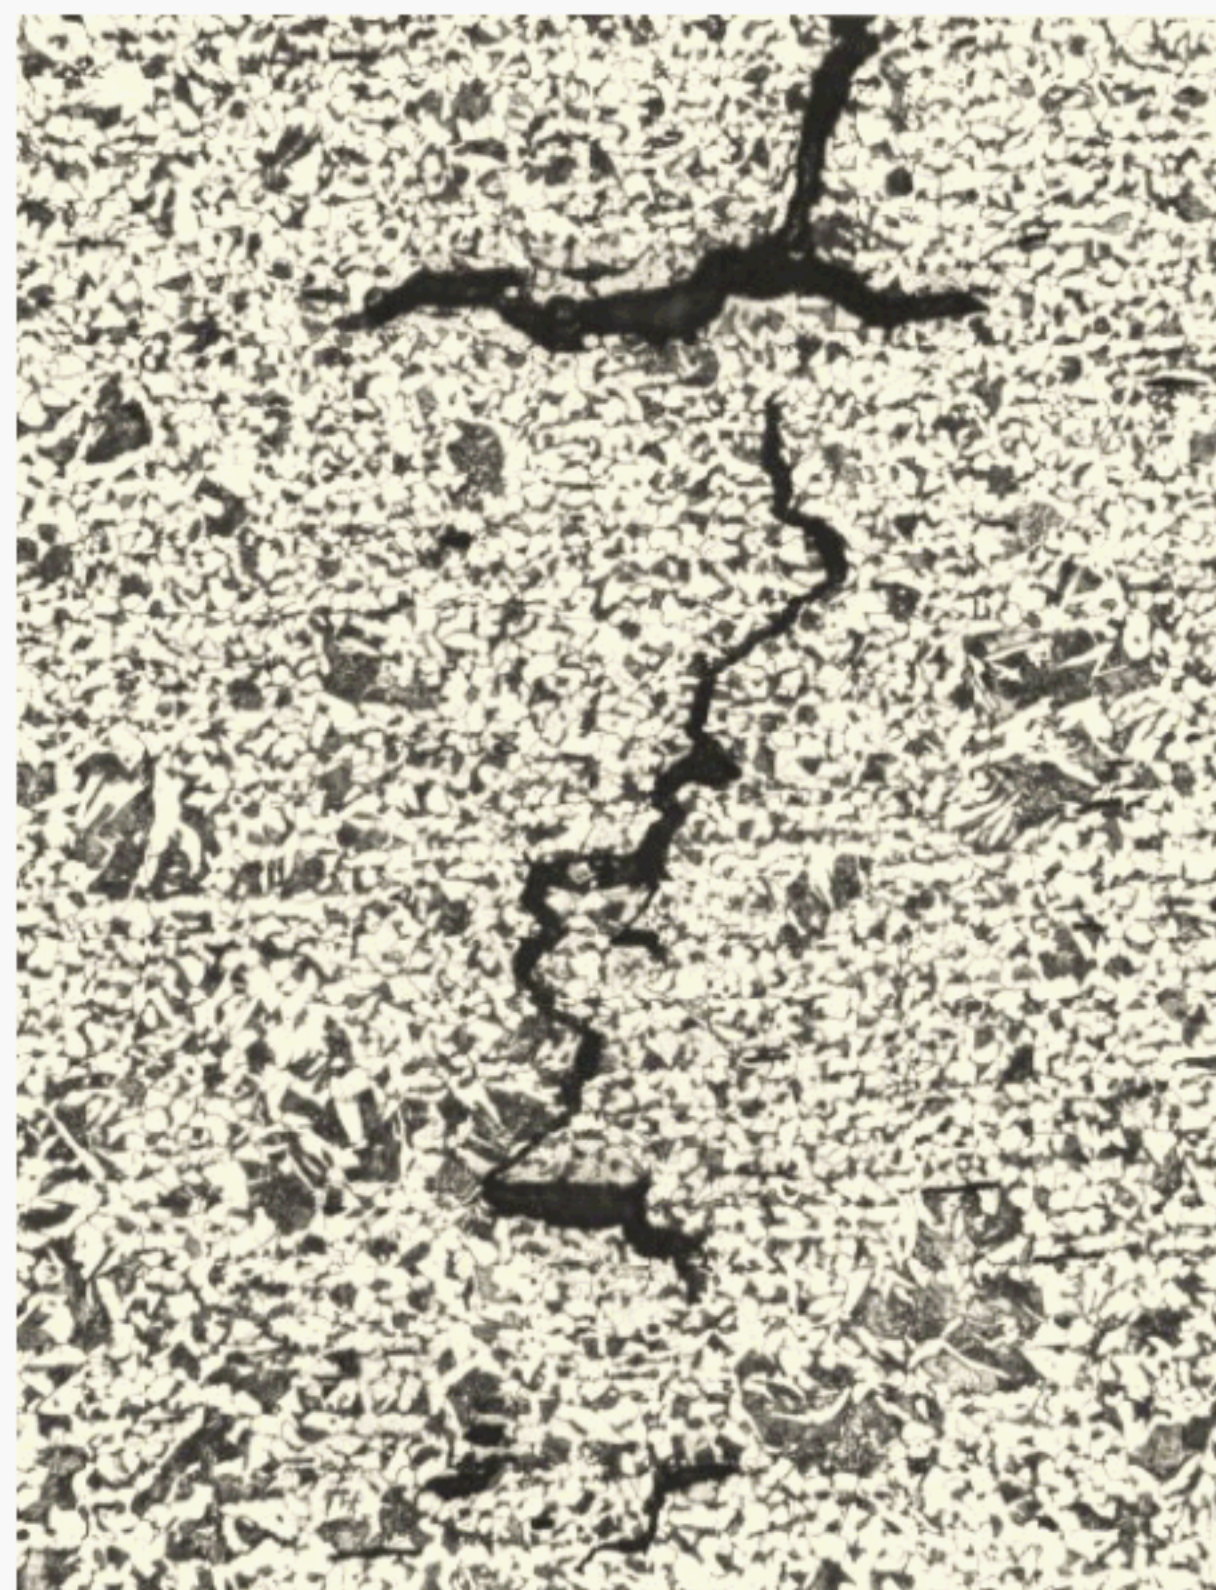
Figure A-4—Stress-Oriented Hydrogen-Induced Cracking

Note: The top panel is a two-percent nital etch at 2X magnification. The bottom panel is a higher magnification view of the crack tip shown in the top panel (two-percent nital etch at 200X magnification).

Figure A-4 shows SOHIC propagating from the tip of a sulfide stress crack in a hard heat-affected zone of a weld. In this instance, cracking progressed by a classical SSC mechanism through the hard HAZ, but then propagated by SOHIC in the adjacent lower hardness base metal. Although SOHIC often occurs at the process-exposed surface, or connects to a surface-breaking flaw, it has been found to exist subsurface only, with no connection to the ID surface. There is no evidence that hardness control of the weldment has any direct impact on reducing SOHIC. SOHIC has been found in steel with hardness less than 200 HB. However, hardness control might be of indirect benefit by reducing SSC, which can serve as an initiation point for SOHIC as illustrated in Figure A-4.

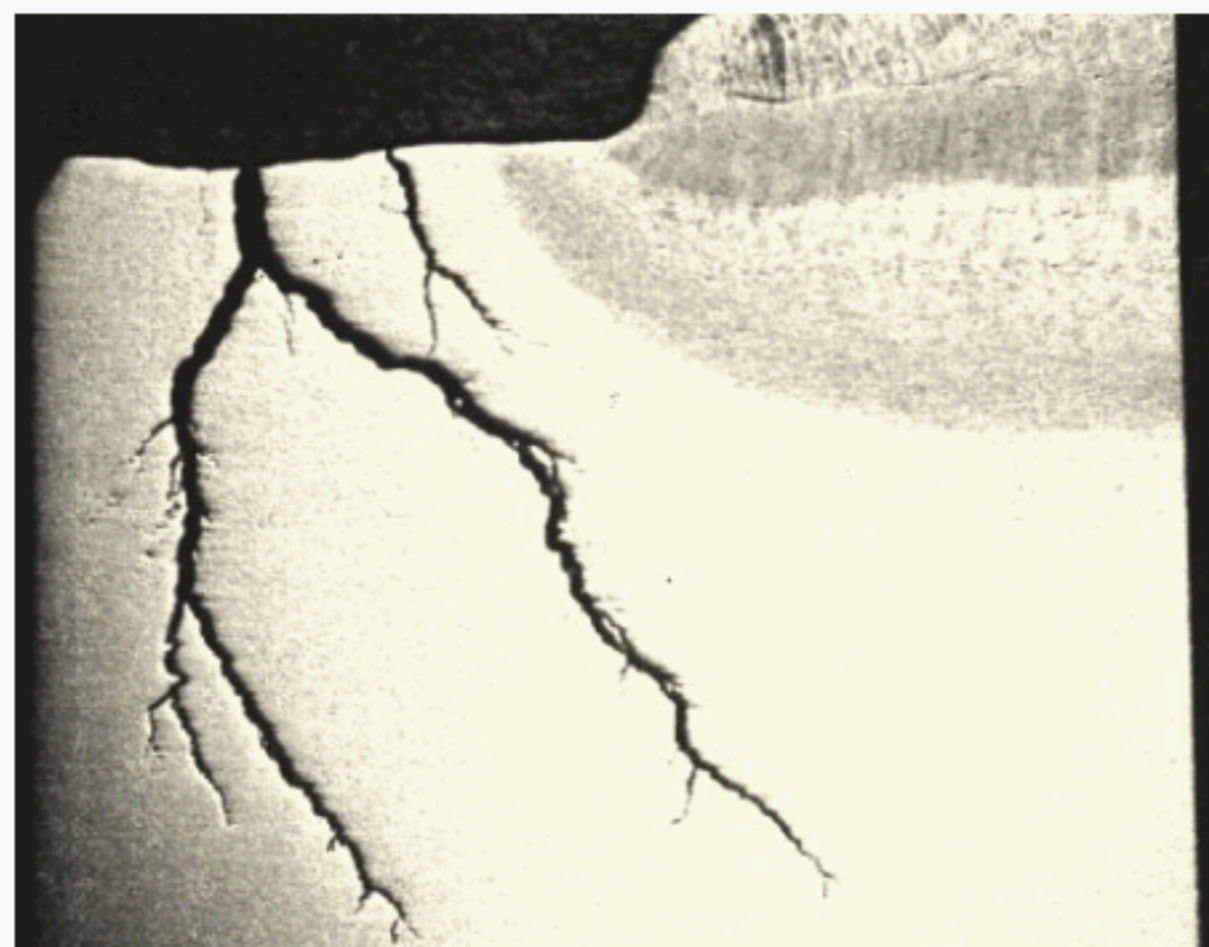
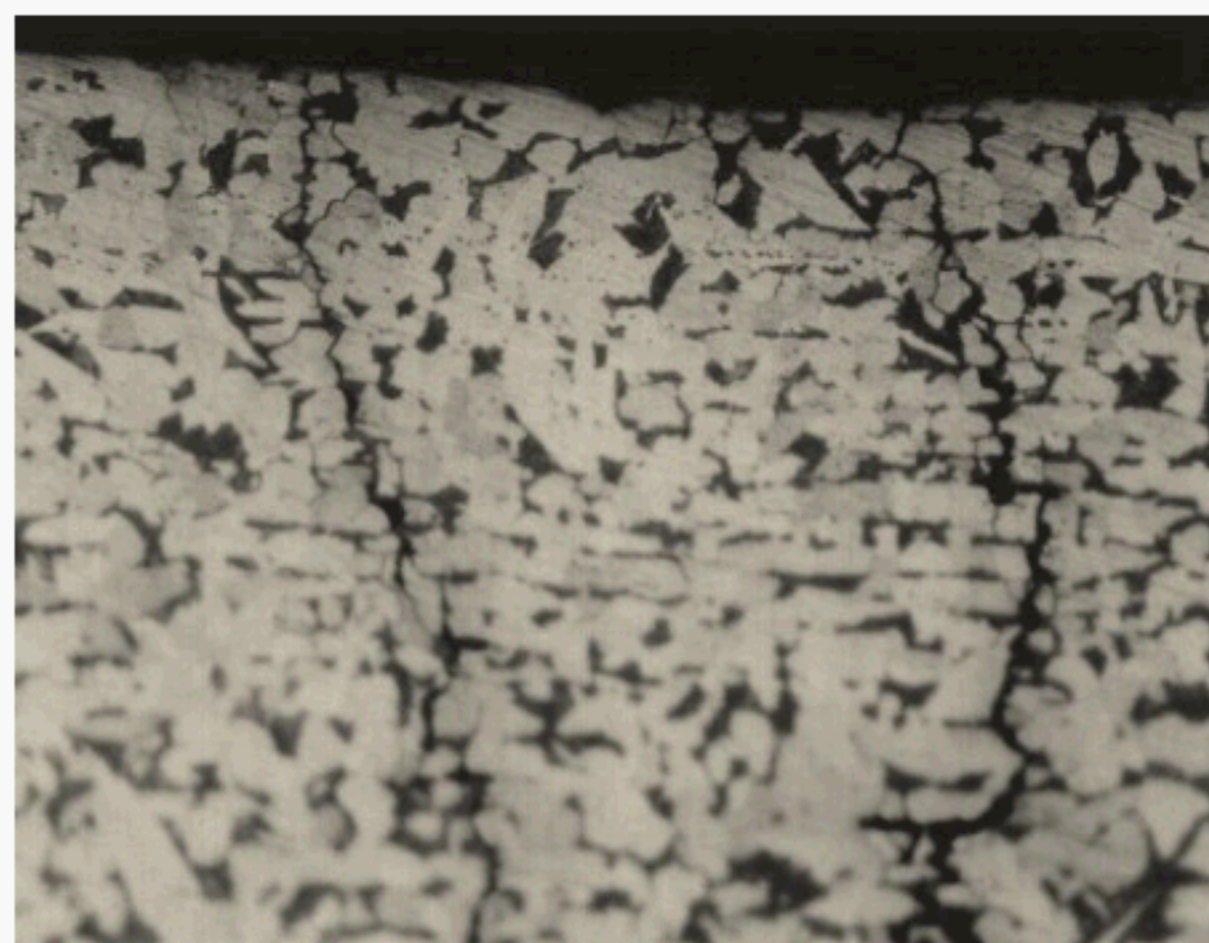
Figure A-5—Alkaline Stress Corrosion Cracking in the Vicinity of a Weld

Note: The top panel is a two-percent nital etch at 6X magnification. The bottom panel is a higher magnification view of the crack tip shown in the top panel. (2-percent nital etch at 200X magnification.)

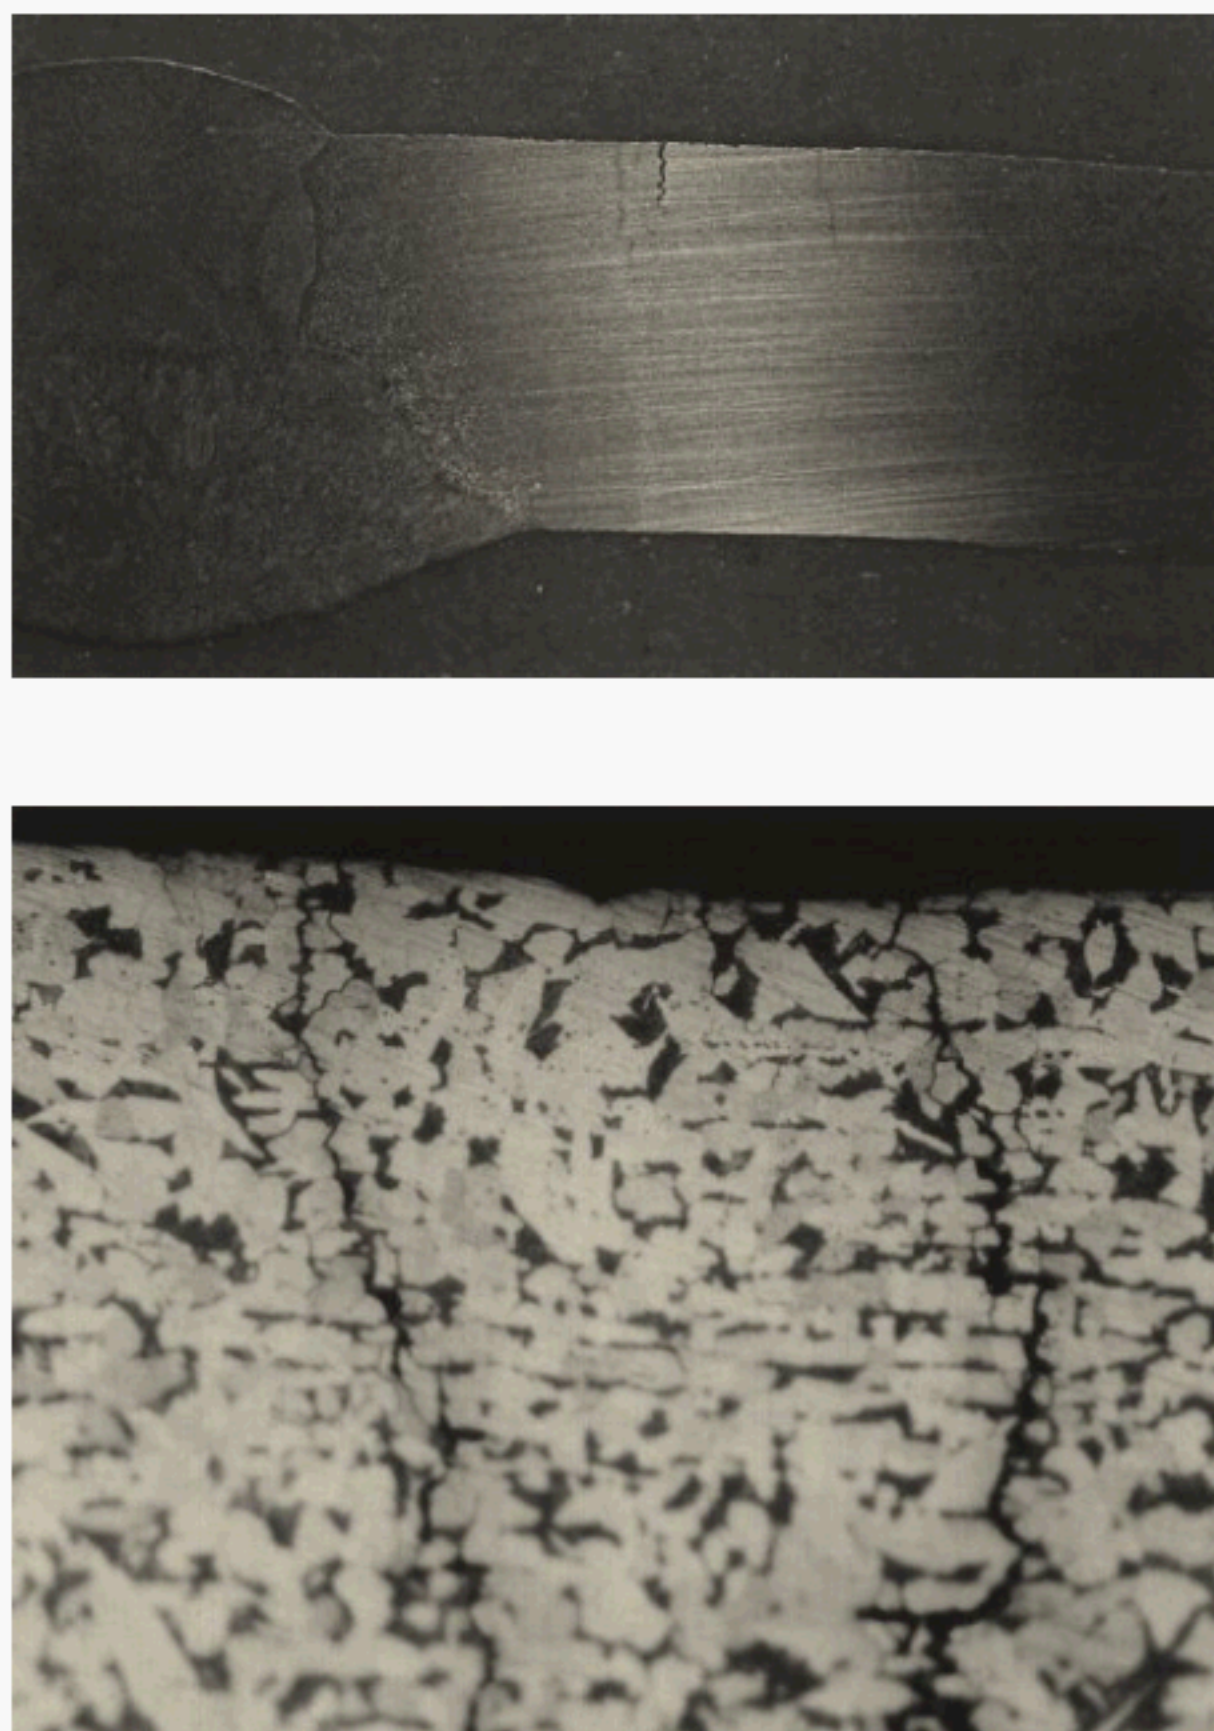
Figure A-6—Alkaline Stress Corrosion Cracking in a Pipe Weld in MEA Service

Note: The top panel illustrates alkaline stress corrosion cracks in a pipe weld in an MEA unit; nital etched specimen at 6X magnification. The bottom panel illustrates the intergranular nature of the cracks; nital etched at 200X magnification

The first example involved amine cracking (ASCC) in the overhead piping that was leading from the absorber column of an MEA unit. The line normally operated at 38°C (100°F), and carried a mixture of propane and butane. MEA was not usually present in the stream. However, MEA carryover may have occurred occasionally and this appears to have been the cause of the problem. Figure A-6 illustrates the parallel cracks that developed near a weld in the ASTM A106B pipe. The weld had not been stress relieved, and the material hardness at the cracks averaged 139 HB. The higher magnification photomicrograph clearly demonstrates the intergranular nature of the cracks.

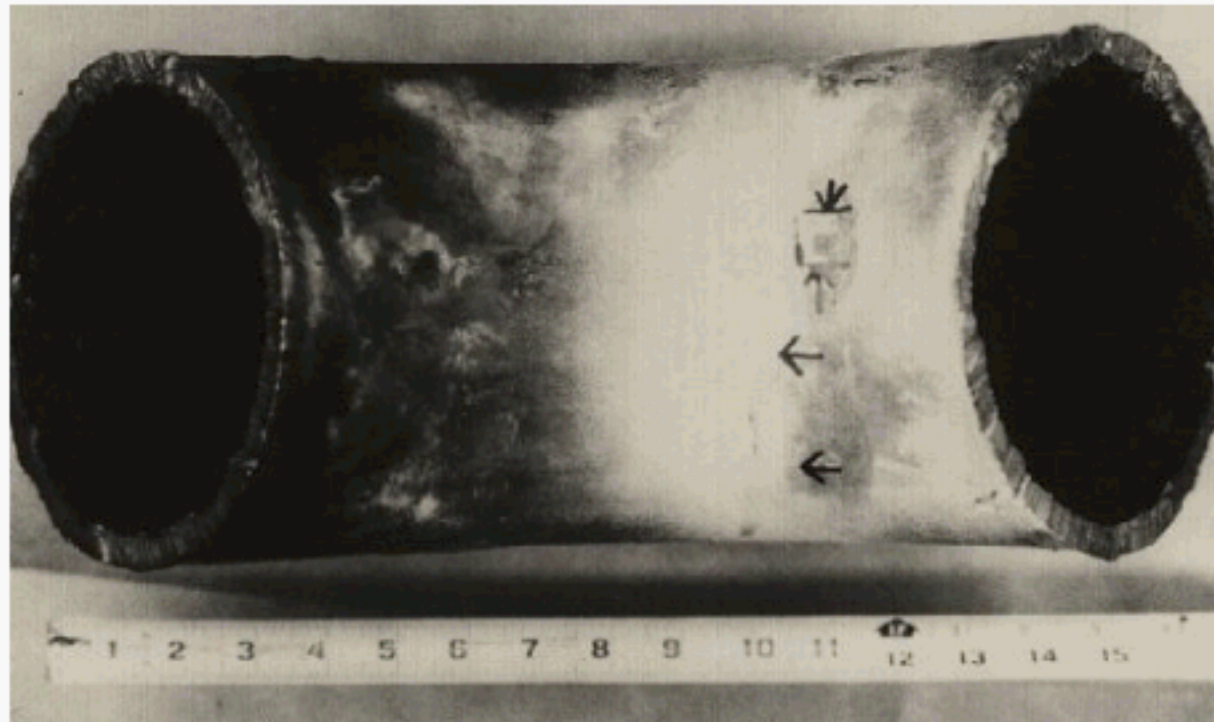
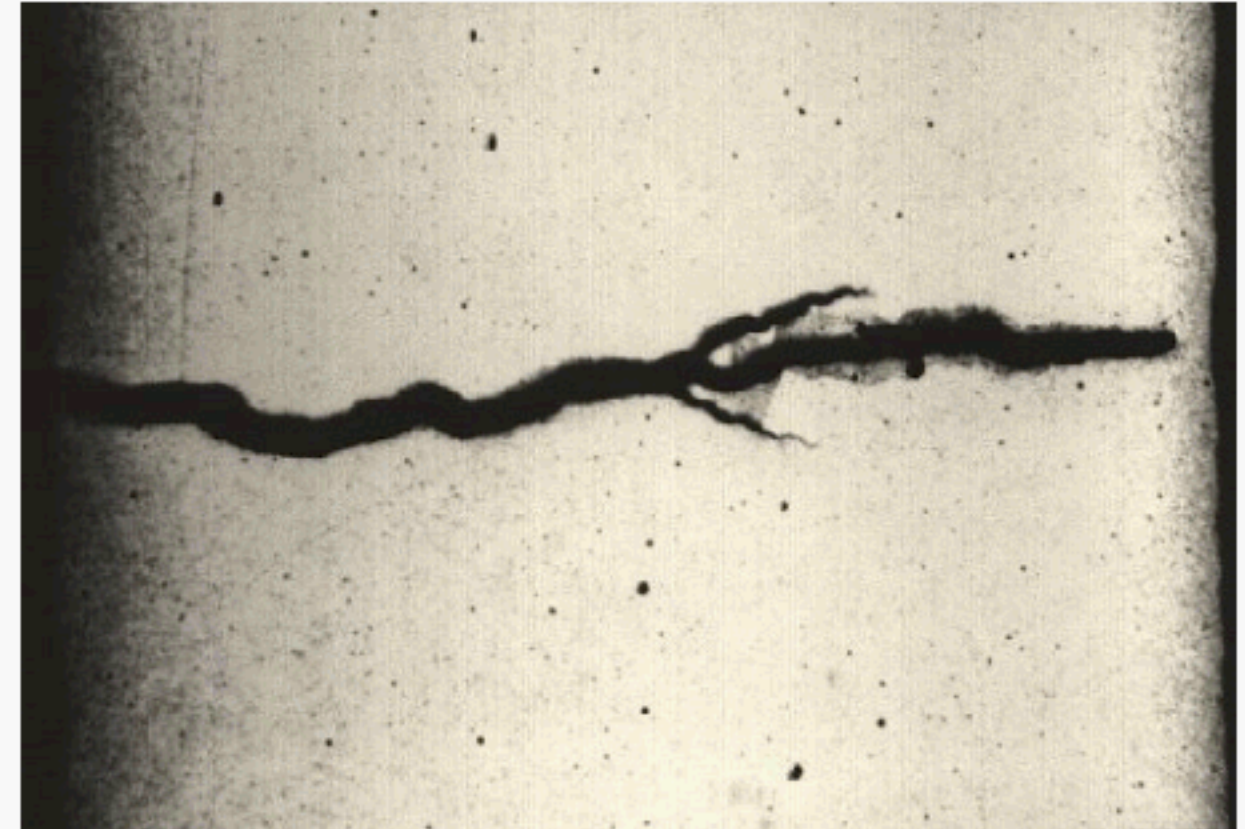
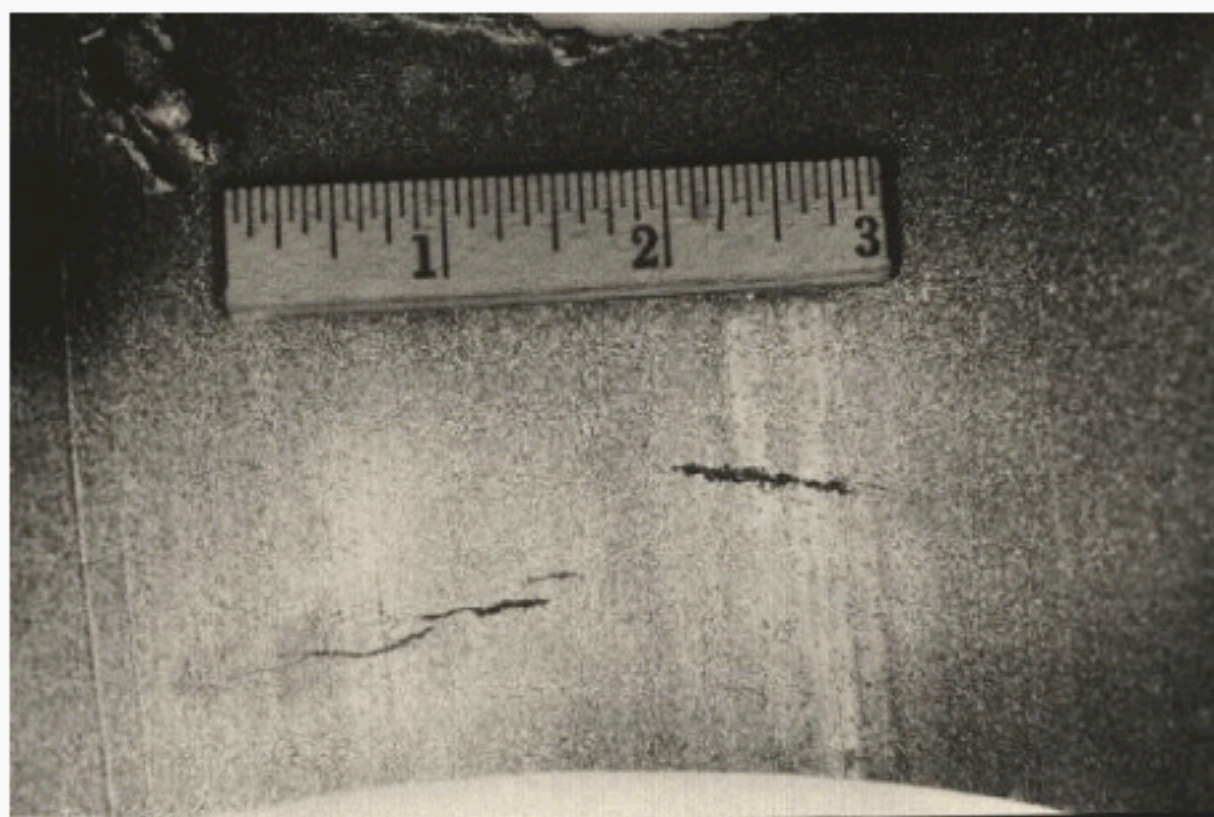
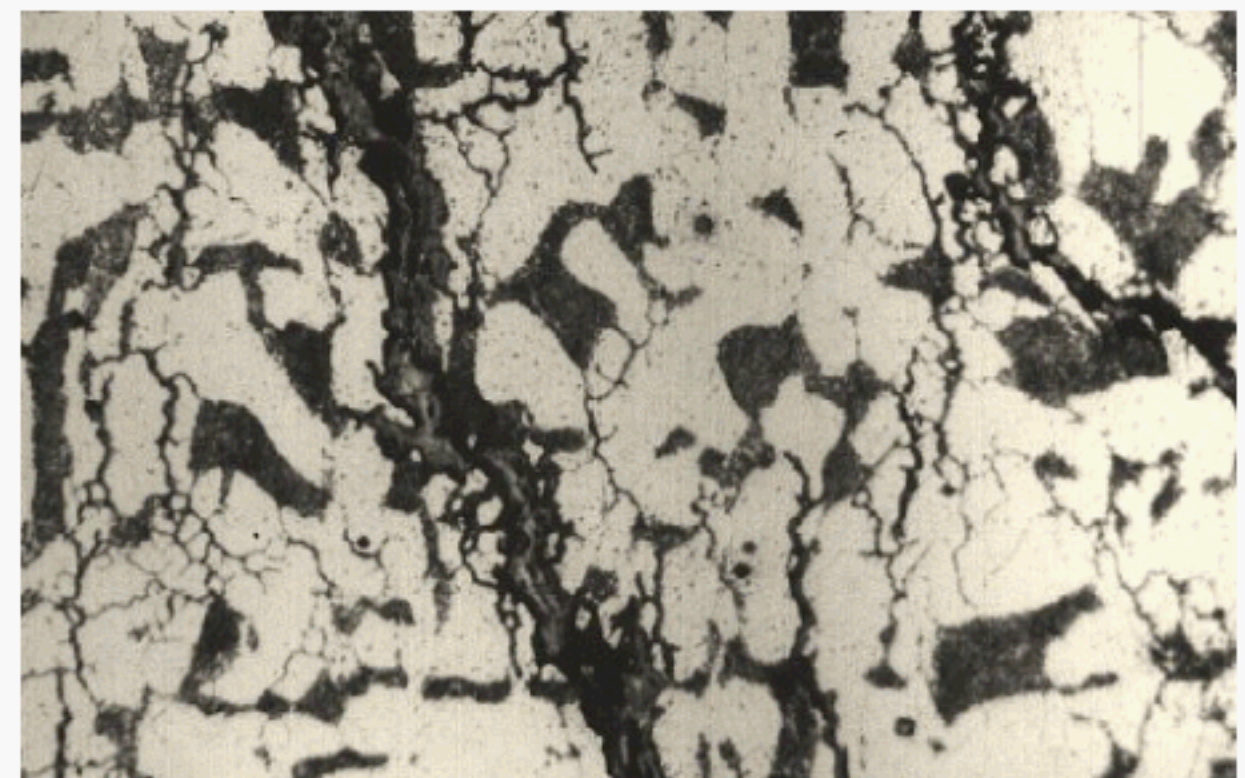
Figure A-7—Alkaline Stress Corrosion Cracking in an Elbow in DEA Service

Note: The top panel shows the location of circumferential cracks in a piping elbow from a DEA unit. The bottom panel confirms the cracks initiated on the ID surface.

The second example involved ASCC of a carbon steel elbow in the suction piping to the lean amine bottoms pump

in a DEA unit. The elbow was made to ASTM A234 WPB specifications, and the piping class required stress relief after welding. The operating temperature of the component was approximately 66°C (150°F). Prior to cracking, the elbow had been heated by a torch to approximately 1093°C (2000°F) to relieve pump strain due to piping misalignment. This heating procedure resulted in high residual tensile stresses in the elbow that subsequently cracked in service. To relieve residual stresses caused by the heating procedure, a stress relieving operation should be performed as outlined in 5.2.3.1. Figures A-7 and A-8 illustrate the intergranular cracking that initiated from the internal surface of the elbow, and verify that amine cracking occurred in the line.
